Appendix 1: Vegetation Map

Maitland Park, Hampstead London, NW3 2ET JCA Ref: 12818/JoC

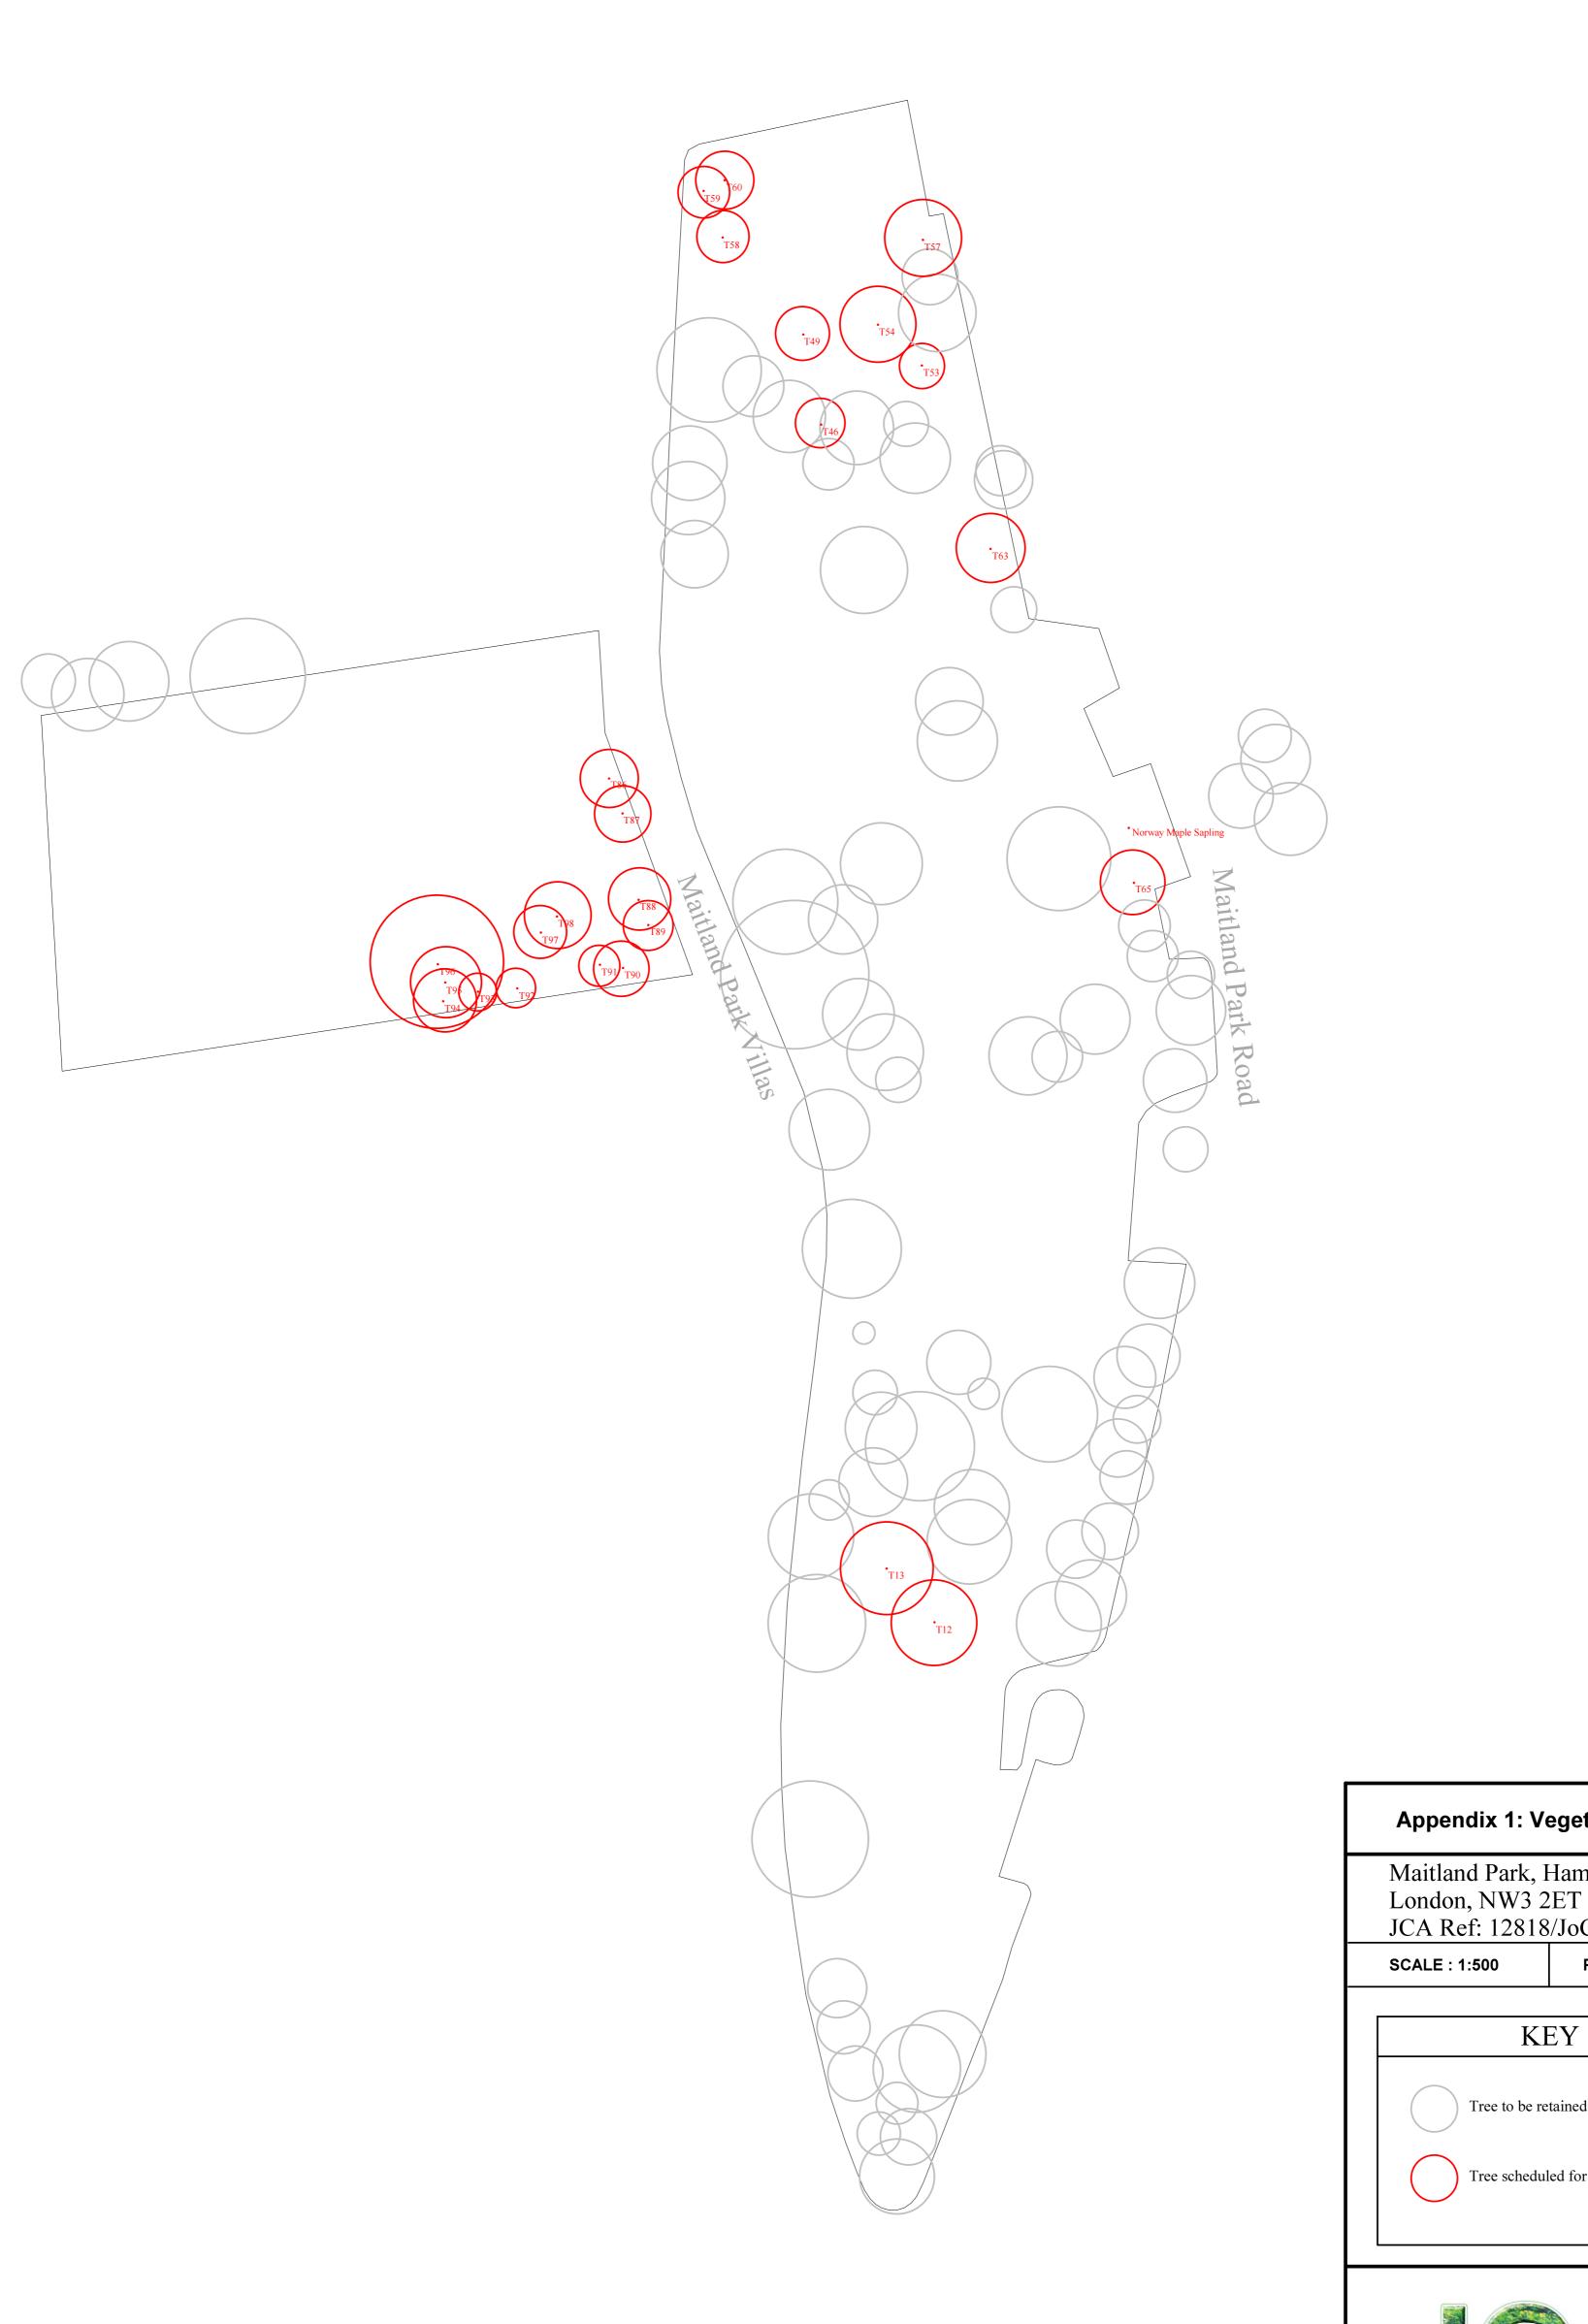
- 3.2.1 A plan detailing the trees present on site, as well as the location of any nests found can be seen in **Appendix 1**.
- 3.2.2 No birds were observed visiting the following trees and the canopies of these trees did not contain any evidence of bird nesting: **T12**, **T13**, **T46**, **T49**, **T53**, **T54**, **T59**, **T60**, **T63**, **T65**, **T86**, **T87**, **T88**, **T89** and the Norway Maple Sapling to the east.
- 3.2.3 **T57** is an Ash tree located to the northeast of the site. A bird's nest is situated within the canopy of this tree; however, after careful observation of this nest it can be determined that this nest is now redundant and works to this tree will not pose any harm on nesting birds.
