**EXISTING & PROPOSED
DIAGONAL SECTIONS M-M**
44 Downshire Hill, London NW3 1NU
1:50 9 May 2016 53036-2
Claymore Design & Build
copyright 2016

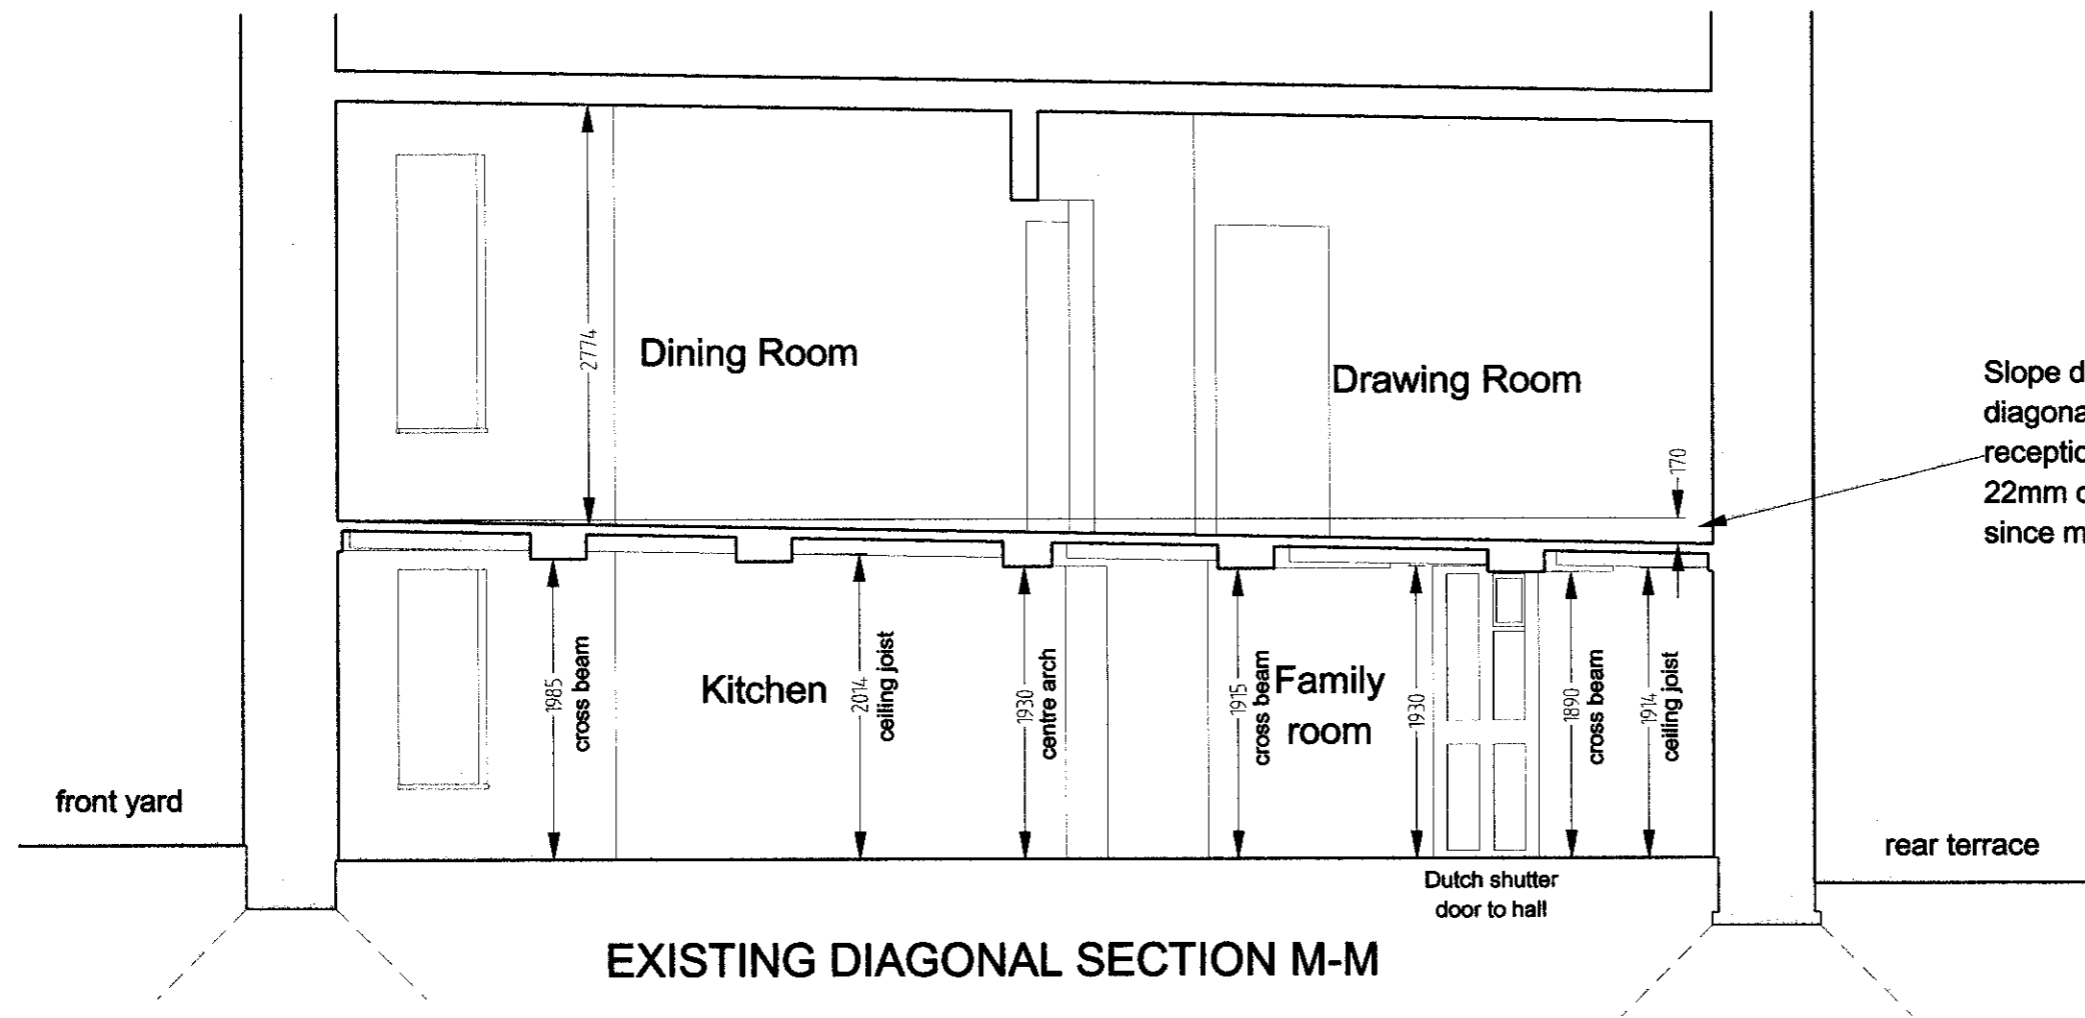
Slope difference of floors front to rear diagonally SW to NE corners on reception floor level 170mm drop. 22mm of settlement drop has happened since monitoring began in 1985.
