Design and Access & Heritage Statement
Application for Full Planning & Listed Building Consent
8 Rothwell Street, NW1 8YH

Updated 13.06.16

8 Rothwell Street

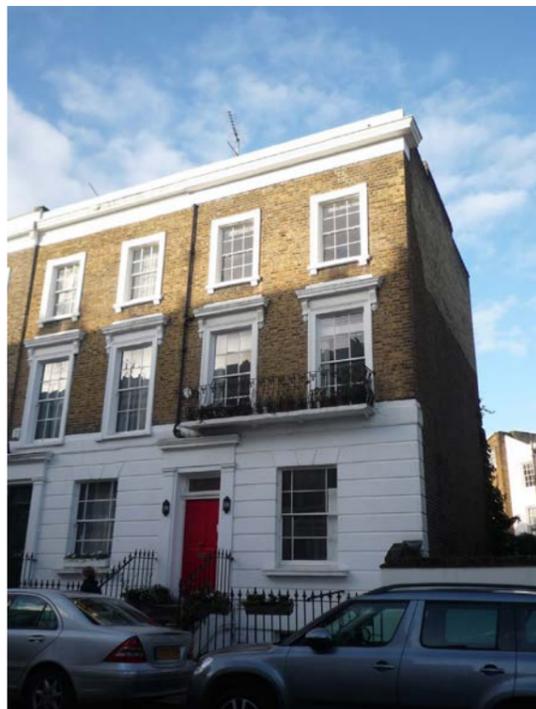
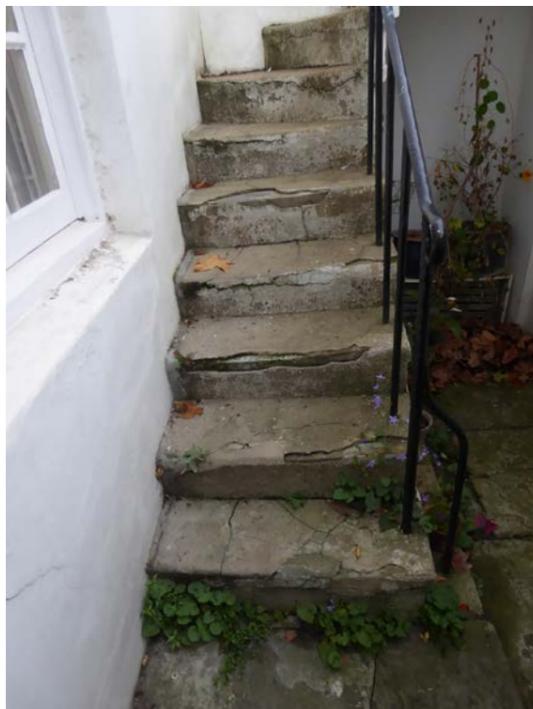
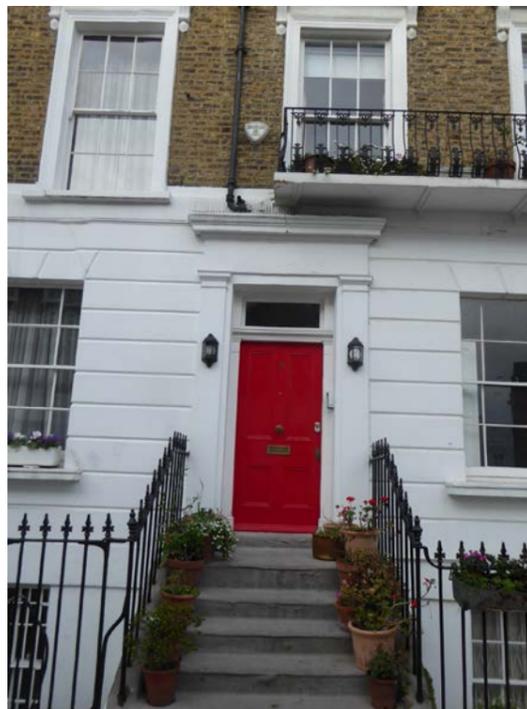
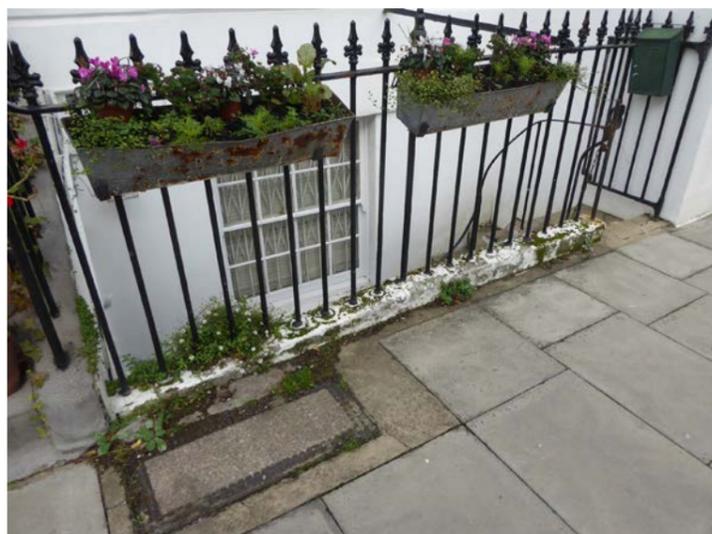
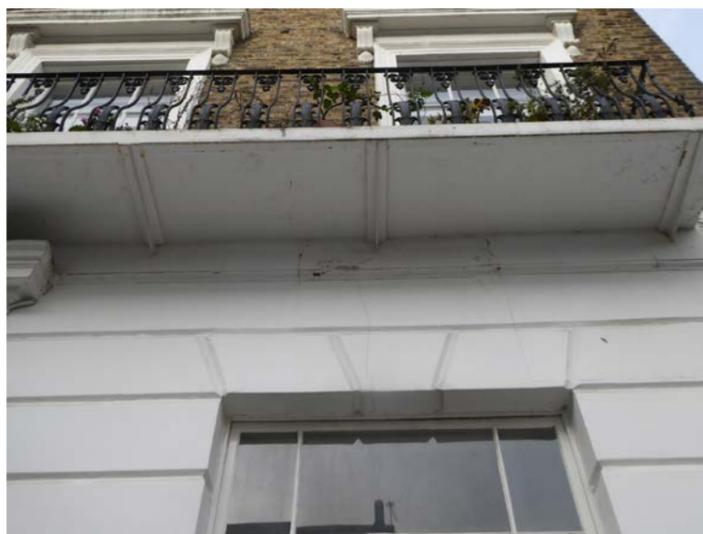
Original condition front façade of London stock brickwork and painted stucco detailing including a rusticated ground level and ornate surrounds to window and door openings and a roof cornice. London stock brickwork is visible on the two upper floors of the building and appears sound and the mortar pointing also generally appears sound. The render coatings to the wall on the two lower floor levels and around the projecting stone features to the upper windows and the cornice at roof level require minor repair and redecoration. The top section of the rendered parapet wall which rises above the main roof and the projecting cornice below is missing lead cappings. The balcony, which projects from the front wall at first floor level, has been historically reconstructed with a cast concrete slab. The original iron railings to the balcony appear to have been refitted as these match the other buildings in the terrace. The concrete structure balcony is in reasonable condition but has no waterproof finish over the top surface of the balcony which may pose a risk of moisture ingress to the metal reinforcement in the concrete balcony structure. The windows are covered with years of paint, both to the interior and exterior surfaces. A pair of modern wall lights are located either side of the front door on the pilasters. A defunct soil pipe runs above the entrance across the 1st and 2nd floor that is likely to have served a former bathroom to the front of the property. Original cast iron railings with urn finials to the entry stair, street perimeter and 1st floor balcony appear in good structural condition but poor decorative condition.

Photo survey (clockwise from top left) View of front and flank walls; front light well and steps; entrance door and steps; 1st floor balcony; iron railings to street

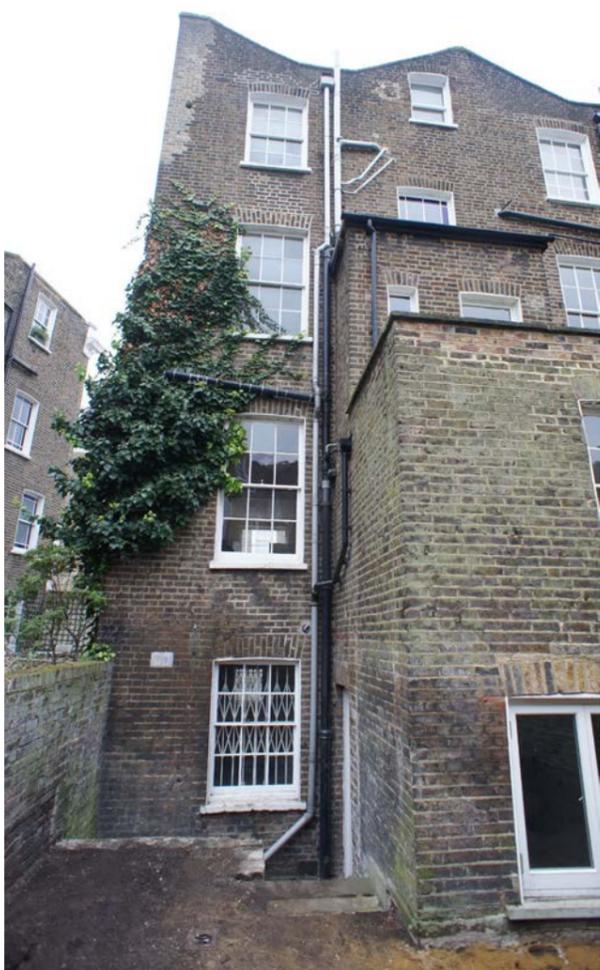
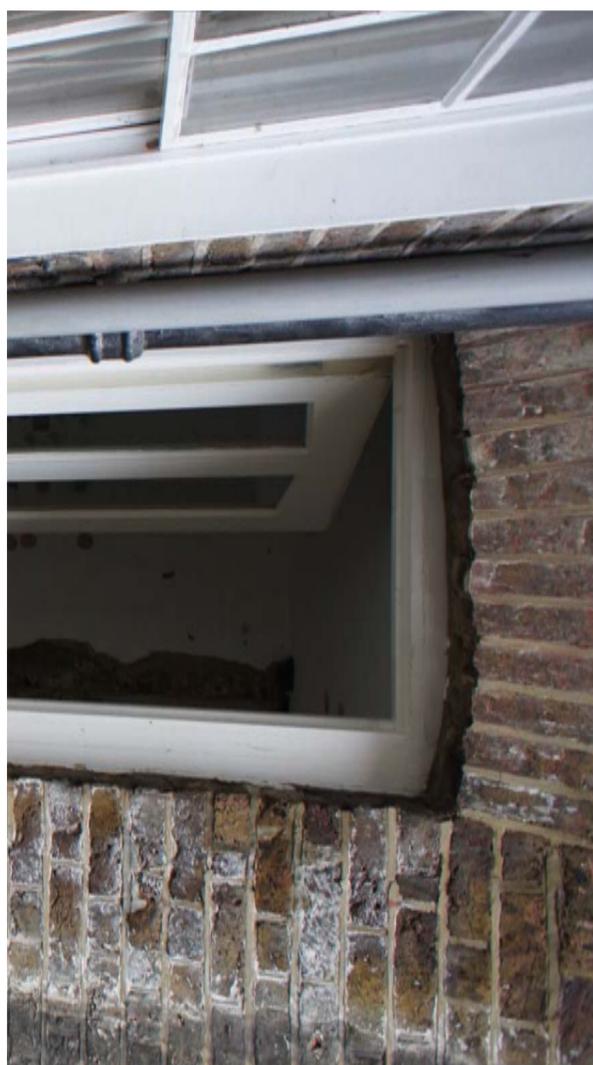
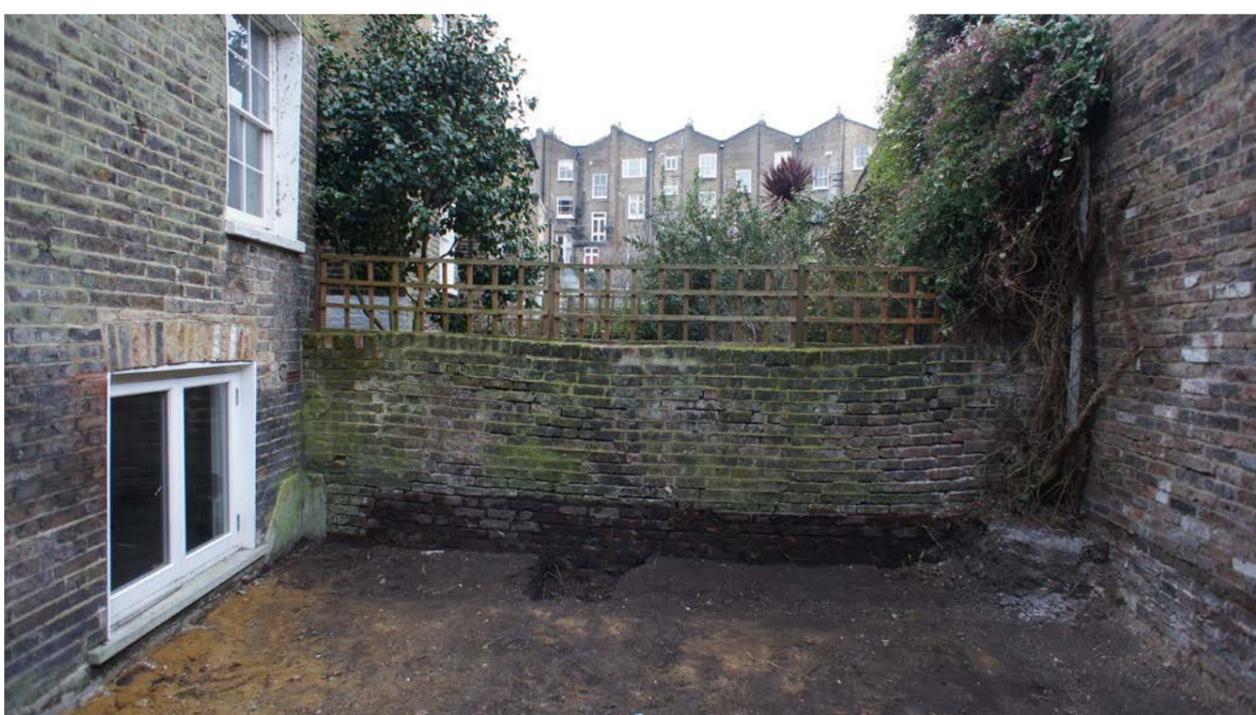
The rear wall of the building has a traditional 'V' shaped parapet to the butterfly roof line. The upper section of this parapet wall coping is quite weathered and the pointing to the upper sections of the wall below eroded. There is also some missing pointing to the walls of the rear addition structure, most notably the rear wall of the addition at basement and ground floor levels. The top section of the flank wall (not shown) also has some missing and eroded pointing. An area of brickwork at 2nd floor level has been reconstructed at the rear and flank walls (around 30-40 years ago) with a visible joint between the old and new brickwork on the rear corner of the building. The joint which is visible to the top of the rear wall is slightly open and there is some minor cracking visible internally in the top rear bedroom. This indicates slight separation of the new and old sections of masonry. In addition an area of brickwork over window W 2.3 is bowing toward the roof and the one brick thick wall under the same window's splayed reveal is loose. The windows are covered with years of paint, both to the interior and exterior surfaces. Rainwater disposal from the main roof is to the rear of the building via the central valley gutter which drains to a PVC hopper mounted on the rear wall. The connecting PVC rainwater pipe passes down to ground level but simply spills onto the floor at the base of the wall. This will increase the risk of damp penetrating into the base of the wall and causing internal damp problems. There is also evidence of leakage of the rainwater pipe serving the rear addition roof causing water saturation and staining of the exterior brickwork to the side of the kitchen door below. The arrangement of the PVC rainwater and drainage pipework to the rear wall has become convoluted and messy due to historic reconfiguration of the property.

Photo survey (clockwise from top left) Rear elevation from upper garden level; lower garden level; Closet wing rear at upper garden level.

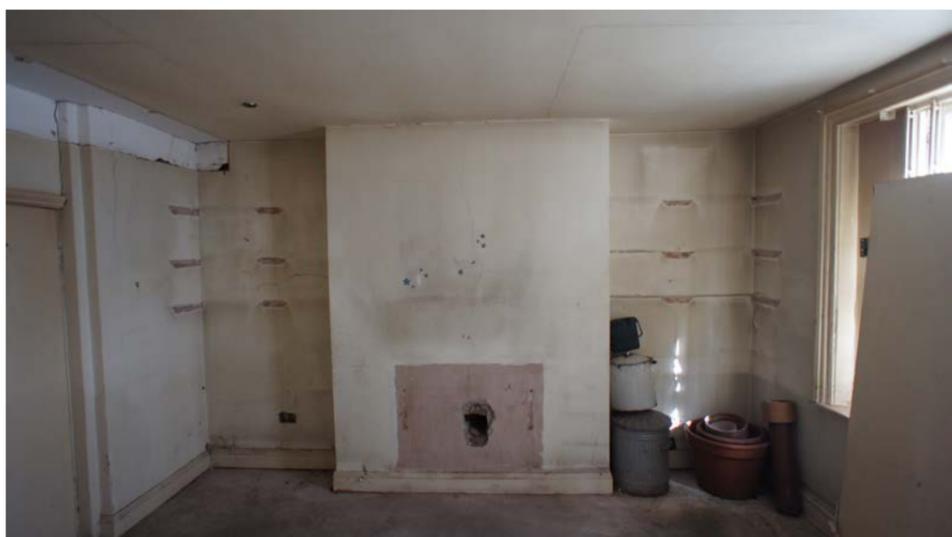
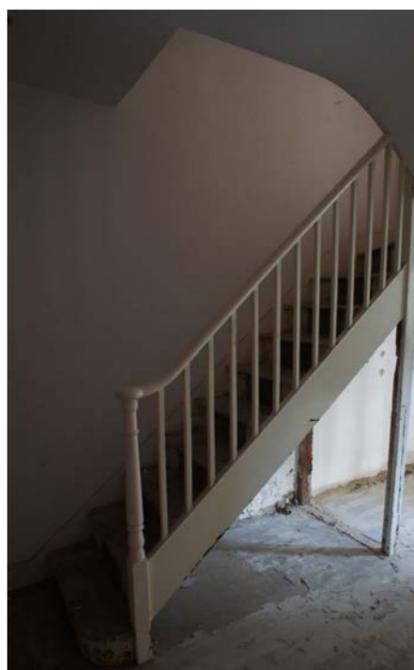
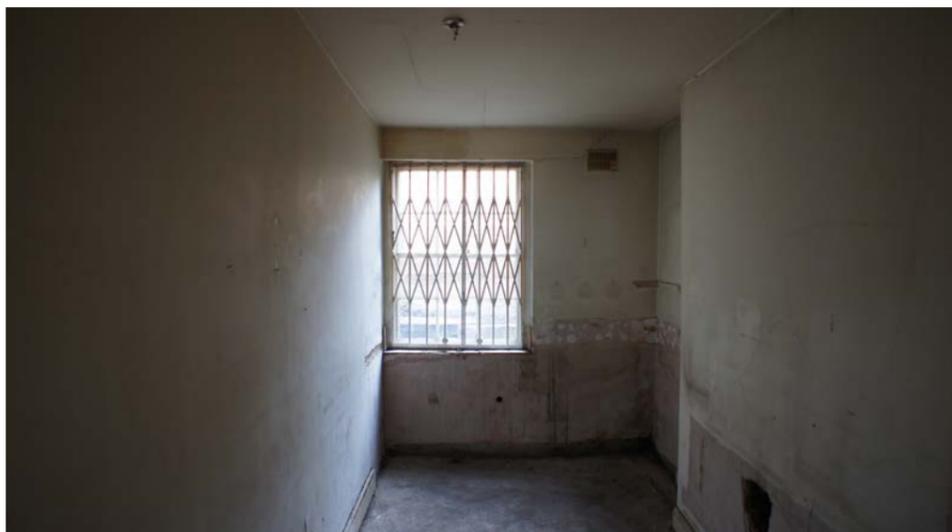
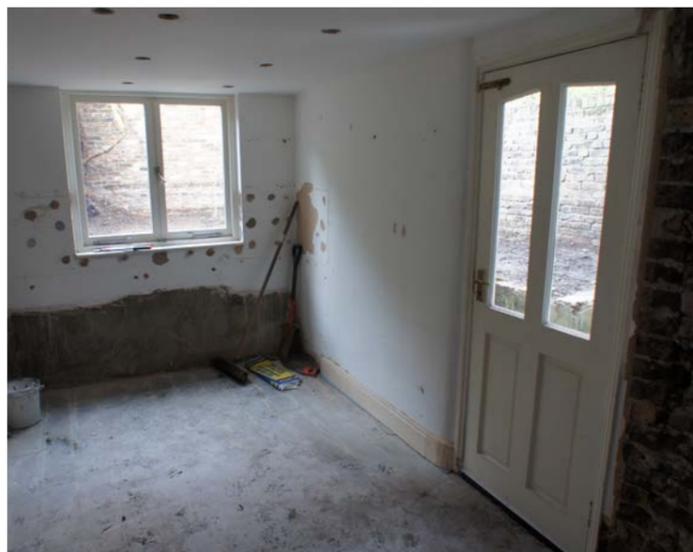
Photo survey (clockwise from top left) Studio flat living room; Main dwelling staircase; Main dwelling closet wing; Studio flat kitchen;

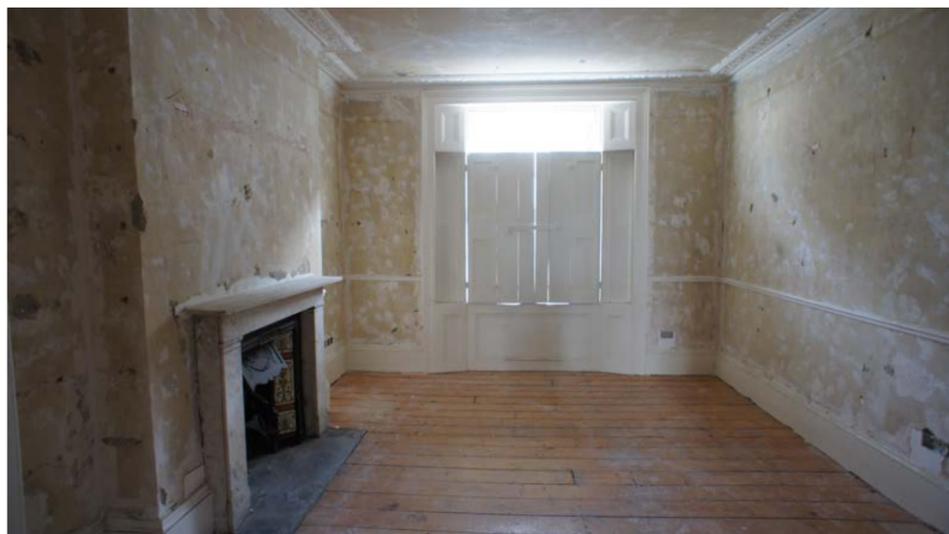
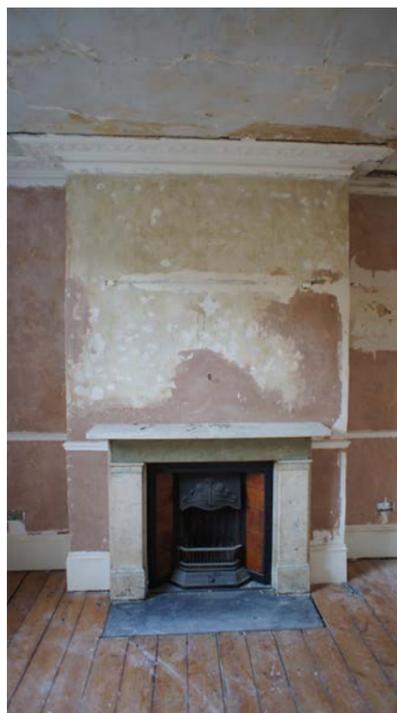
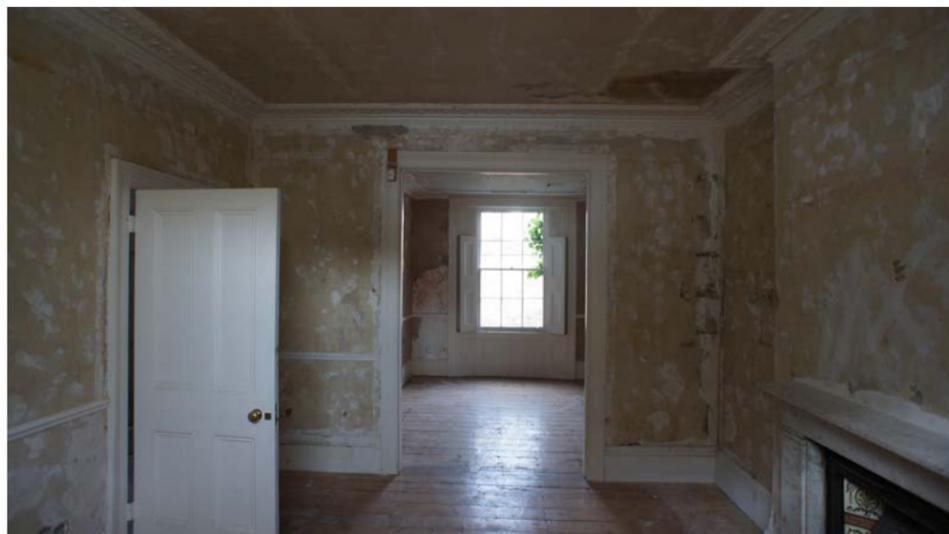
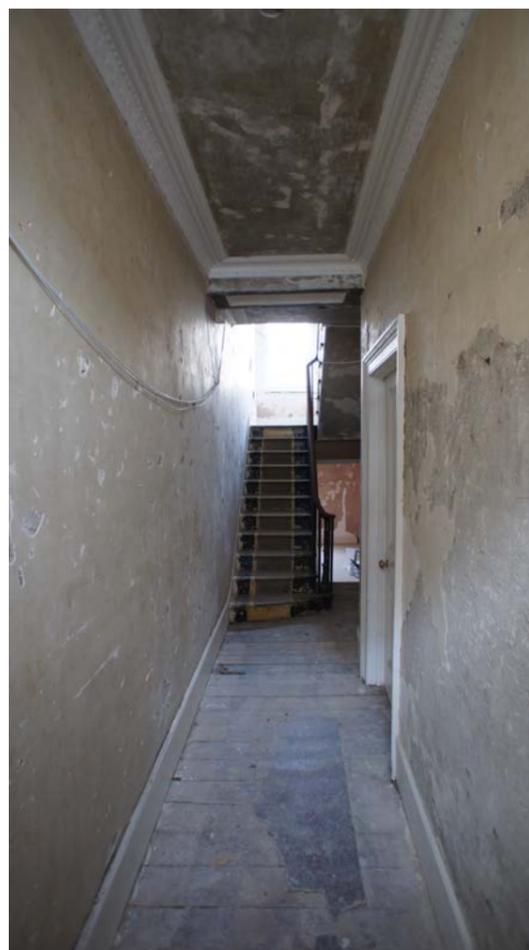
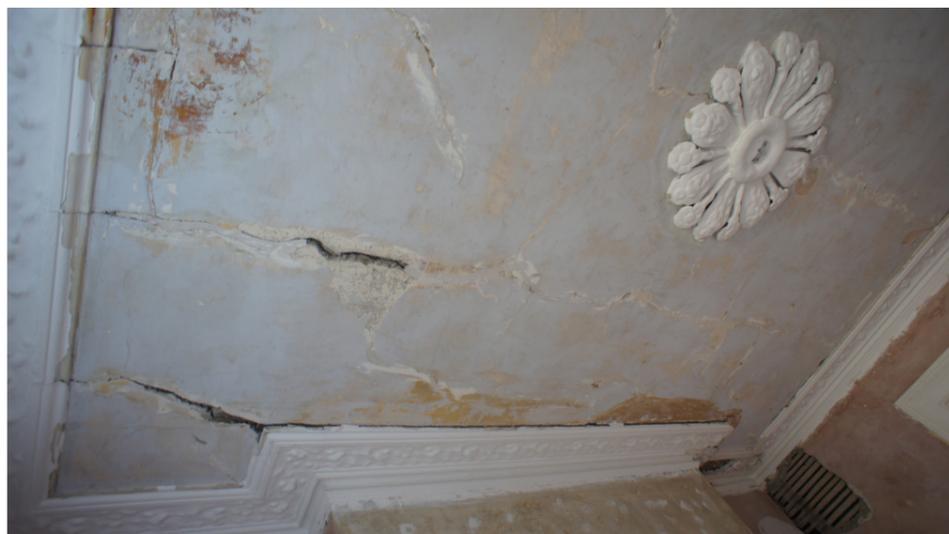
Photo survey (clockwise from top left)
Front living room view from spine wall;
Rear living room fireplace; Hallway view
from front door; Ceiling and rose in rear
living room; Front living room viewed
from window.

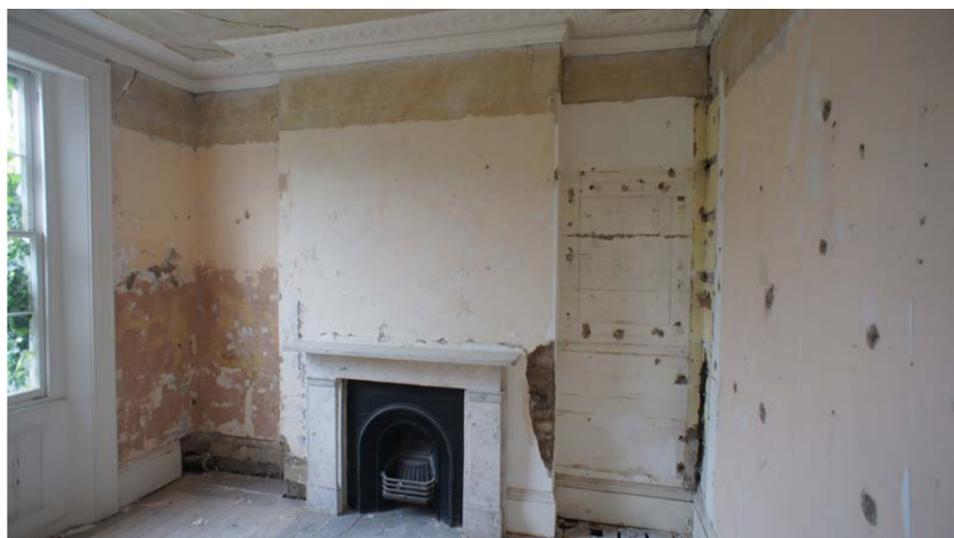
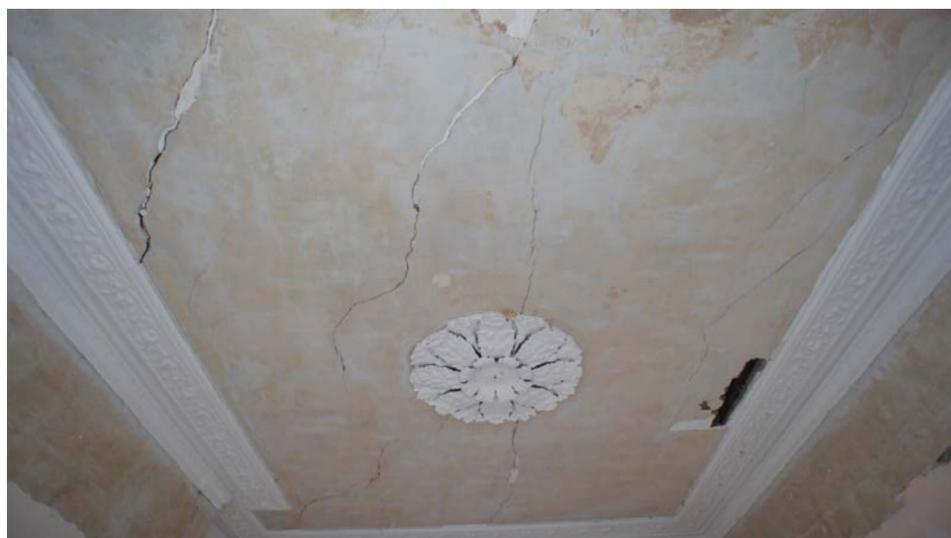
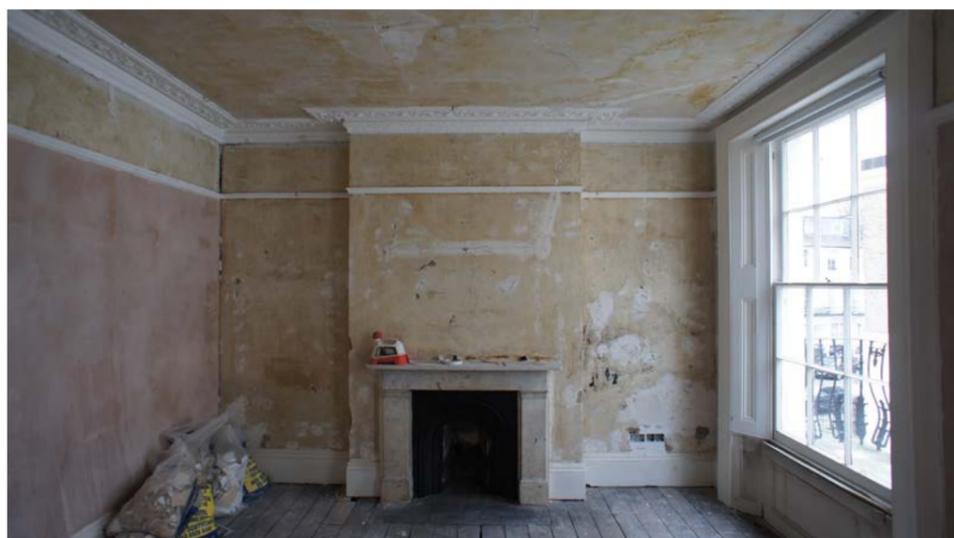
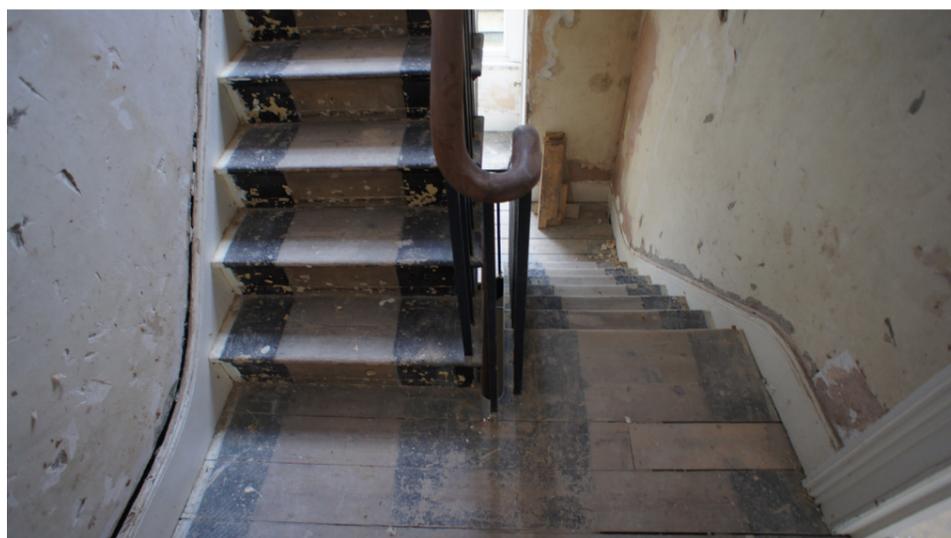
Photo survey (clockwise from top left) Rear Bathroom; Rear Bathroom ceiling; Front Bedroom; Staircase detail

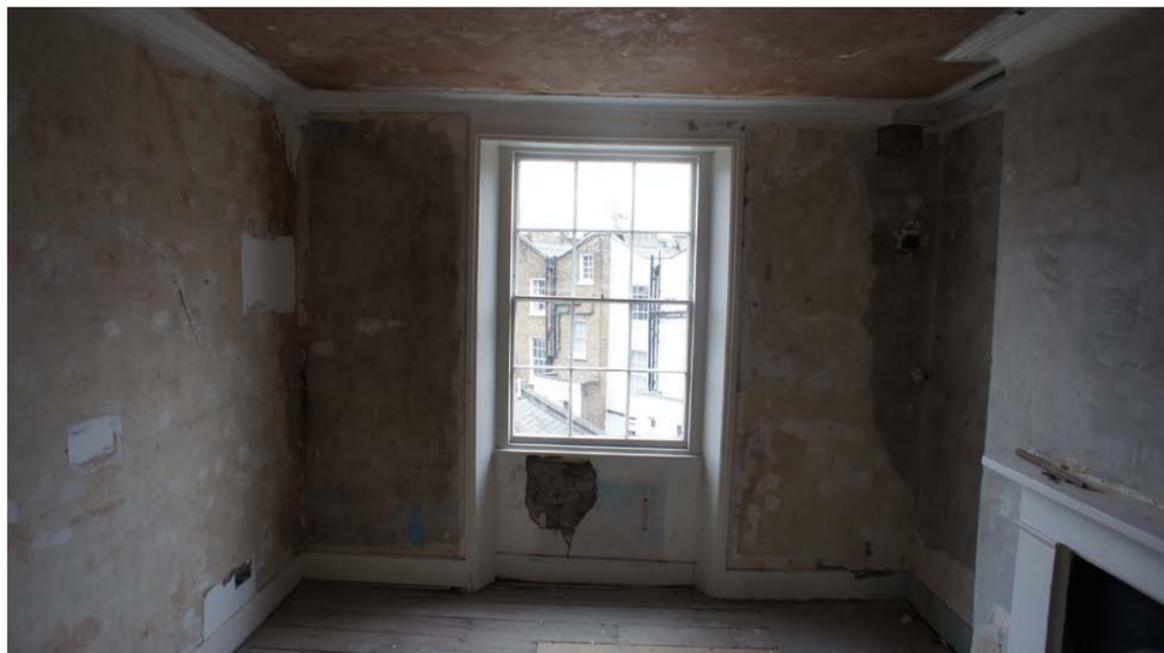
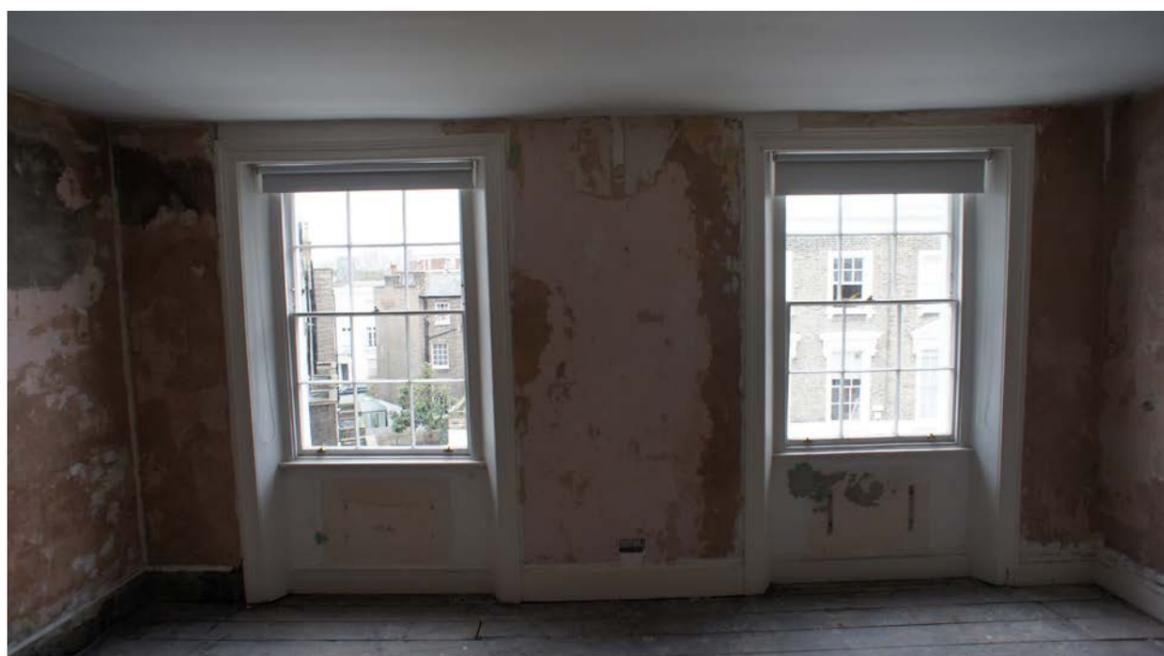
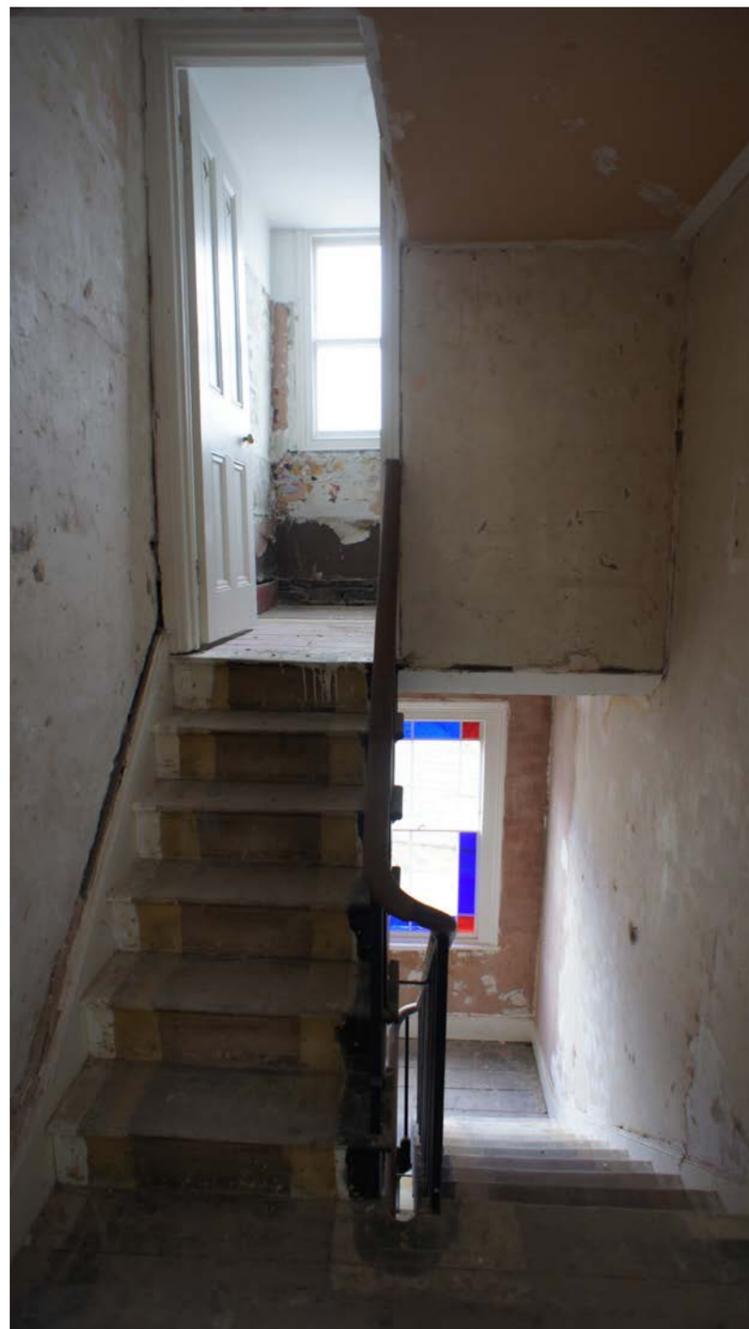
Photo survey (clockwise from top left) Rear bedroom; Front Bedroom; Staircase and Bathroom on upper landing

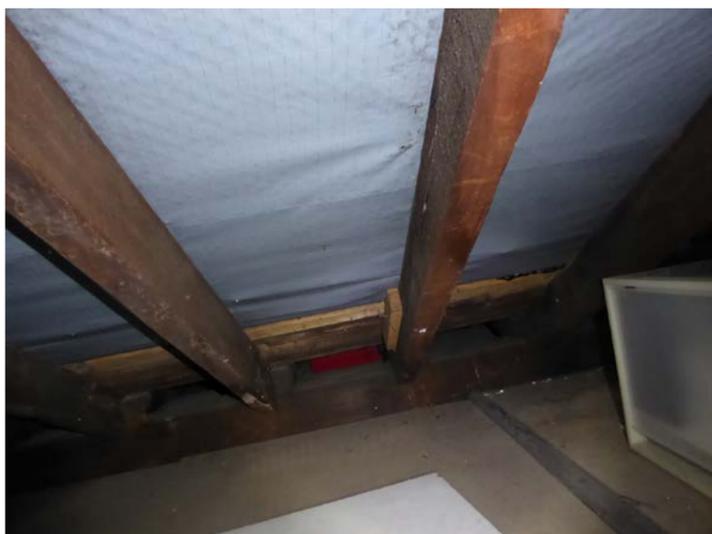
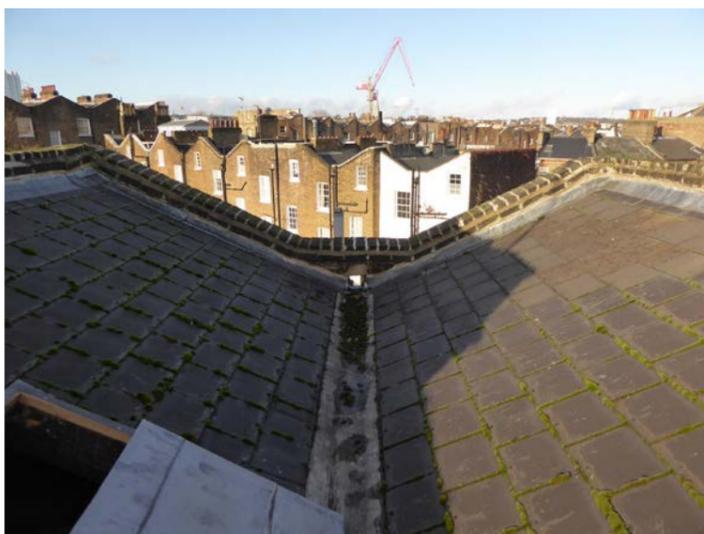
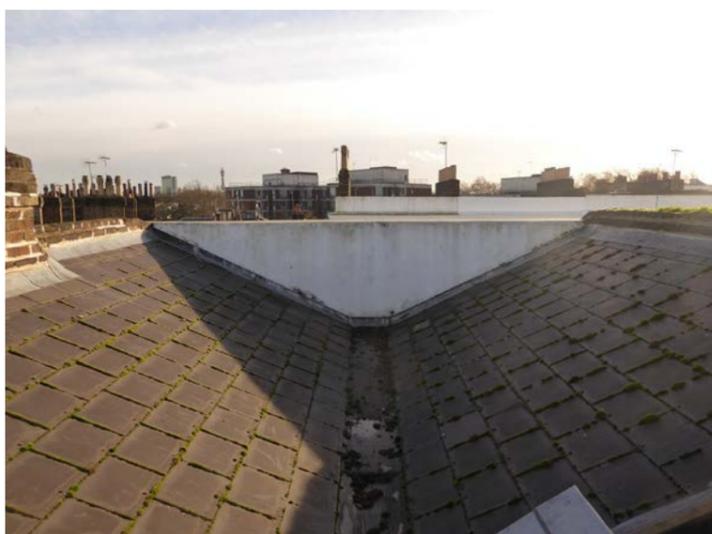
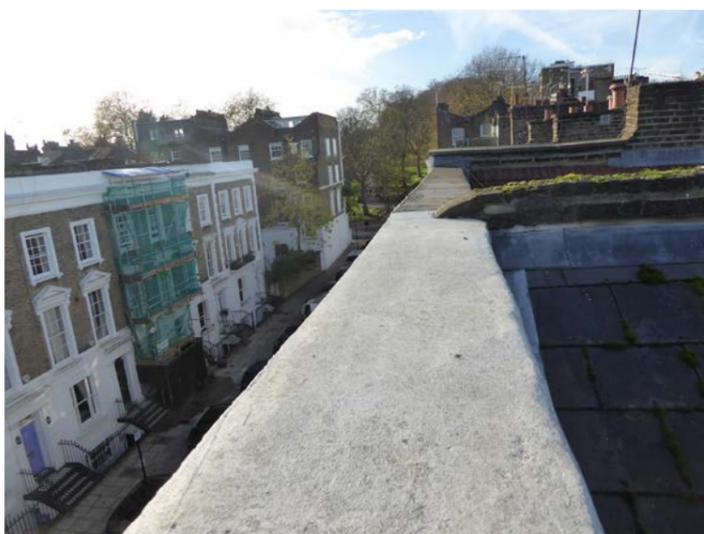
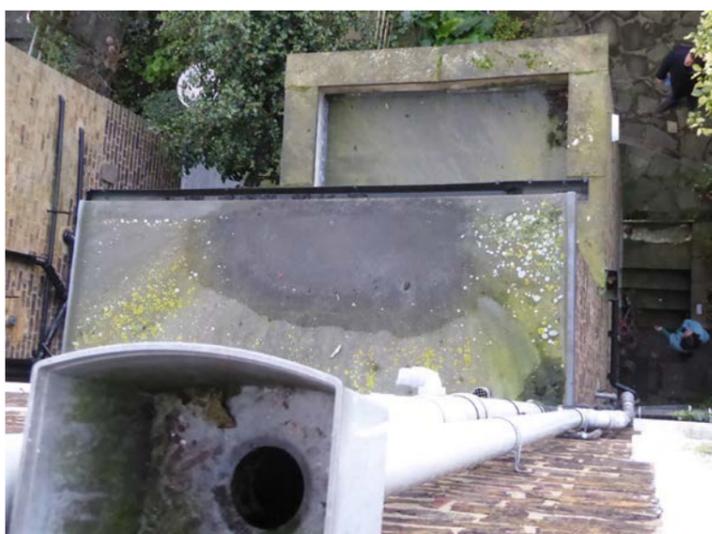
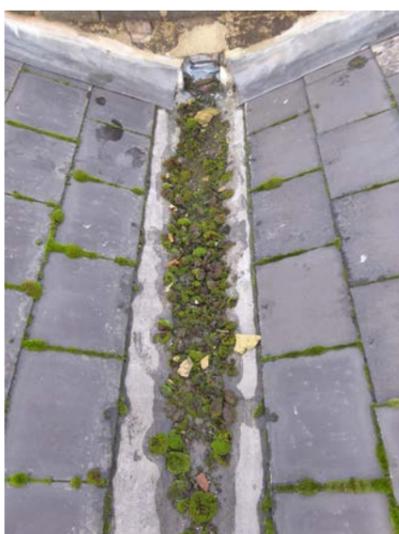
The main roof to the building is a butterfly type with a central valley gutter and two roof slopes pitching from the party and flank walls either side down to the valley. The roof slopes are clad with artificial fibre cement slates that are probably 30-40 years old with heavy moss growth sealing the joints between the slates. The condition appears acceptable but the tiles are likely approaching the end of their life expectancy. Where the slate covering abuts the parapet walls to the sides and top of the roof slopes there are lead cover flashings dressed into the masonry above that generally appears in sound condition. The slates are positioned over a plastic underlay fitted over the timber structure. This plastic underlay will be airtight preventing any meaningful ventilation through the slate covering. This poses a risk of condensation problems occurring within the roof void or to the underside of the slates. The central valley gutter to the roof has been overlaid with asphalt and there are splits and deterioration visible to the surface. The solar reflective paint coating to the asphalt is badly deteriorated leaving the asphalt exposed to direct sunlight and at risk of further damage. The front end of the gutter above the front bedroom ceiling is set to inadequate falls, causing water to pond on the surface of the gutter above the ceiling. The rainwater goods (hopper and drainage) are modern grey PVC-U fittings.

Photo survey (clockwise from top left) Plastic DPM over rafters; View toward rear parapet; front parapet coping; central valley gutter; rear rainwater goods; view toward front parapet.

The roof coverings are approximately 30-40 years old and elements of the roof are in need of repair. It is proposed to match the existing materials during the repair work or, where the scope of the repair allows, to reinstate original materials such as lead and slate that have historically been replaced with modern materials. The central valley gutter will need to be relaid to appropriate falls to avoid ponding. The plastic roof underlay will be replaced by a modern breather membrane to address any potential concerns with condensation. Insulation and a vapour control layer will be incorporated into the roof void and will not affect the visible build-up of the roof.

All existing PVC rainwater goods will be replaced with heritage type, socketed metal hoppers and downpipes in black.

Lead flashing will be reinstated to the coping at the street elevation to match the neighbouring property.

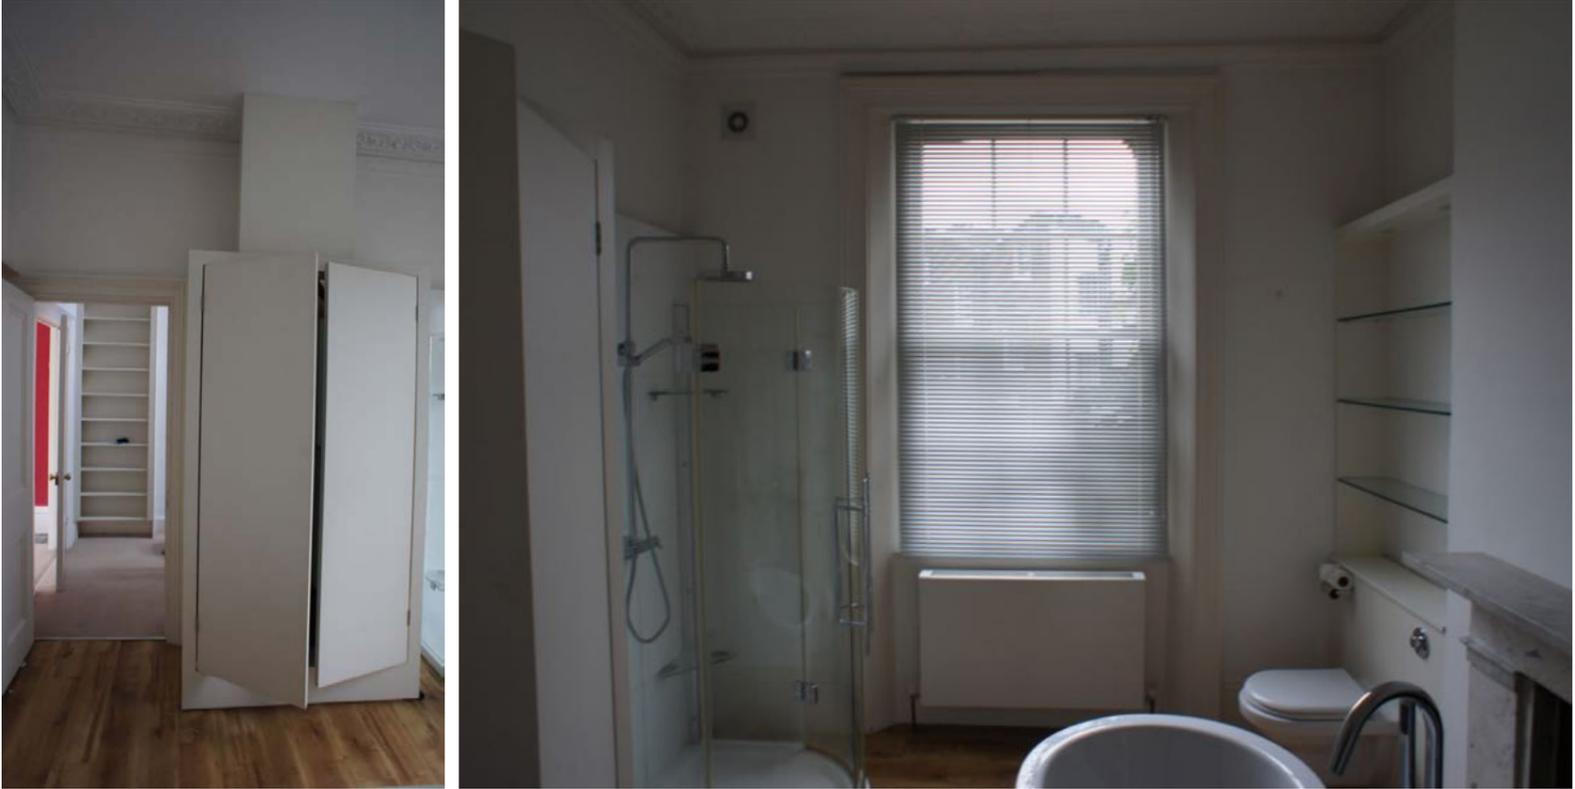
Master Bathroom as laid out by previous occupants: large boiler cupboard, left; view from spine wall to window, right.
