<b>Arboricultural Advice</b>		<b>Prepared by:</b>	<b>Hal Appleyard</b>
<b>Project:</b>	<b>2 Maresfield Gardens, London NW3</b>	<b>Produced for:</b>	<b>AZ Urban Studio</b>
<b>Date: 13.06.16</b>	<b>Ref: ha/an1/2maresfield</b>		
<b>Planning Ref:</b>	<b>2015/6894/P</b>

## 1.0 Introduction

## 2.0 Tree root investigation report

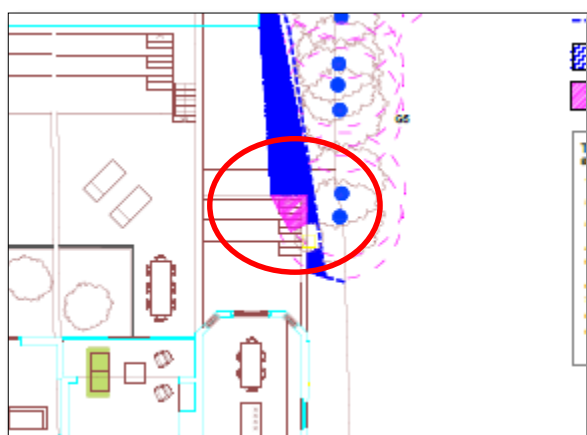
Fig. 1 Root investigation work location as requested by Camden Council (hatched area circled)

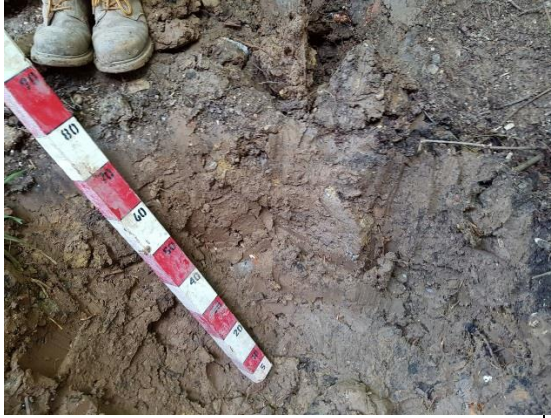
*'We [Ruskins] excavated a small pit around 90cm deep and 1 metre square, through thick heavy clay (the Air Spade was very very slow and we carefully hand dug where it was not working). **We found no roots.** The pit was much smaller than anticipated due to the adjacent and very large manhole cover. The extent of works in light of the manhole cover were agreed on site.'*

Negligible rooting within the heavy clay	The robust inspection chamber is arrowed and prevents lateral root growth

- 2.3 In view of the very heavy clay conditions, the lack of substantial rooting and the presence of existing physical root barriers to lateral growth, the prospect of harm arising to the retained trees within G5 is very low. This is not to say however, care is to be taken when excavating in this area for the construction of the proposed steps and it will continue to be prudent to undertake this work manually in the first instance, with specialist supervision.

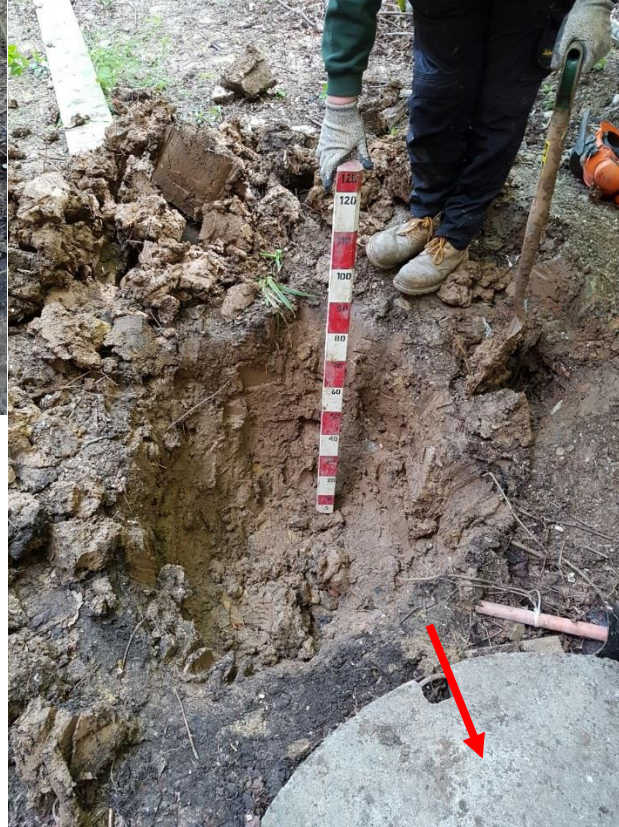
- 2.2 It is to be noted that the adjacent manhole (inspection chamber) is a mass concrete chamber, physically preventing lateral root growth. It is also to be noted that no roots were encountered, potentially owing to the very dense clay that was excavated, which is commonly an inhospitable growing medium. I have provided the photographic record below.
