Branch Hill Estate

Spedan Close Type 5P

Design & Access Statement

Jan 2016

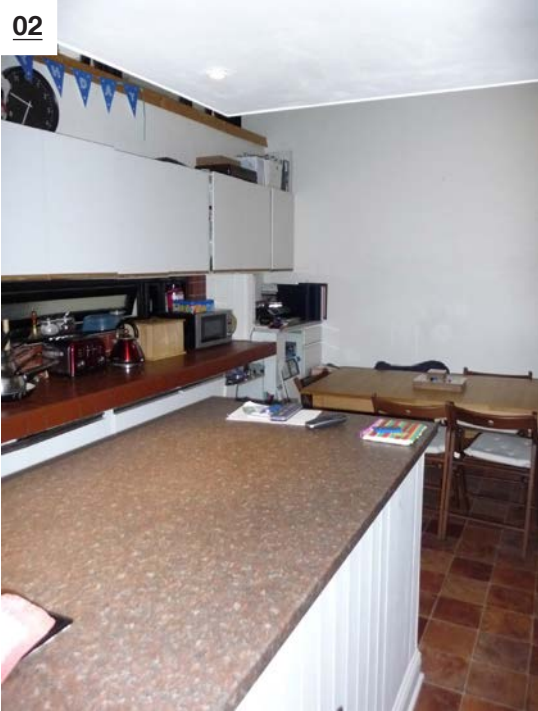
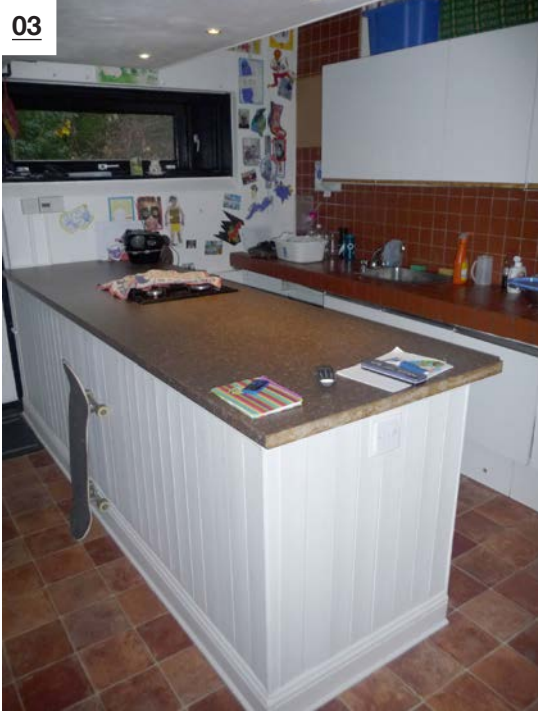
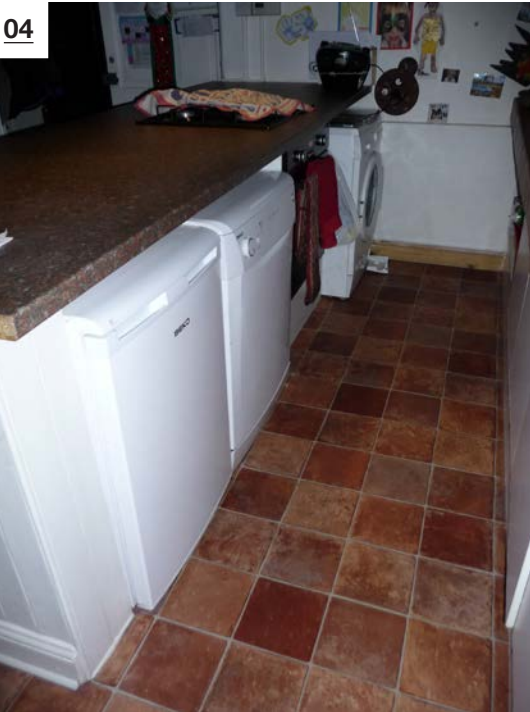
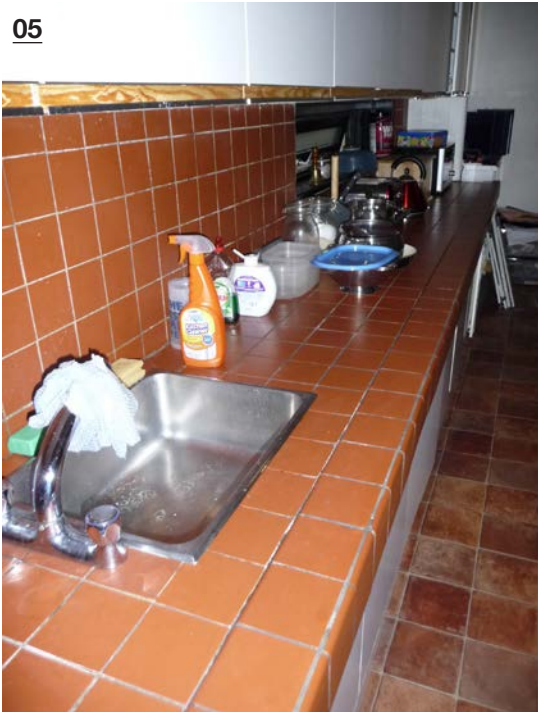
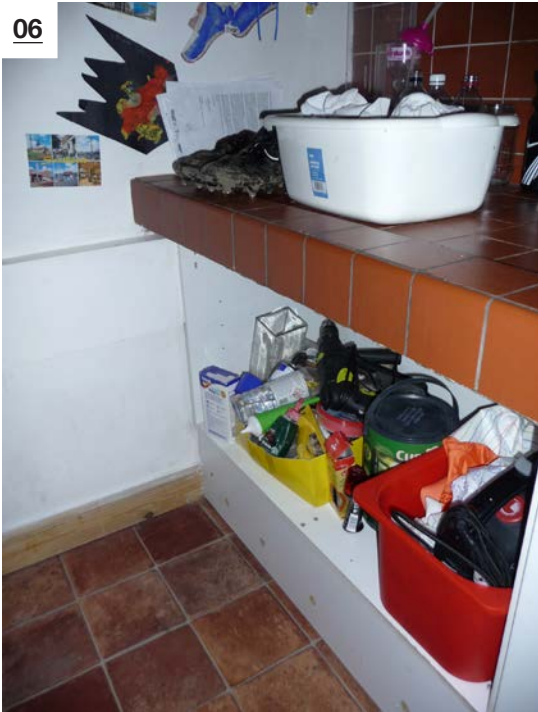
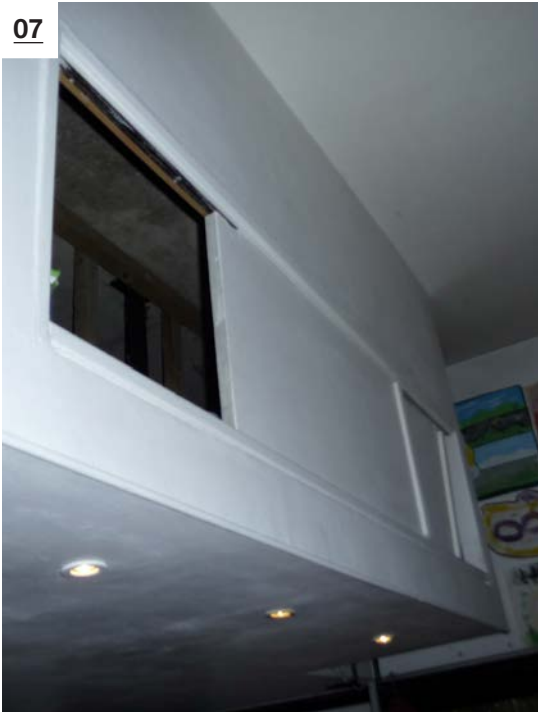
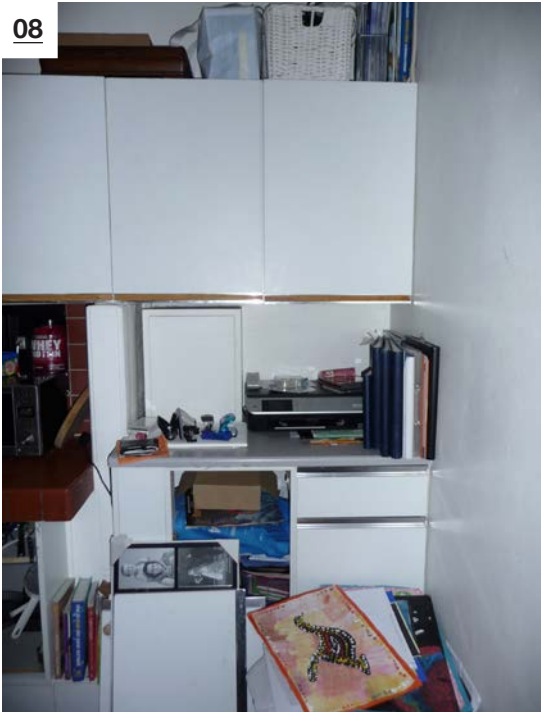
No. 23 Spedan Close

- Original concrete worktop and tiling retained. [01+03+05+06]
- Original tiled splashback retained. [01+03+05]
- Original wall mounted cupboards removed including carcass. [01+02+03]
- Original below-counter cupboards removed, including carcass. [01+06]
- Island unit walls modified and worktop installed to top. [02+03+04]
- Timber panelling applied to island walls. [03]
- Loft doors replaced. [07]
- Full height cupboard doors replaced and worktop installed. [08]

Proposed Schedule of Works		Condition	Works	Listing sensitive feature
Feature				
KITCHEN				
1.0	Worktop			
1.1	Tiled worktop	Tiles retained and generally good condition, some leaking around the sink	Replace damaged tiles and renew all grout	Y

1.2	Stainless steel sink	In poor condition	Replace with new stainless steel sink	N
2.0	Tiled splashback			
2.1	Tiled splashback	Retained and in good condition	Tiles retained and grout to be renewed	Y

4.1	Solid walls	Height modified, panelling applied and worktop fitted	Height to be reinstated, panelling removed and wall made good	Y
4.2	Shelves	Original shelves removed. Non-original worktop installed	Worktop to be removed and solid hardwood worktop replacement installed with tiled splashback, to match original tiles	Y

5.0	Flooring and walls			
5.1	Sheet lino flooring	In poor condition	Sheet lino replacement to be laid	N
5.2	Walls	In good condition	To be repainted	N
6.0	Loft door

6.1	Sliding timber doors	Doors missing	Doors to be replaced to match original	Y
WC				
NO WORKS				
BATHROOM				
NO WORKS

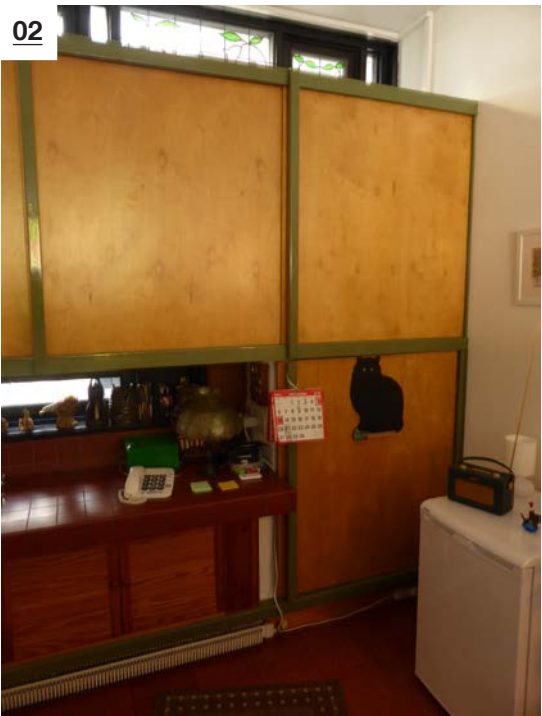
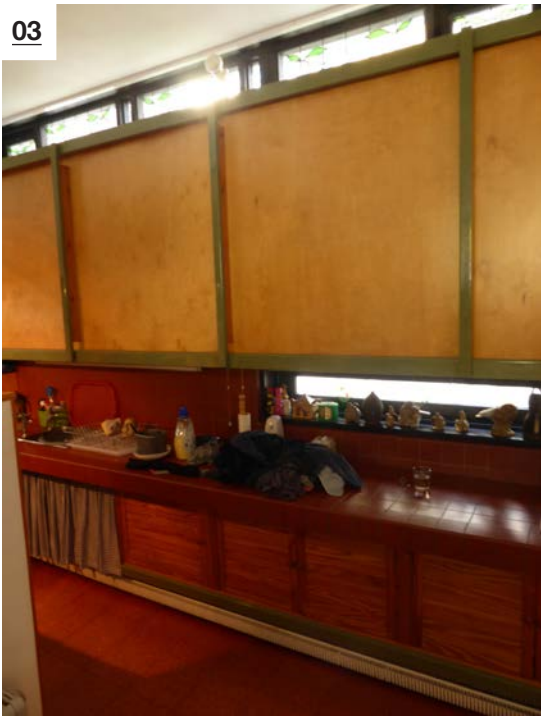
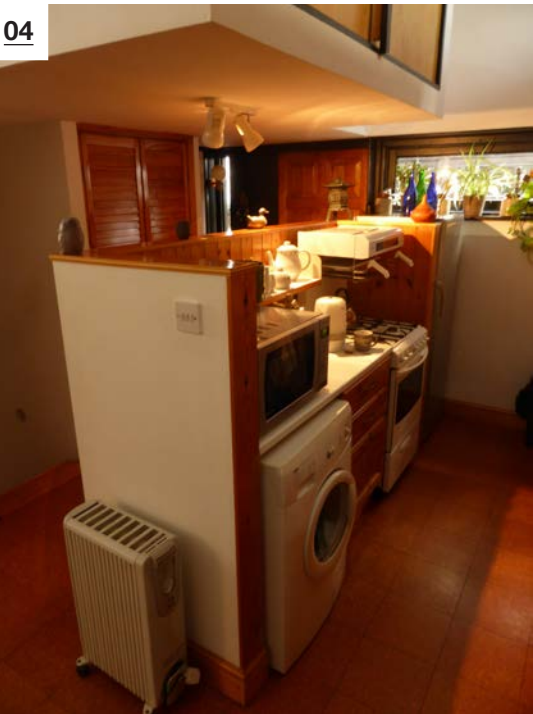
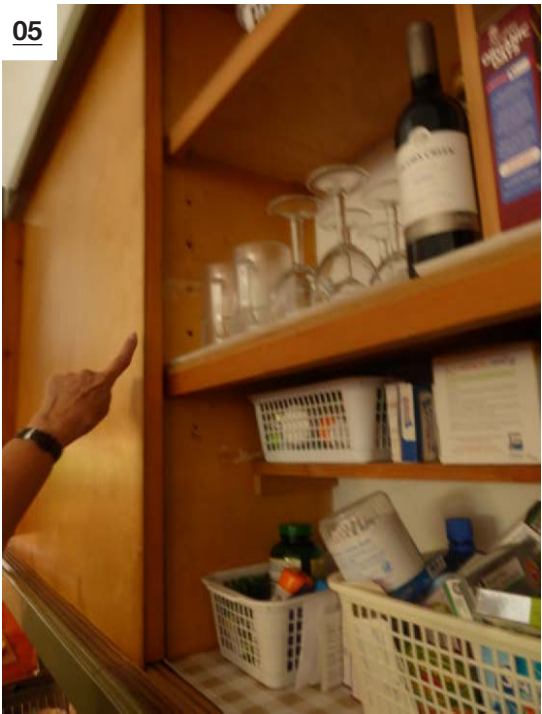
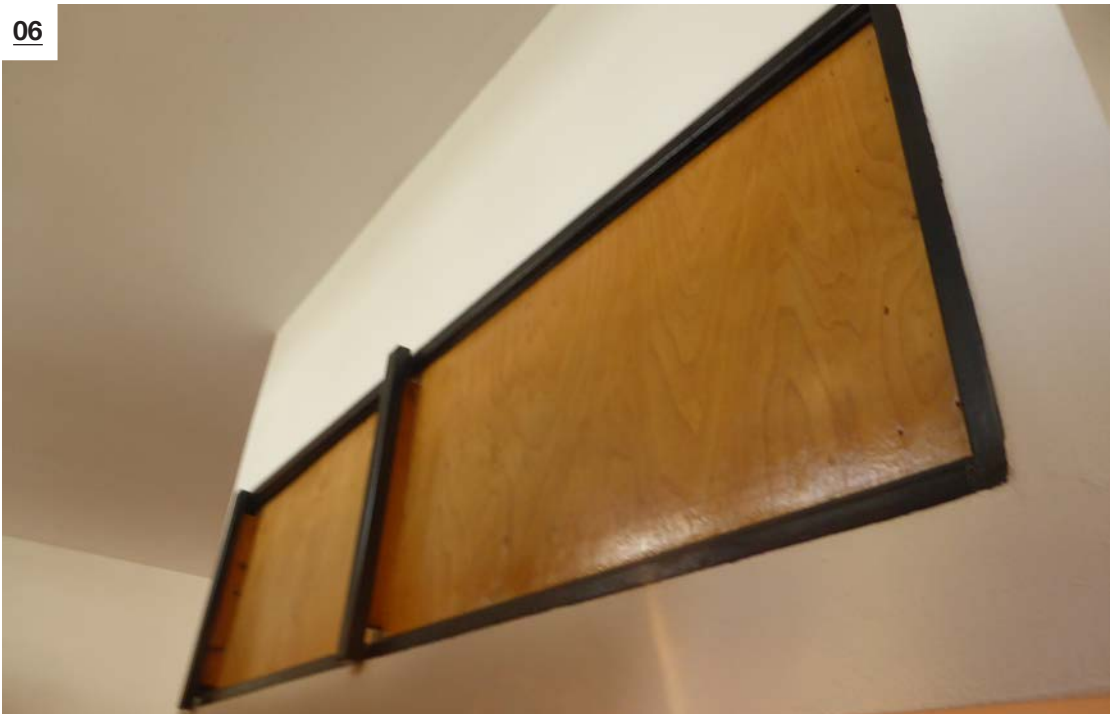
No. 25 Spedan Close

- Original concrete worktop and tiles retained. [01+02+03]
- Original tiled splashback retained. [01+02+03]
- Original wall mounted cupboard carcass and doors retained. [01+02+03]
- Original below counter cupboard carcass retained and doors replaced. [01+02+03]
- Island retained and clad internally with timber panelling. [04]
- Worktop and fitted drawers installed to island. [04]
- Loft door retained. [06]

Proposed Schedule of Works				
	Feature	Condition	Works	Listing sensitive feature
KITCHEN				
1.0	Worktop			
1.1	Tiled worktop	Tiles retained and generally good condition	Replace any damaged tiles and renew all grout	Y

1.2	Stainless steel sink	In poor condition	Replace with new stainless steel sink	N
2.0	Tiled splashback			
2.1	Tiled splashback	Retained and in good condition	Replace any damaged tiles and renew all grout	Y

3.0	Cupboards			
3.1	Below worktop cupboards	Original carcass retained and doors replaced	Replica doors to be birch plywood facing with solid timber replica handle	Y

3.2	Wall mounted cupboards	Original carcass retained and doors replaced	Replica doors to be birch plywood facing with solid timber replica handle	Y
4.0	Half-height kitchen island

4.1	Solid walls	Panelling applied to internal face	Panelling to be replaced with tiles to match original, external face of island to be painted	Y
4.2	Shelves	Original shelves removed. Non-original worktop installed	Worktop to be removed and solid hardwood worktop replacement installed with tiled splashback, to match original tiles	Y

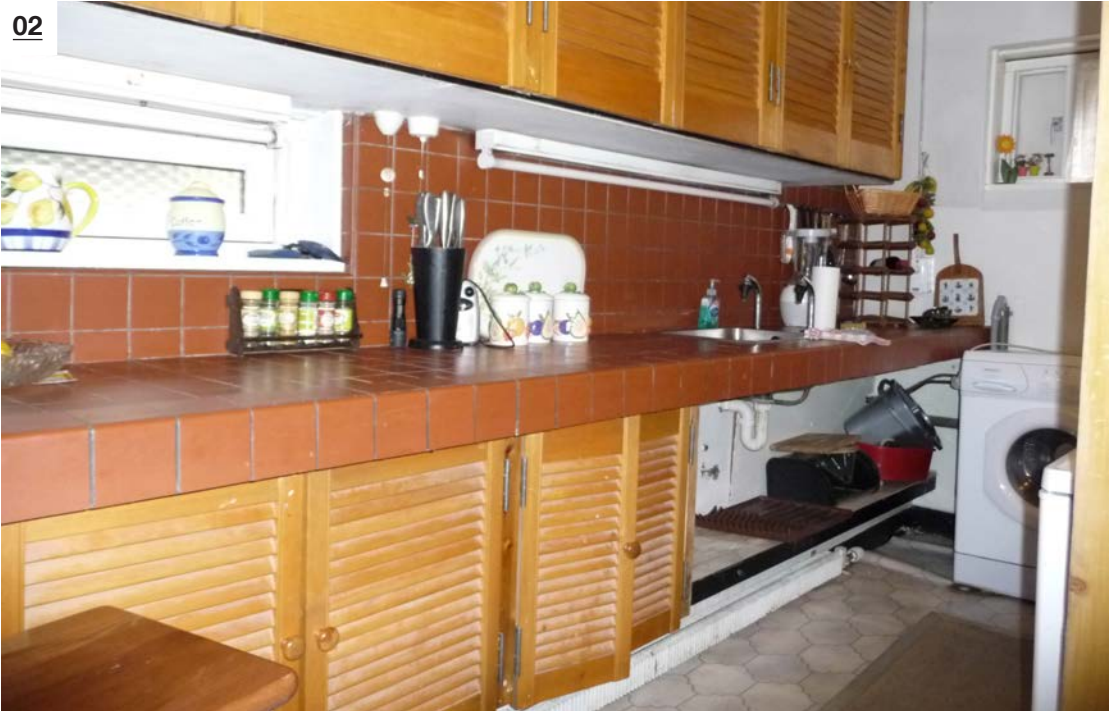
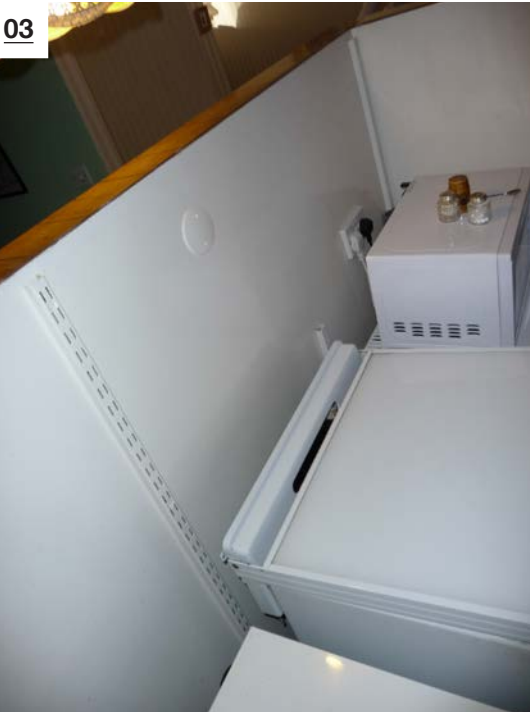
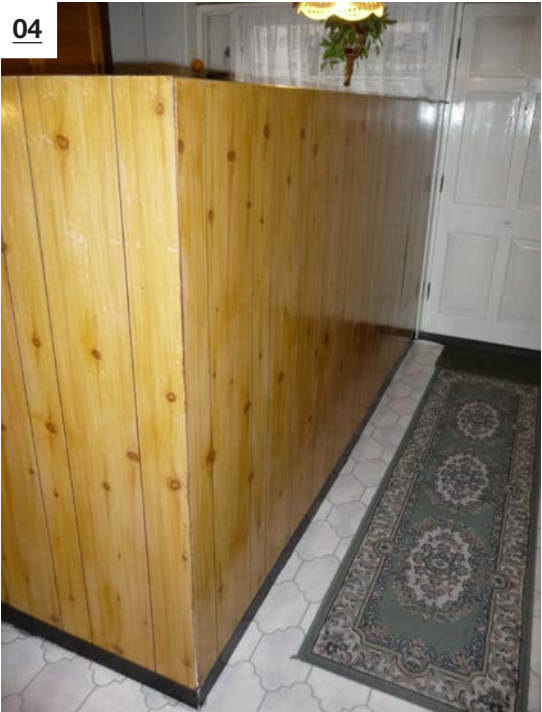
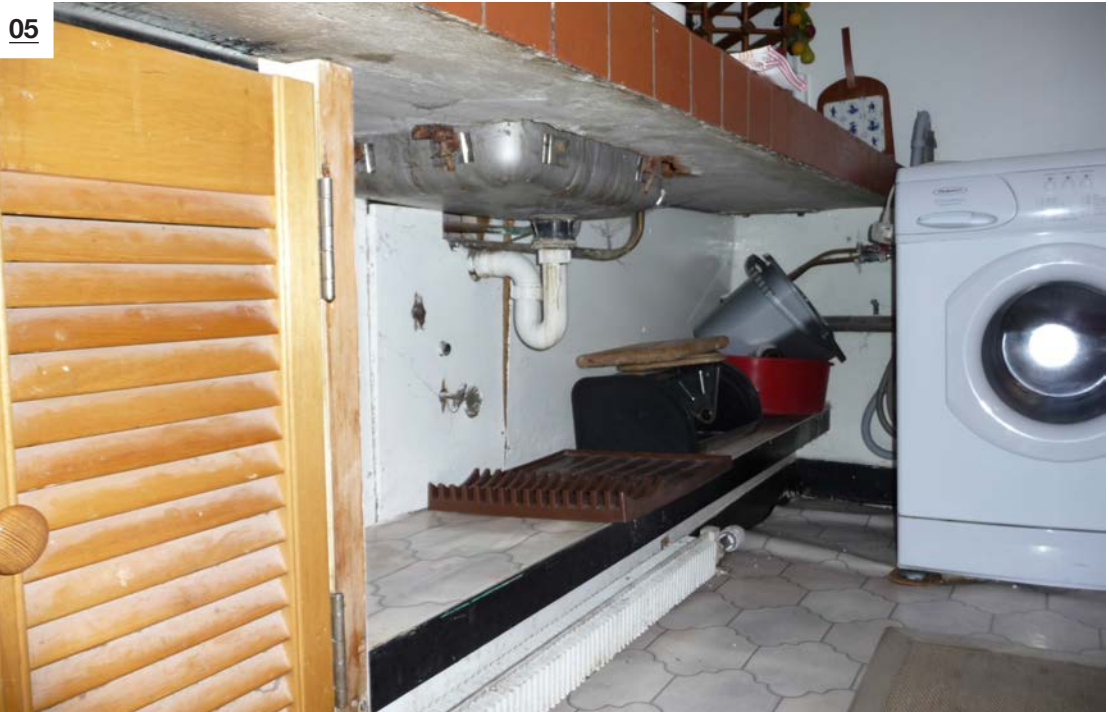
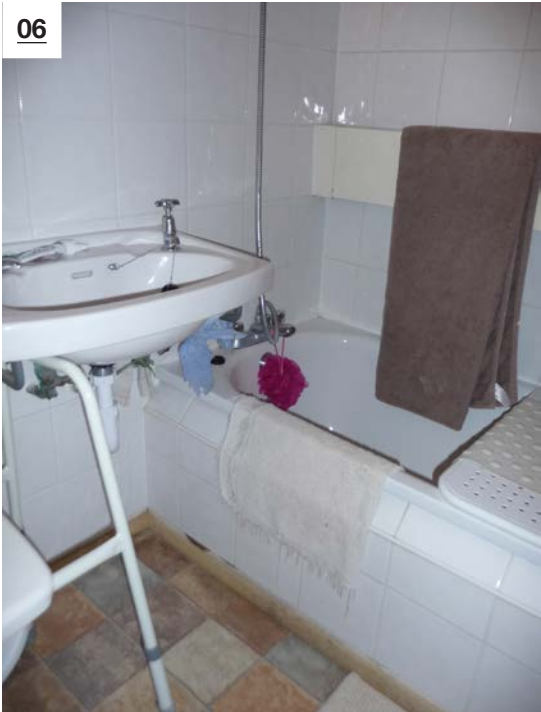
No. 26 Spedan Close

- Original concrete worktop and tiles retained. [02+05]
- Original tiled splashback retained. [02]
- Original wall mounted cupboard carcass retained and doors replaced. [01+02]
- Original below counter cupboard carcass retained and doors replaced. [01+02+05]
- Island timber panelled to external face and original spur shelving racks in place. [03]
- Original stainless steel sink in place. [02+05]

- Original heating panel mounted to wall above bath. [06]
- Bathroom fully tiled to all walls. [06]

Proposed Schedule of Works		Condition	Works	Listing sensitive feature
Feature				
KITCHEN				
1.0	Worktop			
1.1	Tiled worktop	Non-original tiles applied over original	Replace any damaged tiles and renew all grout	Y

1.2	Stainless steel sink	To be replaced	Replace with new stainless steel sink	
2.0	Tiled splashback			
2.1	Tiled splashback	Non-original tiles applied over original	Replace any damaged tiles and renew all grout	Y

4.1	Solid walls	Timber panelled to external face	Timber panelling to be removed and wall made good and repainted	Y
4.2	Infill shelving	Original shelves removed	Solid hardwood worktop replacement installed and wall above tiled to match original

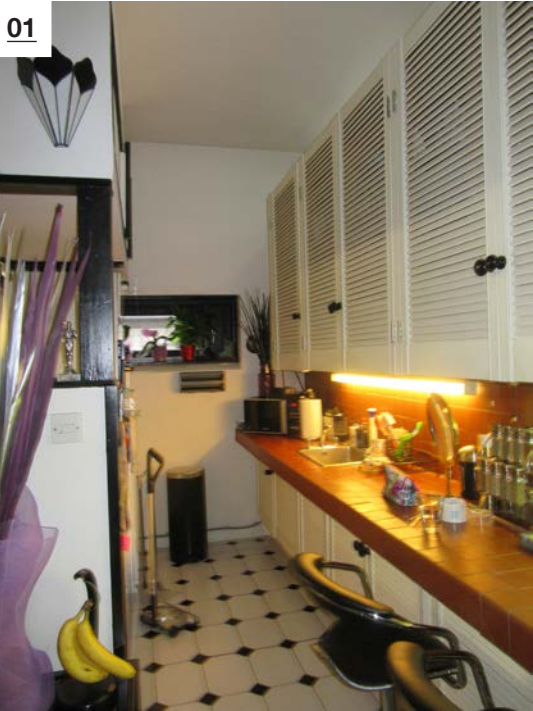
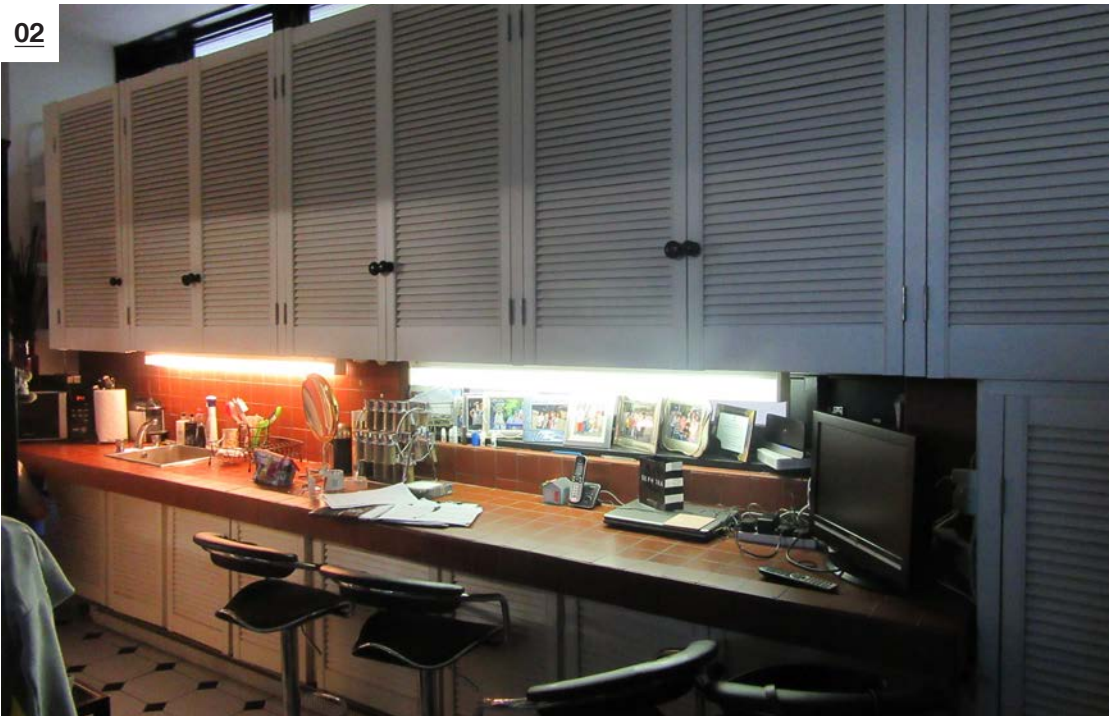
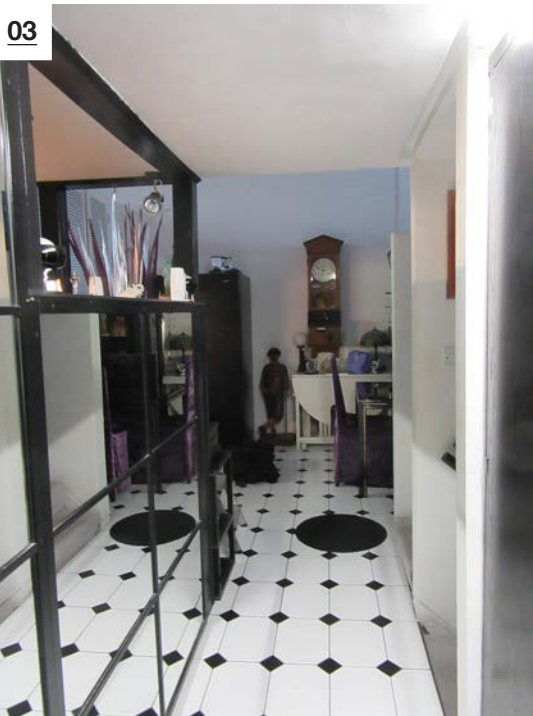
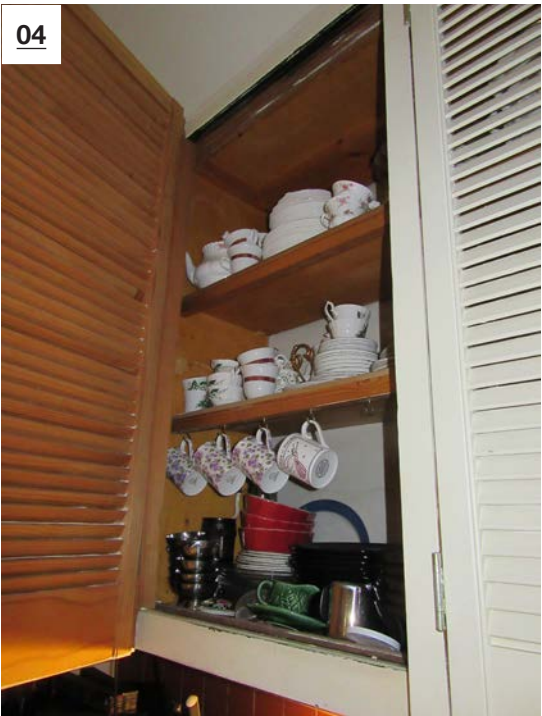
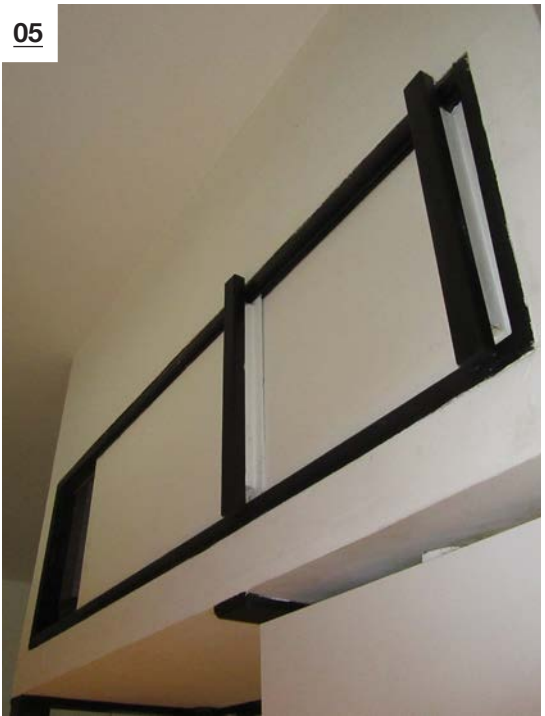
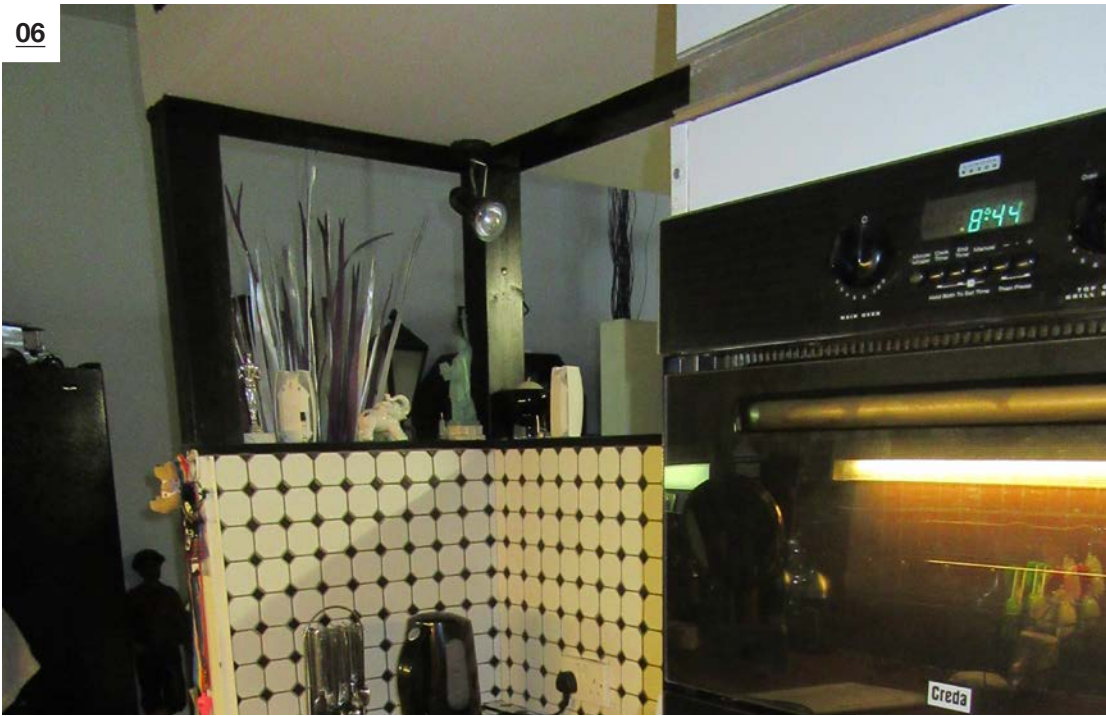
• Original concrete worktop and tiles retained and in good condition. [01+02]

• Original tiled splashback retained and in good condition. [01+02]

• Original wall mounted cupboard carcass retained and timber doors replaced. [01+02+04]

• Original below worktop cupboard carcass retained and timber doors replaced. [01+02]

• Original stainless steel sink retained. [02]

• Island fitted with full-height oven adjacent to front door. Walls infilled around fixture. [06]

• Islan tiled to internal face and mirrored to external face. [03+06]

Proposed Schedule of Works		Condition	Works	Listing sensitive feature
Feature				
KITCHEN				
1.0	Worktop			
1.1	Tiled worktop	Tiles retained and generally good condition	Replace any damaged tiles and renew all grout	Y

1.2	Stainless steel sink	To be replaced	Replace with new stainless steel sink	
2.0	Tiled splashback			
2.1	Tiled splashback	Tiles retained and generally good condition	Replace any damaged tiles and renew all grout	Y

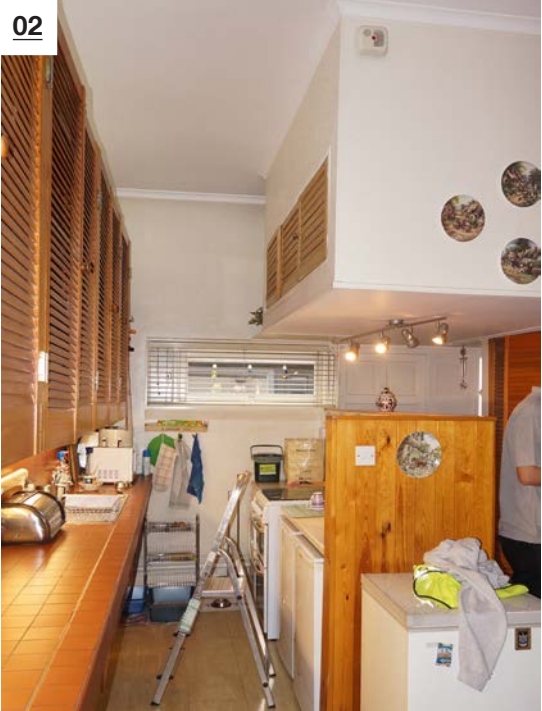
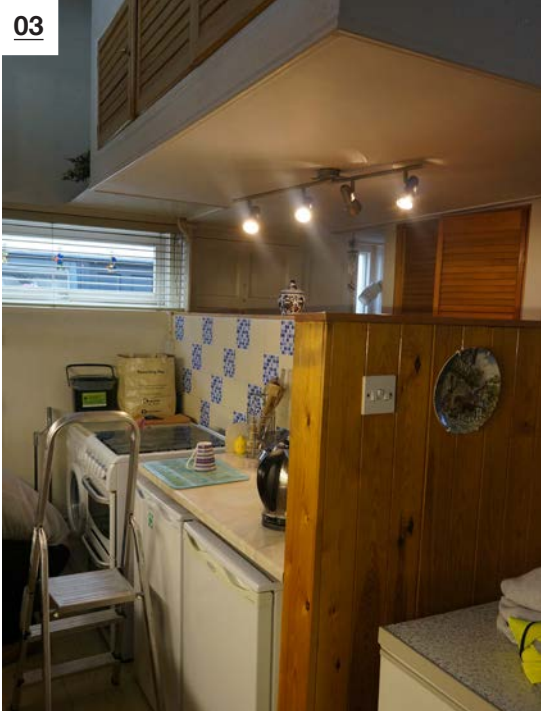
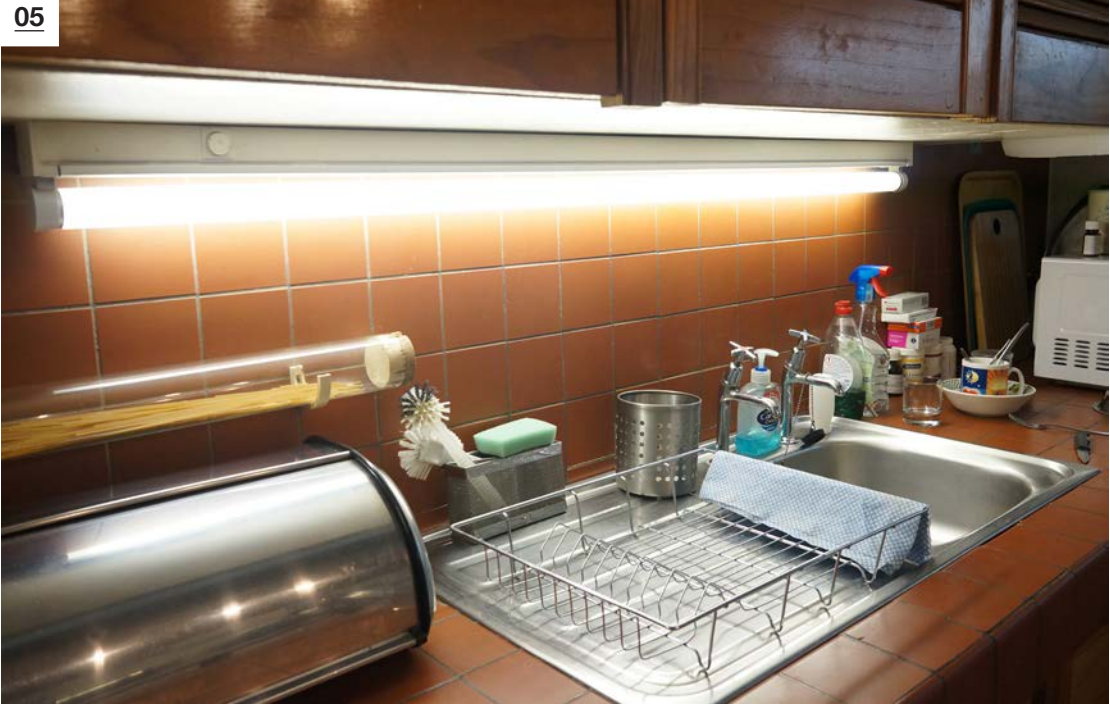
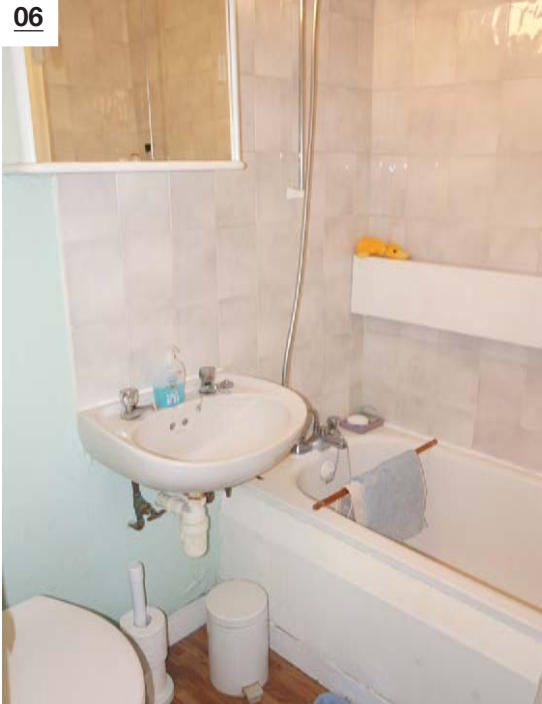
No. 28 Spedan Close

- Original concrete worktop and tiling retained and in good condition. [01+02+05]
- Original tiled splashback retained and in good condition. [01+02+05]
- Original wall mounted cupboard carcass retained and timber doors replaced. [01+02]
- Original below worktop cupboard carcass retained and timber doors replaced. [01]
- Original sliding doors to loft replaced. [02]
- Non-original worktop fitted to island. [03]
- Timber panelling fitted to external face of

- Non-original tiles to bath and sink. [06]

Proposed Schedule of Works		Condition	Works	Listing sensitive feature
Element				
KITCHEN				
1.0	Worktop			
1.1	Tiled worktop	Tiles retained and generally in good condition	Replace any damaged tiles and renew all grout	Y

1.2	Stainless steel sink	To be replaced	Replace with new stainless steel sink	N
2.0	Tiled splashback			
2.1	Tiled splashback	Tiles retained and generally good condition	Replace any damaged tiles and renew all grout	Y

4.1	Solid walls	Timber panelling and tiles applied	Timber panelling to be removed and tiles replace wit tile to match original	Y
4.2	Shelves	Shelves removed	Solid timber worktop to be fitted	Y

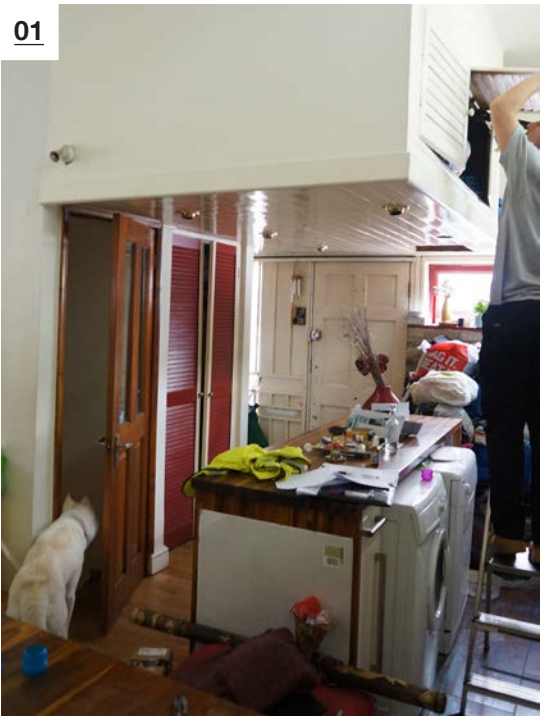
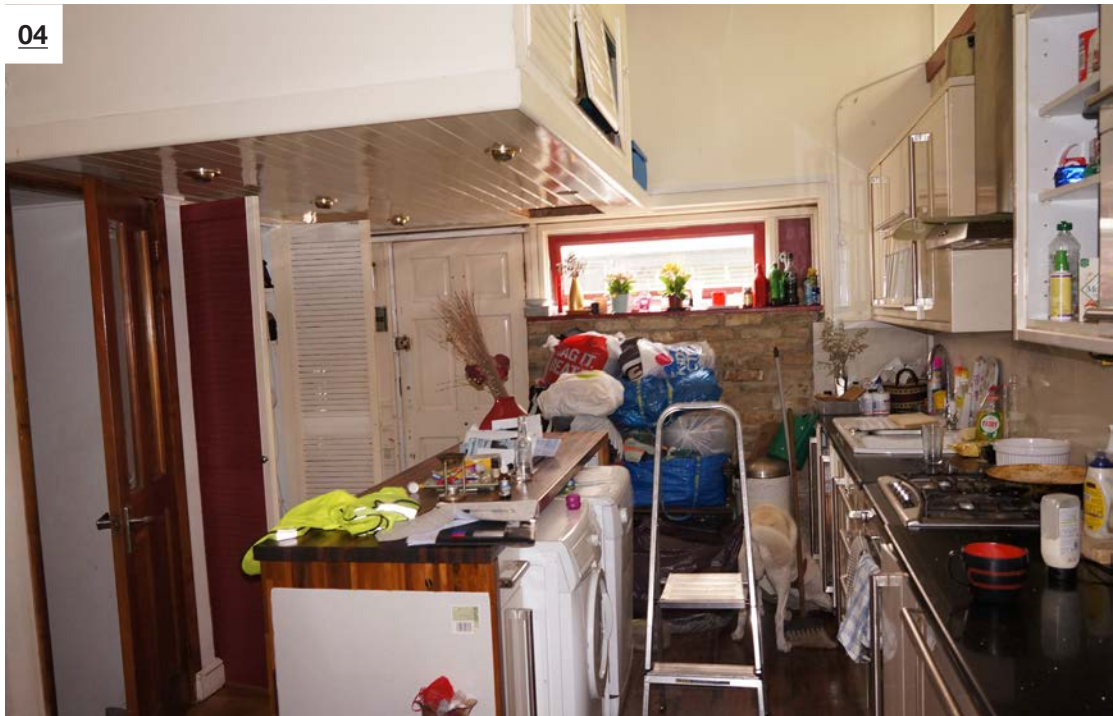
- Original concrete worktop removed. [03 + 04]
- Original tiled splashback replaced. [03]
- Original wall mounted cupboard carcass removed. [03+04]
- Original below worktop cupboard carcass and timber doors removed. [02 + 03]
- Original sliding doors to loft replaced. [02]
- Non-original worktop fitted to island and walls modified. [01 + 02 + 03 + 04]

Proposed Schedule of Works		Condition	Works	Listing sensitive feature
Feature				
KITCHEN				
1.0	Worktop			
1.1	Tiled worktop	Tiles and concrete removed	Replace worktop with solid timber worktop	Y

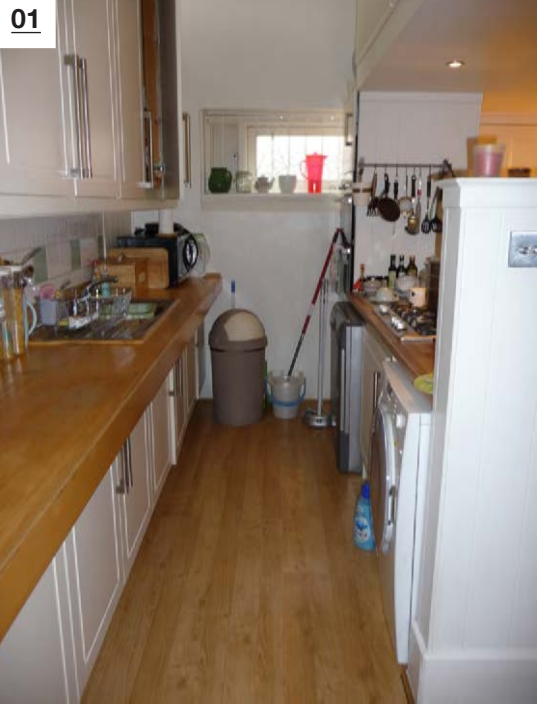
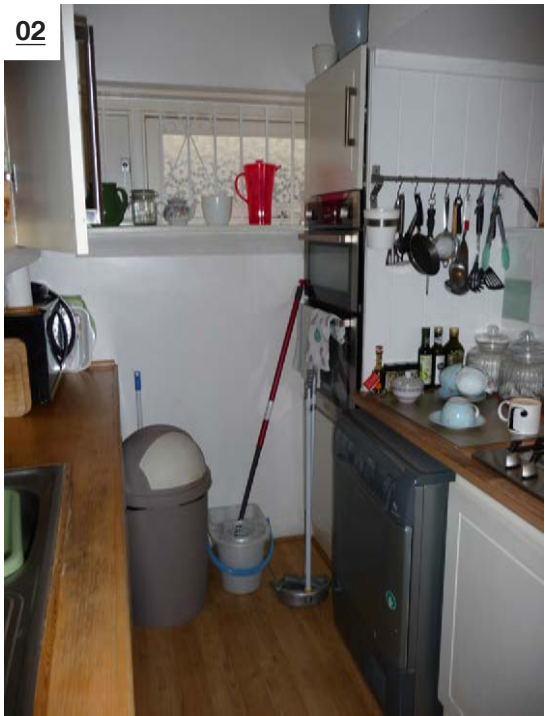
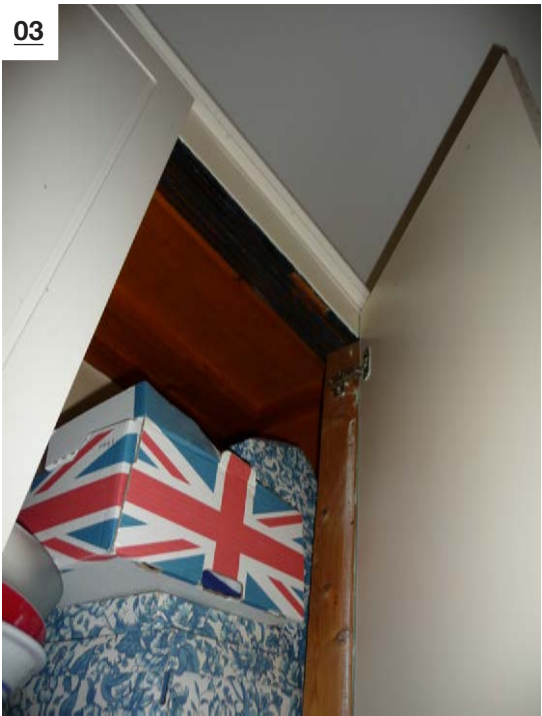
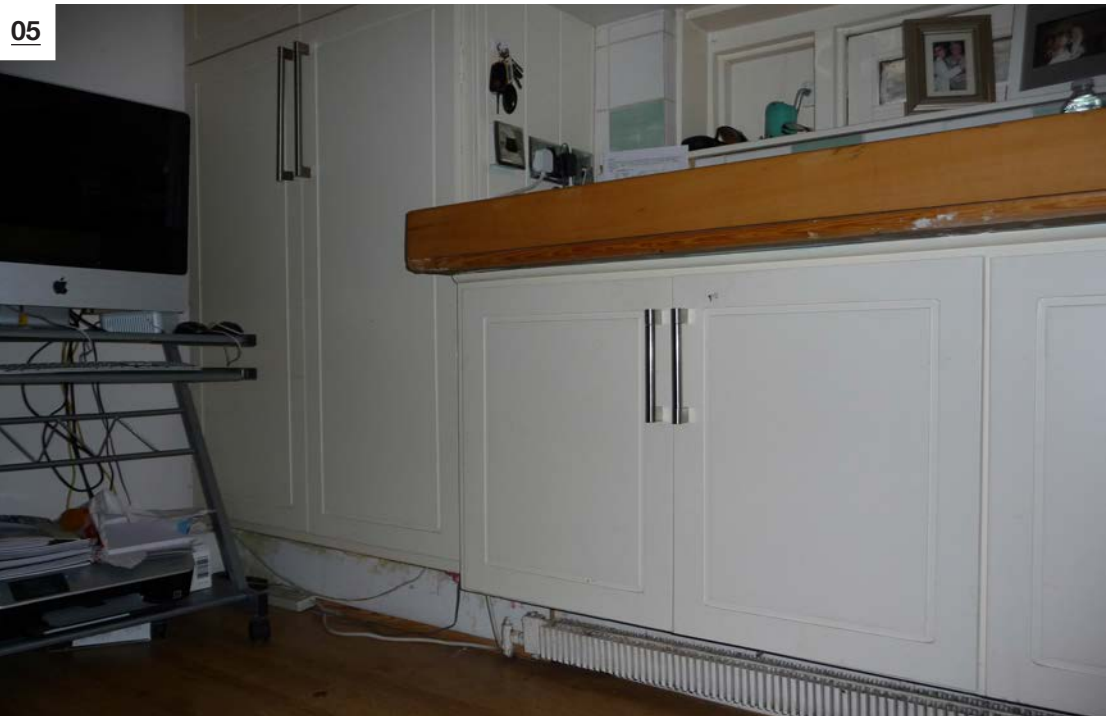
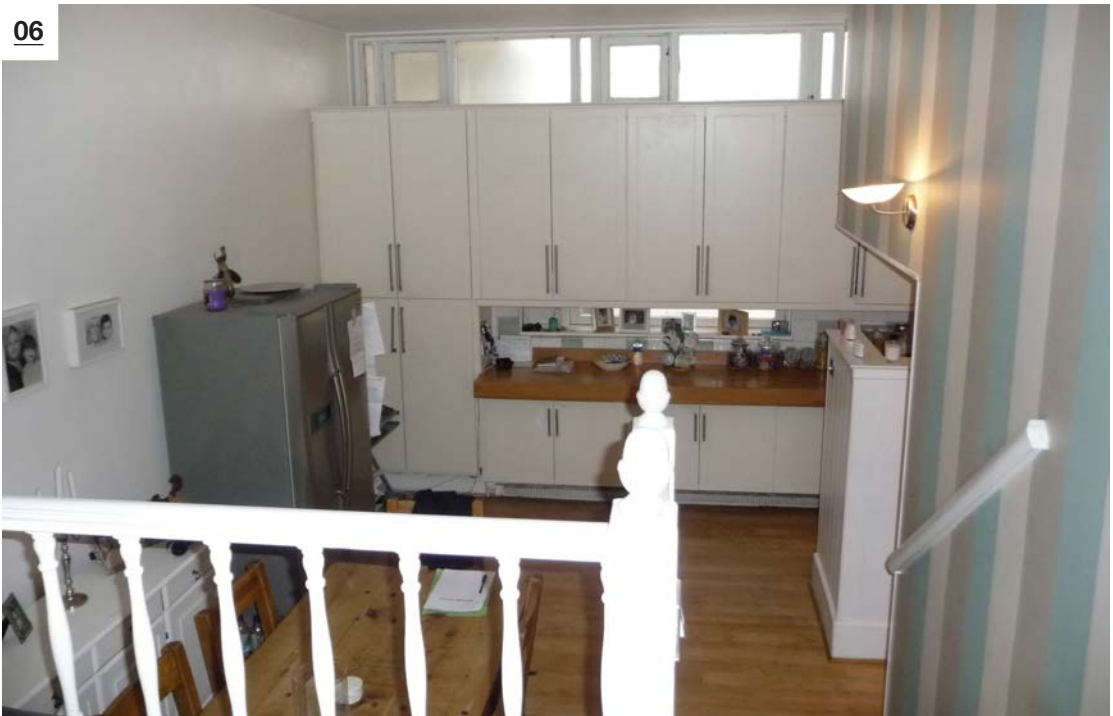
No. 30 Spedan Close

- Original concrete worktop and tiled retained, timber worktop fitted over. [01+02+05]
- Original tiled splashback retiled. [01+05]
- Original wall mounted cupboard carcass retained and timber doors replaced. [01+04]
- Original below worktop cupboard carcass retained and timber doors replaced. [01+05]
- Original sliding doors to loft replaced. [02]
- Non-original worktop fitted to island. [03]
- Full height oven installed to one end of island. [02]
- Island walls tiled to internal face and timber panelled to external face. [06]

Proposed Schedule of Works		Condition	Works	Listing sensitive feature
Element				
KITCHEN				
1.0	Worktop			
1.1	Tiled worktop	New timber worktop fitted over original	Remove worktop and retile, tiles to match existing	Y

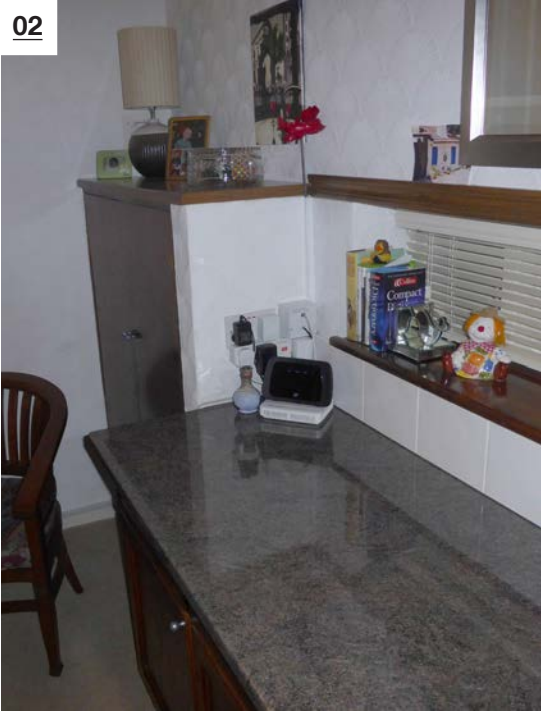
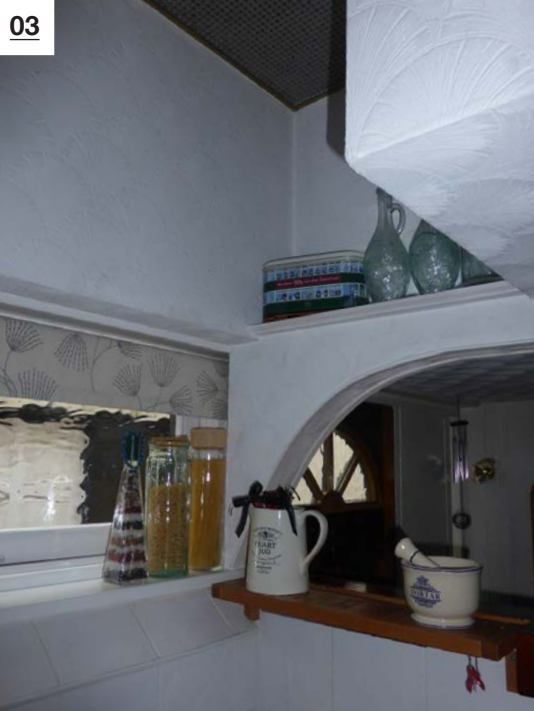
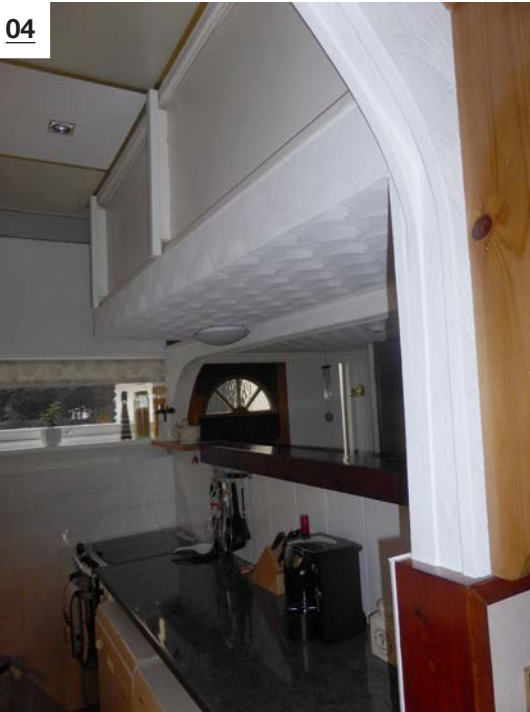
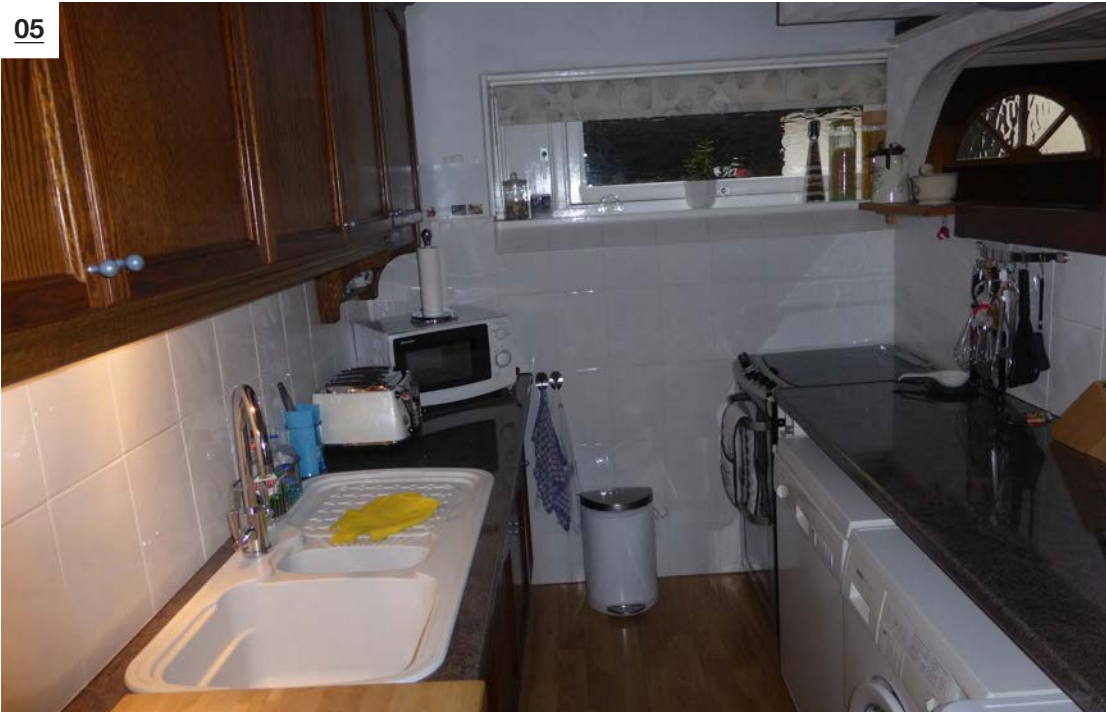
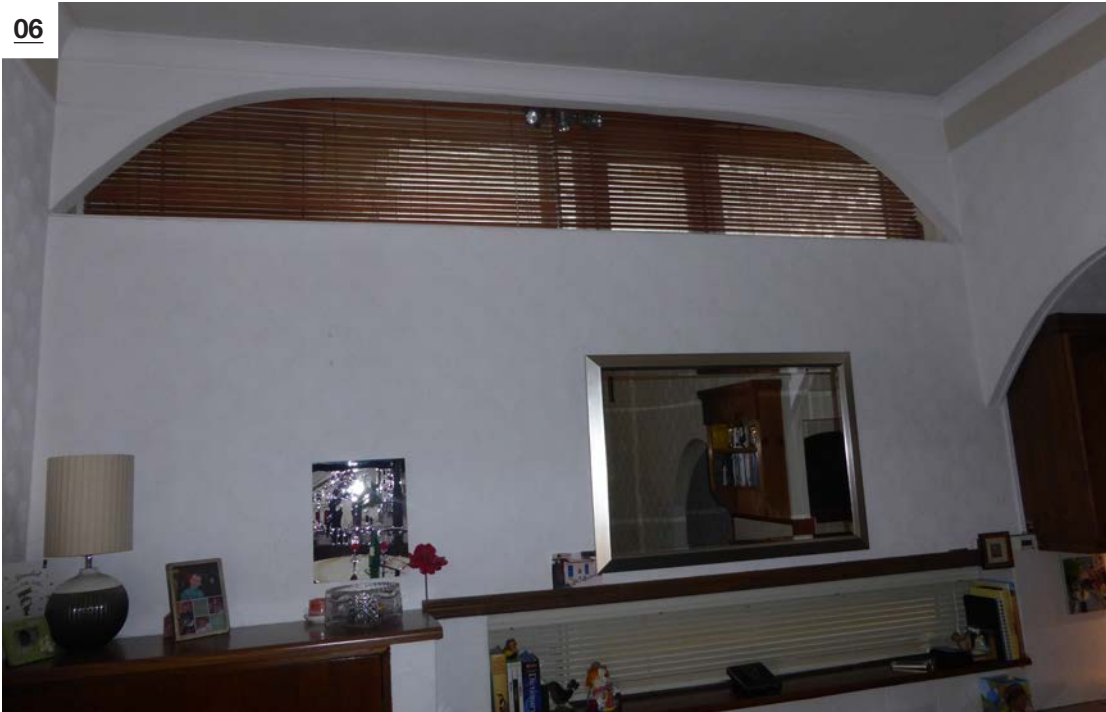
- Original concrete tiled worktop replaced. [01+02+05]
- Original tiled splashback retiled. [01+02+05]
- Original wall mounted cupboards replaced. [01+05]
- Original below counter cupboards replaced. [01+02]
- Ceiling lowered and glass ceiling tiles fitted. [01+04]
- Arches formed above island and above high level windows. [01+03+06]
- Island return infilled to ceiling.[01]
- Island wallpapered to external face and tiled to internal face. [04]
- Textured wallpaper applied to all walls. [ALL]

Proposed Schedule of Works		Condition	Works	Listing sensitive feature
Element				
KITCHEN				
1.0	Worktop			
1.1	Tiled worktop	Tiles and worktop completely removed	Worktop to be replaced with solid timber worktop	Y

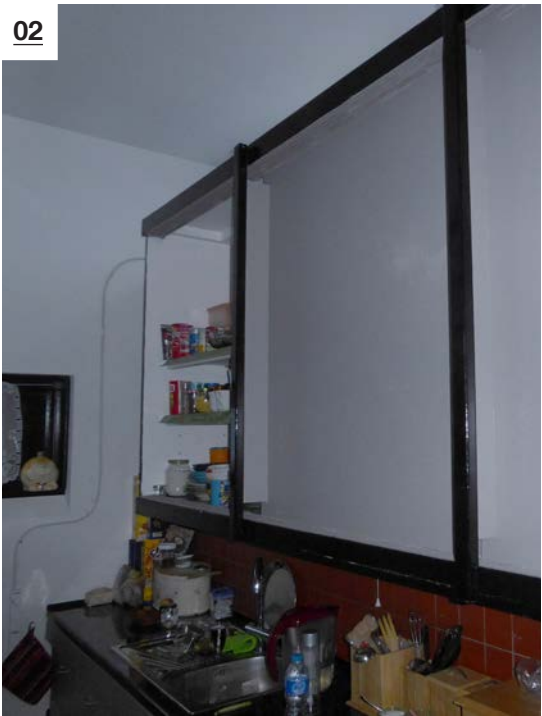
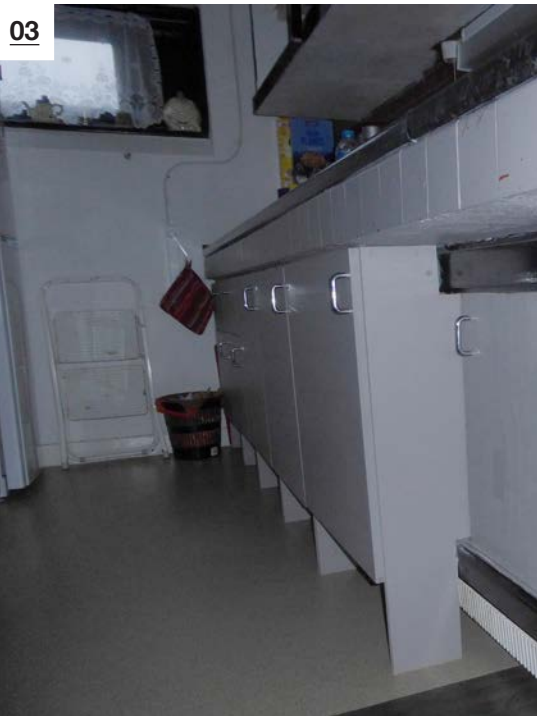
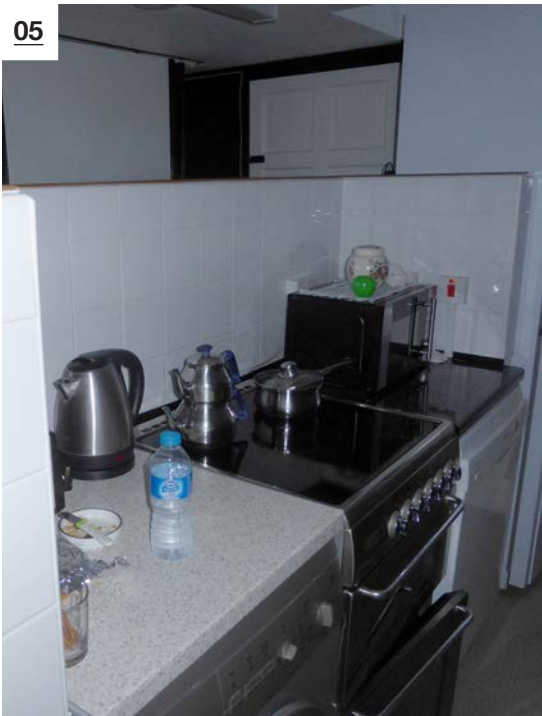
- Original concrete worktop and tile retained and new worktop fitted over the top. [01+03]
- Original tiled splashback retained and in good condition. [01+02]
- Original wall mounted cupboard carcass and doors retained and painted. [02+04]
- Original below counter worktop cupboards replaced. [03]
- Original island retained and all wall faces tiled. [05]

Proposed Schedule of Works		Condition	Works	Listing sensitive feature
Element				
KITCHEN				
1.0	Worktop			
1.1	Tiled worktop	Retained and clad over	Some tiles painted, all damaged tiles to be replaced and grout renewed	Y
