Branch Hill Estate

Spedan Close Type 5P

Design & Access Statement

Jan 2016

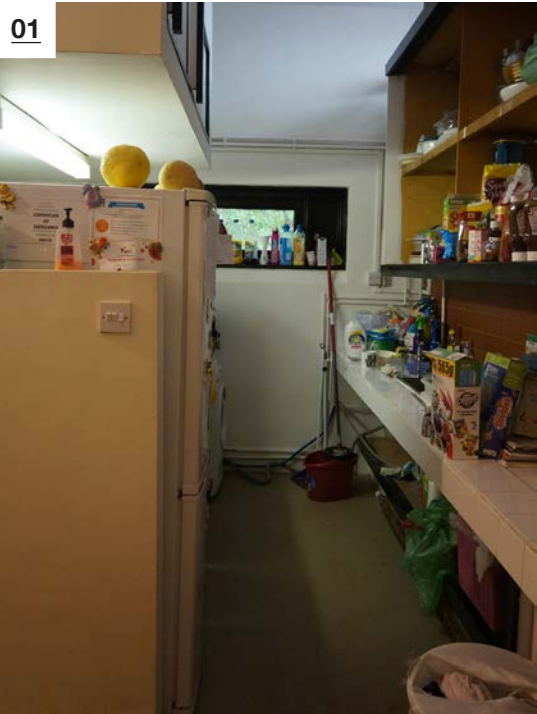
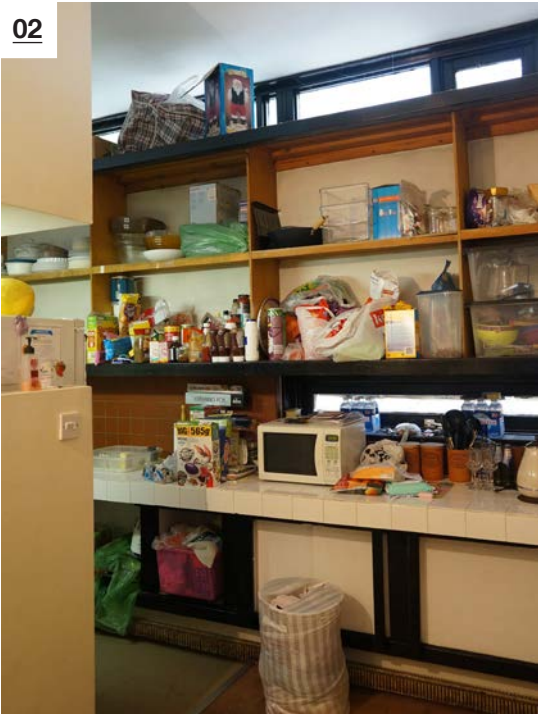
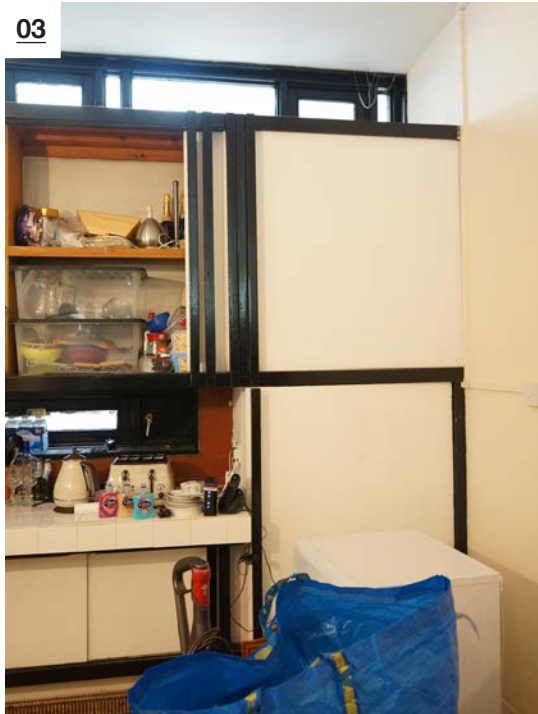
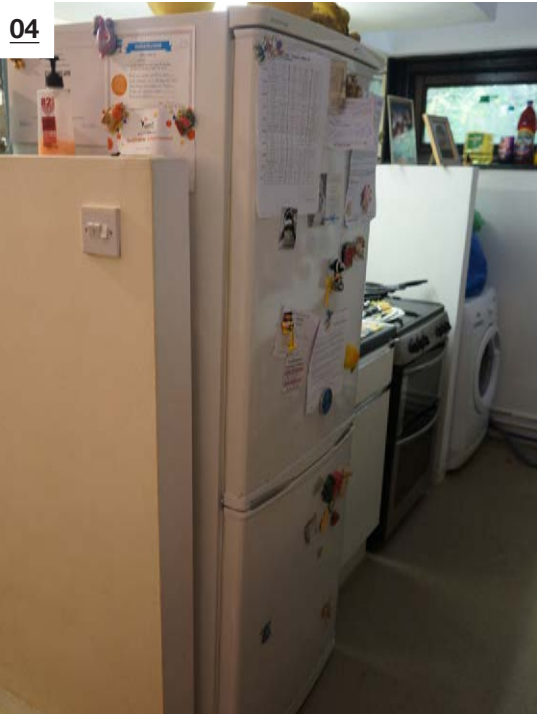
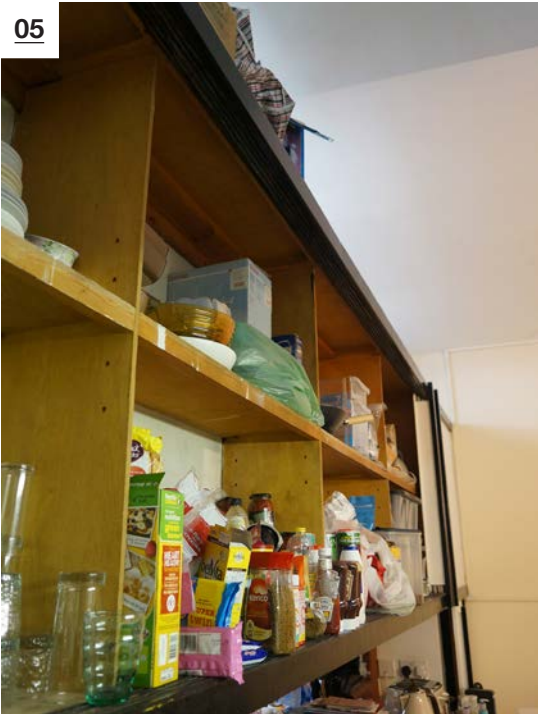
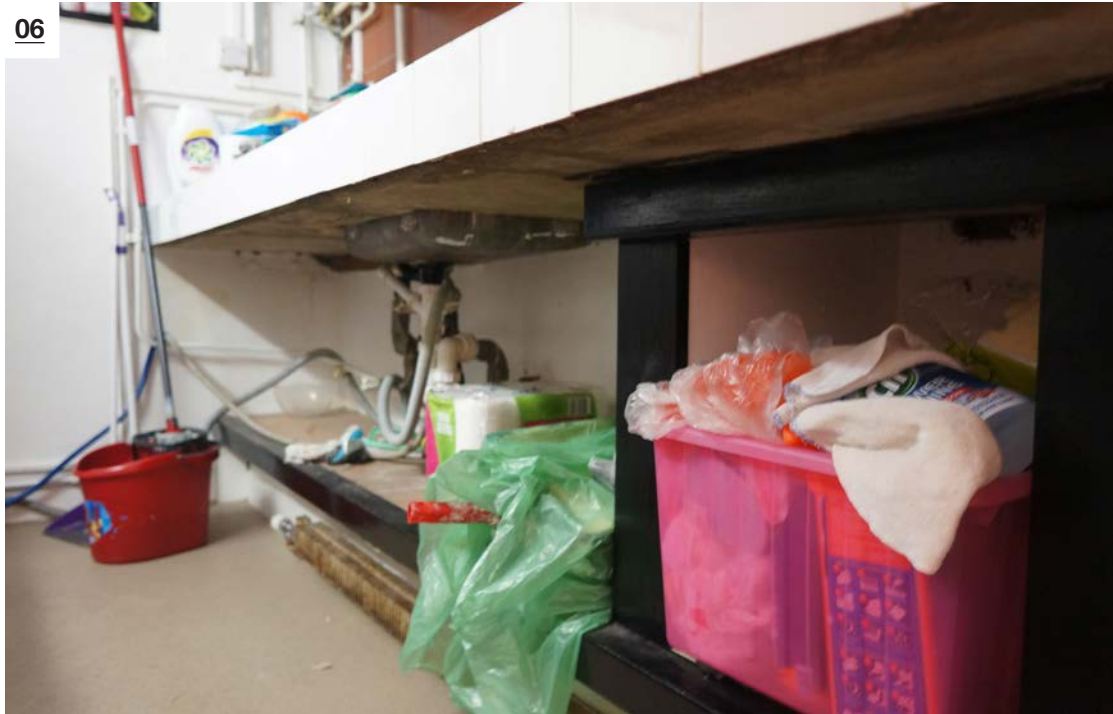
No. 37 Spedan Close

- Kitchen:**
- Original concrete worktop retained and tiles replaced. [01+02+03]
 - Original tiled splashback retained. [02+03]
 - Original wall mounted cupboard carcass and doors retained. [01+02+03+05]
 - Original below counter cupboard carcass and doors retained. [02+03]
 - Original island retained, shelves removed. [04]

Proposed Schedule of Works		Condition	Works	Listing sensitive feature
Element				
KITCHEN				
1.0	Worktop			
1.1	Tiled worktop	Concrete worktop retained and tiles replaced	Tiles to be removed and replaced, tiles to match original	Y

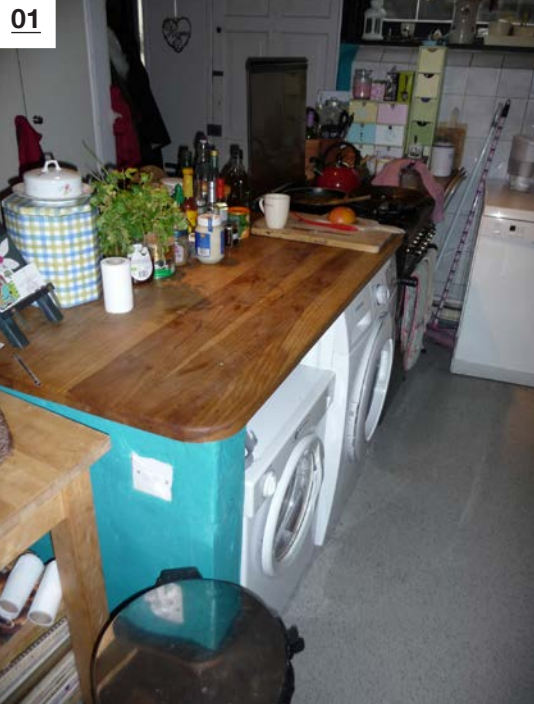
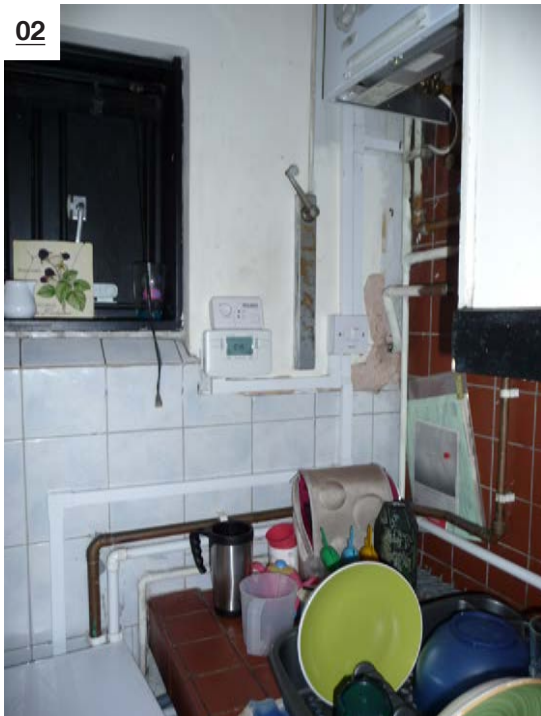
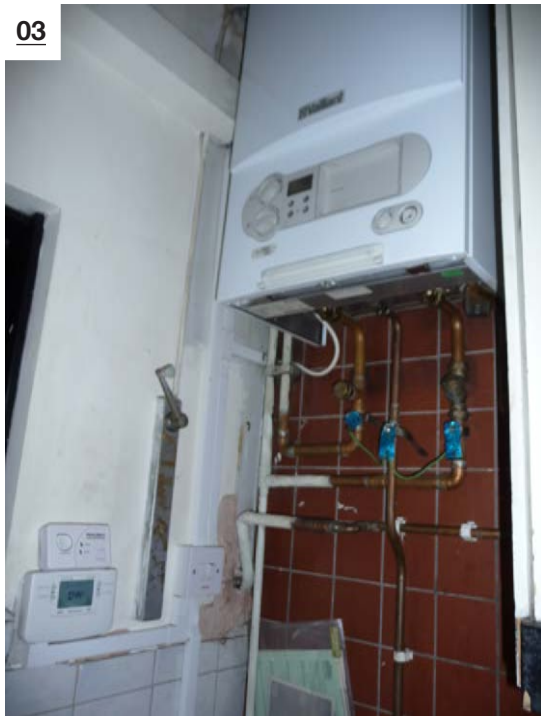
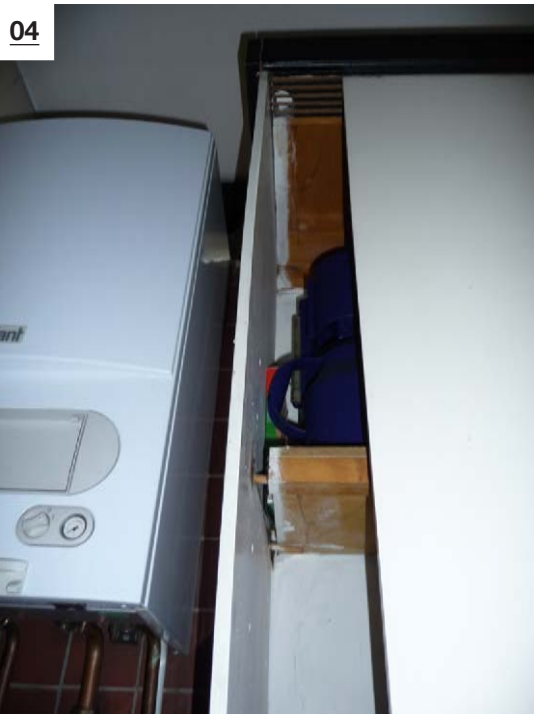
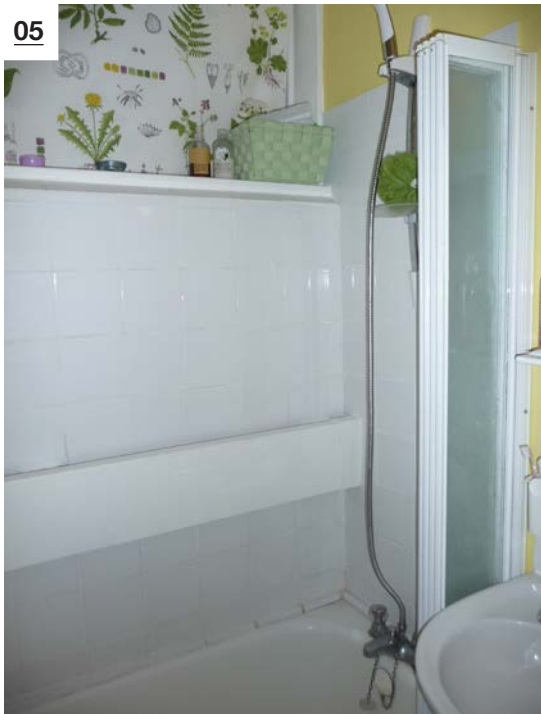
No. 39 Spedan Close

- Original heating panel fixed to wall. [01]

Proposed Schedule of Works		Condition	Works	Listing sensitive feature
Element				
KITCHEN				
1.0	Worktop			
1.1	Tiled worktop	Original tiles retained, in poor condition	Damaged tiles to be replaced and grout renewed	Y
