ARBORICULTURAL IMPACT ASSESSMENT REPORT  
BS 5837:2012 'Trees in relation to design, demolition and construction.  
Recommendations'

145 - 147 Camden Road,  
London  
NW1 9HA

**DATE: 16.03.16**

**OUR REF: SHA 153**

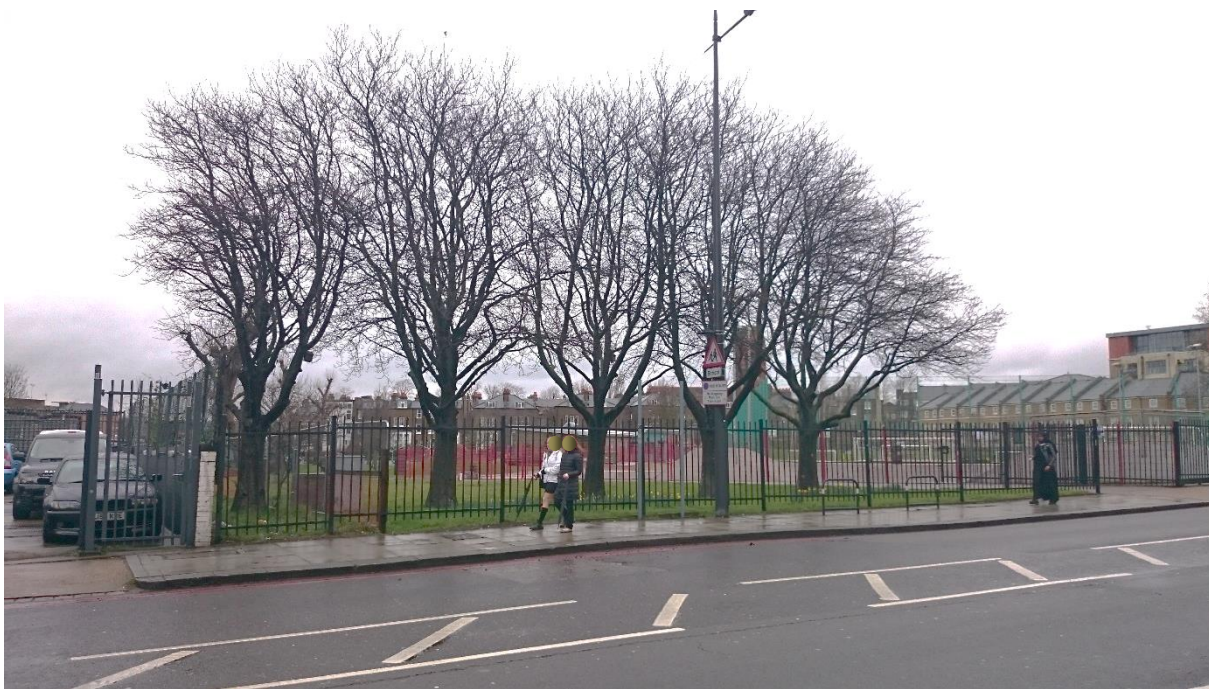
3.2. Cantelowes Gardens is a large green space beside Camden Road. There are five whitebeams equidistantly planted 5m from the pavement. I agree with the tree officer's opinion that *'the whitebeams make an important contribution to character of the park and form an important buffer from the busy road.'* (Source:- pre-application meeting report dated 10.6.2013).

*Photo 1 of T1 – T5 from Camden Road*

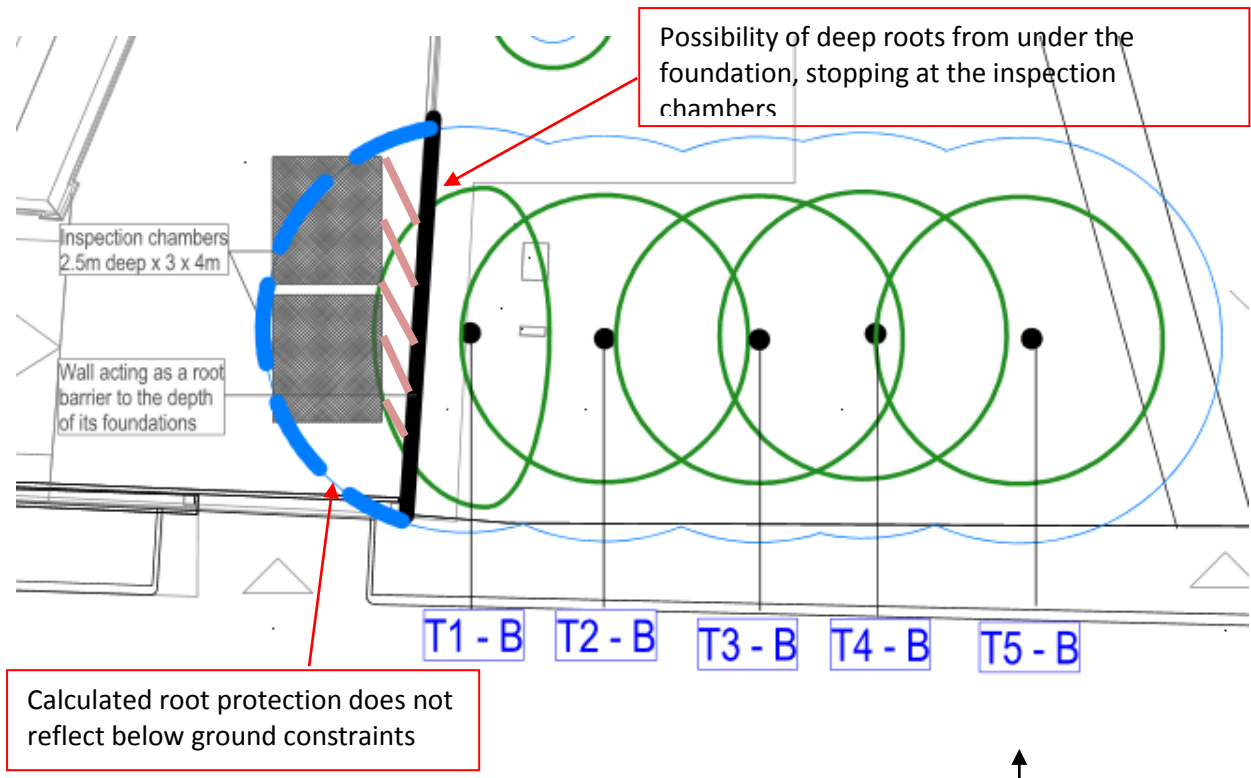
Plan 1 extract from SHA 153 TSP. Do not scale. North ↑

The calculated root protection area, shown in the tree survey plan SHA 153 TSP cannot indicate the actual rooting area, as indicated on the plan extract below:

In my experience, there are probably roots growing up to the wall and tracking down the foundations, as roots flourish on the condensation layer that forms, due to the temperature differential between soil and brick.

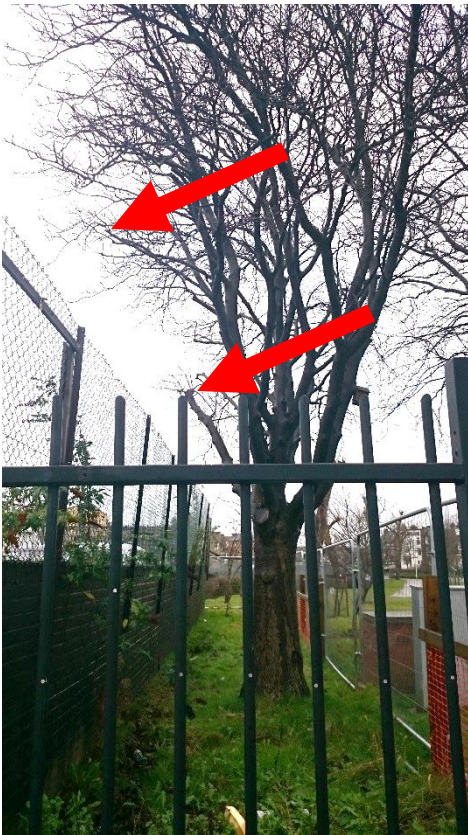
This tree is nearest the site and is slightly shorter than the rest of the group. It has been cut back on the site side in the past, and has an asymmetric crown, it being so close to the neighbouring tree. The tree has a good vitality with no obvious signs of pest and disease. It has re-grown from the pruned branches with a typical vigour for the species. It is growing 1.5m from a boundary brick wall (approximately 1.8m high). This wall is likely to have foundations at least 600mm deep, probably deeper. The foundations will be acting as a root barrier at least to the depth of the foundations. There may be tree roots under the foundations into the site. However, I noticed entry points to inspection chambers at the site (see photo 3) visit and discussed this with the client. There are two chambers 2.5m deep with dimensions 3 x 4m. The chambers are 1m from the wall at the closest point. These two chambers will definitely be acting as a root barrier, and there will be no roots beyond or underneath the chambers growing towards the site.

*Photo 2 of T1 looking from Camden Road  
Pruned branches are shown arrowed*

- The crown will need to be trimmed back slightly to facilitate the scaffold, and be maintained at this new profile. When the tree is in leaf, any windows on this side will be in shade. However the part of the building nearest the tree is a stairwell, and not habitable living space. The internal lighting design will need to take the shading effect of the tree in summer into account. The tree has a good vitality and has responded well to previous pruning. Works will be carried out under the control of Camden Council. Note, the building nearest the road is single storey.
- The wall will be demolished with care in accordance with the method statement at appendix 6.
- The tree will be protected with ground protection and fencing in accordance with the specification at appendix five and at the location on the tree protection plan at appendix three (extract below):

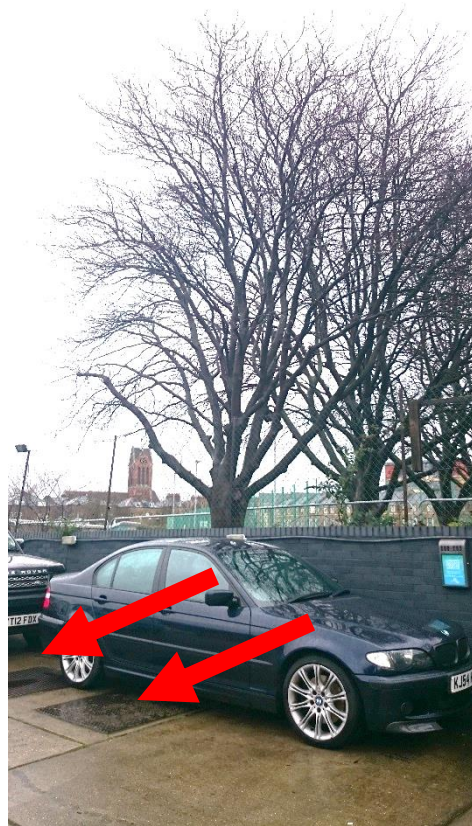
Tree roots grow where their requirements for oxygen, water, organic matter and a permeable rooting environment are met. Whilst trees do root under hard surfaces, roots will preferentially grow where these conditions are more easily met. The park meets these requirements and therefore I consider it highly probable that the majority of the roots are in the park, with only a few deeper roots possibly passing under the wall's foundations, and stopping at the inspection chamber.

*Photo 3 looking towards the tree from the site.  
Note the entrance covers for the large inspection  
chambers (shown arrowed)*
