HILL GARDEN PERGOLA OAK FRAMEWORK Photos of English Oak sample

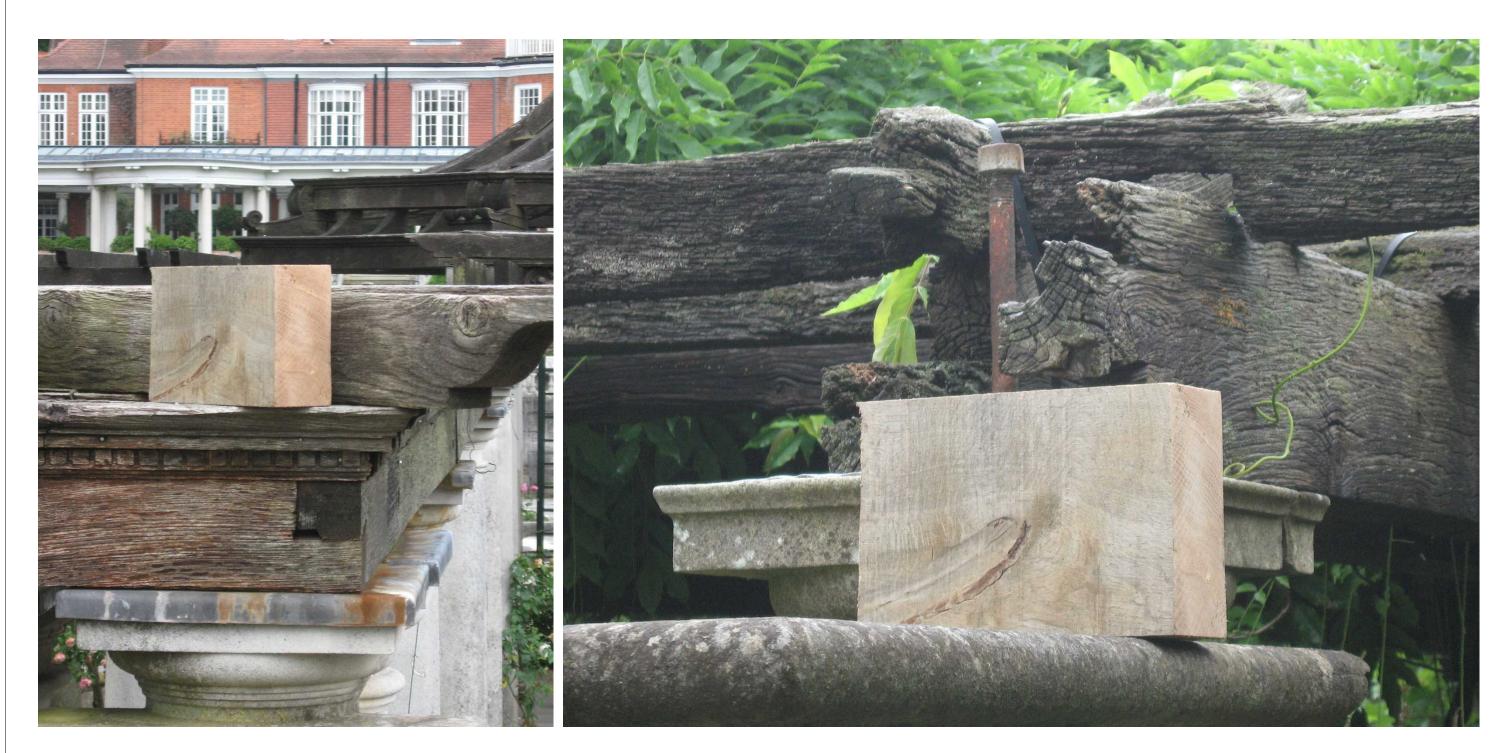
Photo of seasoned English Oak sample against 1990's oak beams and joists in the Pergola extension West of the footbridge

Photo of seasoned English Oak sample against 1911 oak beams and joists in the Pergola Colonnade extension. Note existing wet timber dark colour due to rain water darkening the oak. The sample instead is completely dry oak.
