Arboricultural Survey (BS5837:2012)
& Impact Assessment
incorporating
Arboricultural Method Statement

1-44 Denyer House
Grove End Lodge
College Lane
London
NW5 1BJ

8th August 2016

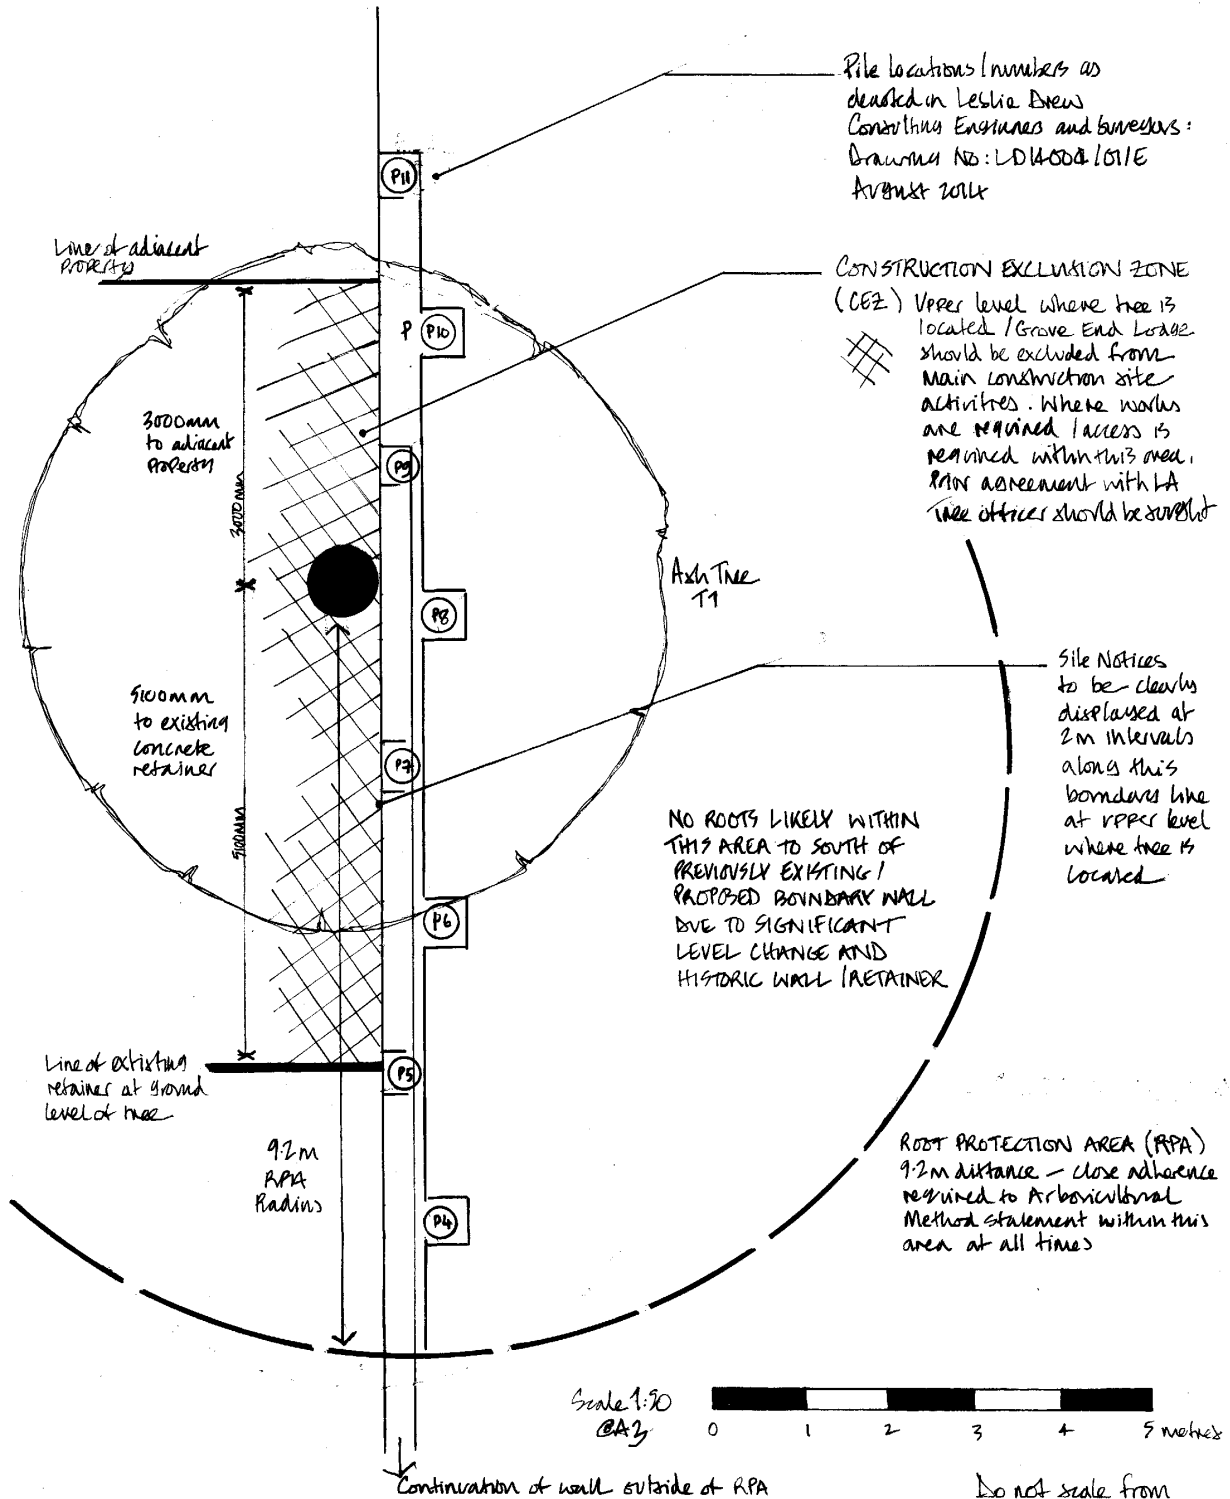
ARBORICULTURAL METHOD STATEMENT
 1-44 Denger House / Grove End Lodge, College Lane, NSW 1871

4.13 The proposed works do not encroach within the main root plate area of this tree as has been highlighted by exposure of the root system from the removal of the existing wall. As shown in *Appendix B.1* the proposed foundations for the re-construction of the boundary wall will be strengthened by extending within the ground of Denyer House which lies approximately 1000mm below the historic ground level where the Ash tree is located.

CONSTRUCTION EXCLUSION ZONE (CEZ) Upper level where tree is located / Grove End Lodge should be excluded from main construction site activities. Where works are required / access is required within this area, prior agreement with LA Tree Officer should be sought

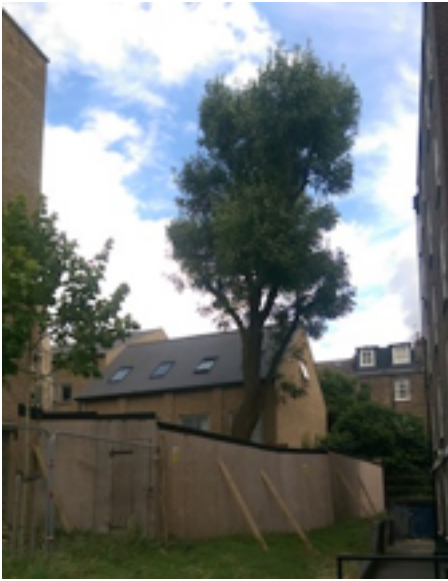
4.6 Tree T1 is a mature Ash tree which has grown directly adjacent to the historic boundary wall between the two properties and has caused direct damage resulting in the dismantling and proposed re-construction of this wall.

C.1 Photograph of tree T1 on boundary between 1-44 Denyer House and Grove End Lodge, College Lane, London, NW5 as viewed in an easterly direction

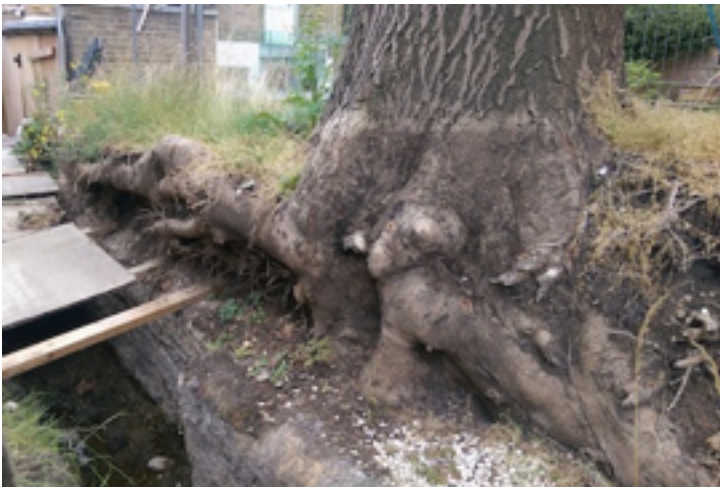
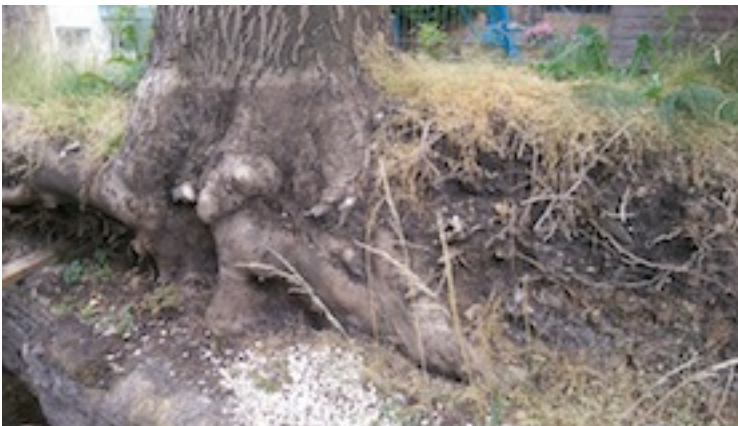
4.8 The removal of the damaged boundary wall has exposed the initial root morphology of the tree as contained by this previously existing wall. It is clear that the roots have been contained by the previous wall which also included a lean concrete mix retainer between the wall and the tree where a void existed. There is a significant lateral root (approx 280mm diameter @ 1.0m distance from the main stem) to the west which extends along the previous length of the wall at ground level to 300mm below ground level, to a distance of 5.0m from the tree in this direction where a historic retaining wall exists. From this root there are a significant number of laterals extending to the north and fibrous roots also which are partially exposed. The root has clearly become accentuated in response to the proximity of the wall and the prevailing south westerly winds from which this root provides anchorage.

4.9 To the east large anchorage roots extend to 400-500mm below ground level and run laterally in an easterly direction beneath ground level. The adjacent building 3.0m to the east indicates that possible root severance may have existed in this area, dependant on the previous history of this site. In addition large anchorage roots extend beneath the main stem and are then likely directed back within the garden area to the north due to the concrete 'ad hoc' retainer in addition to previously existing wall beneath this area which has clearly retained the root development from extending to the south.

C.2 Photographs A and B of lateral roots and base of tree T1 on boundary between 1-44 Denyer House and Grove End Lodge, College Lane, London, NW5 as viewed in a westerly direction

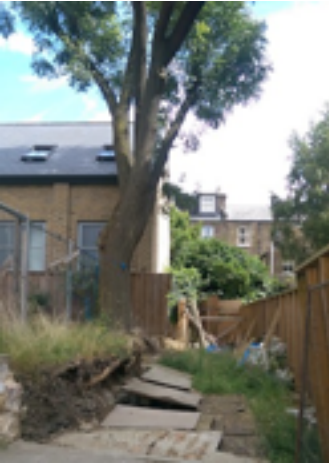
C.3 Photograph of tree T1 on boundary between 1-44 Denyer House and Grove End Lodge, College Lane, London, NW5 as viewed in a easterly direction from within construction site area

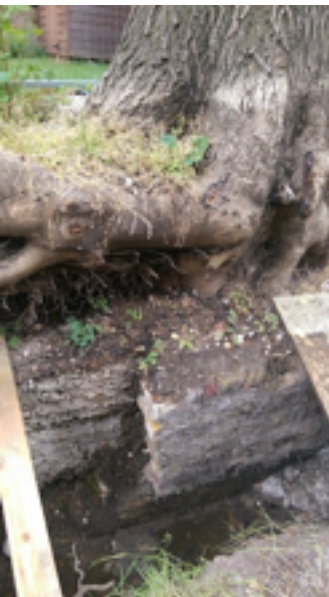
4.10 There is a significant upwards level change between 1-44 Denyer House and the garden area of Grove End Lodge where the tree is located and the previous and proposed boundary wall retains this area incorporating the tree and all associated roots. It is clear from the profile of the site (photographs shown in *Appendix C*) that all roots have been retained in the upper area. The upper 500mm section of soil comprises soil and tree roots, with made up ground comprising a further 200mm layer before the lean mix in fill concrete layer commences and extends to below the ground level as exists within Denyer House.

C.4 Photograph of base of tree and soil / ground profile beneath tree T1 as viewed in a northerly direction

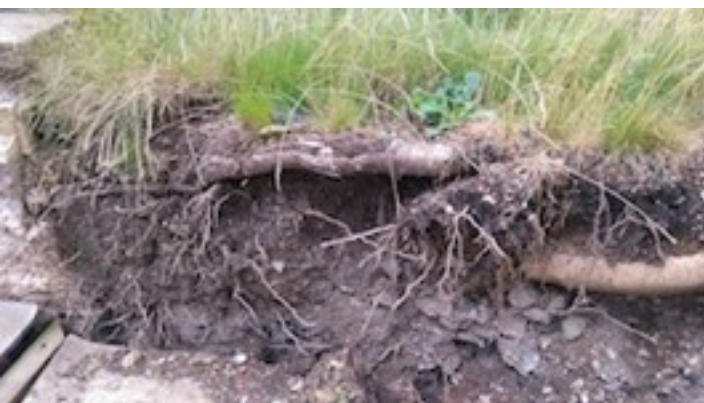
C.5 Photograph of base of tree and soil / ground profile beneath tree T1 as viewed in a northerly direction
