ARBORICULTURAL IMPACT ASSESSMENT REPORT  
& OUTLINE METHOD STATEMENT:

10 Hampstead Square  
London  
NW3 1AB

Ref: SAV/10HMQ/AIM/01

Date: 2<sup>nd</sup> August 2016

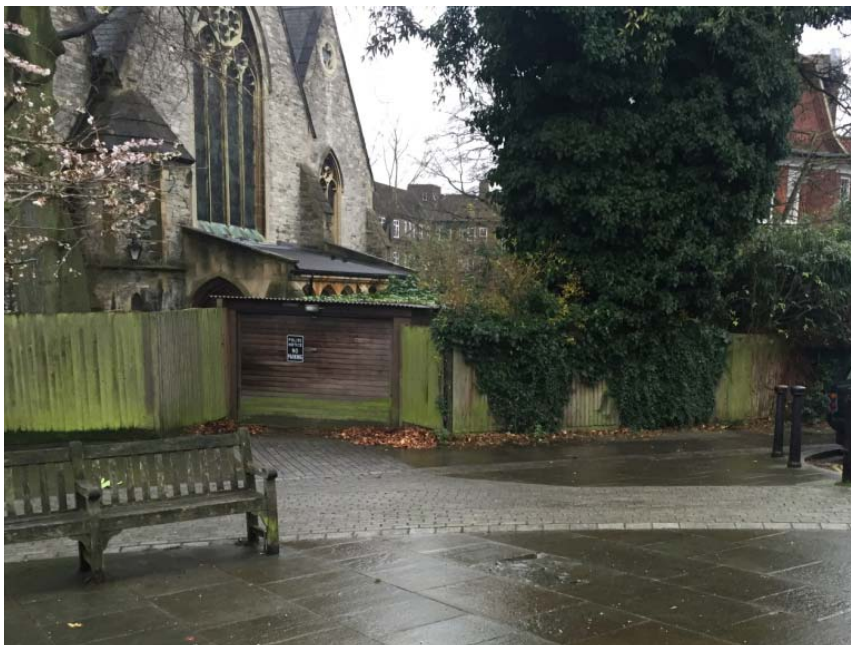
Photograph 1: Garage building at 10 Hampstead Square, London NW3 1AB

- 3.1.1 10 Hampstead Square dates from the late 19th Century and is a brick built semi-detached property with a mansard roof and dormer windows. The property is not listed, however, it is located within the Hampstead Conservation Area which benefits from a range of architectural styles ranging from different periods. The garage building itself is constructed from concrete panels with corrugate sheet roofing and is located to the north of the house.

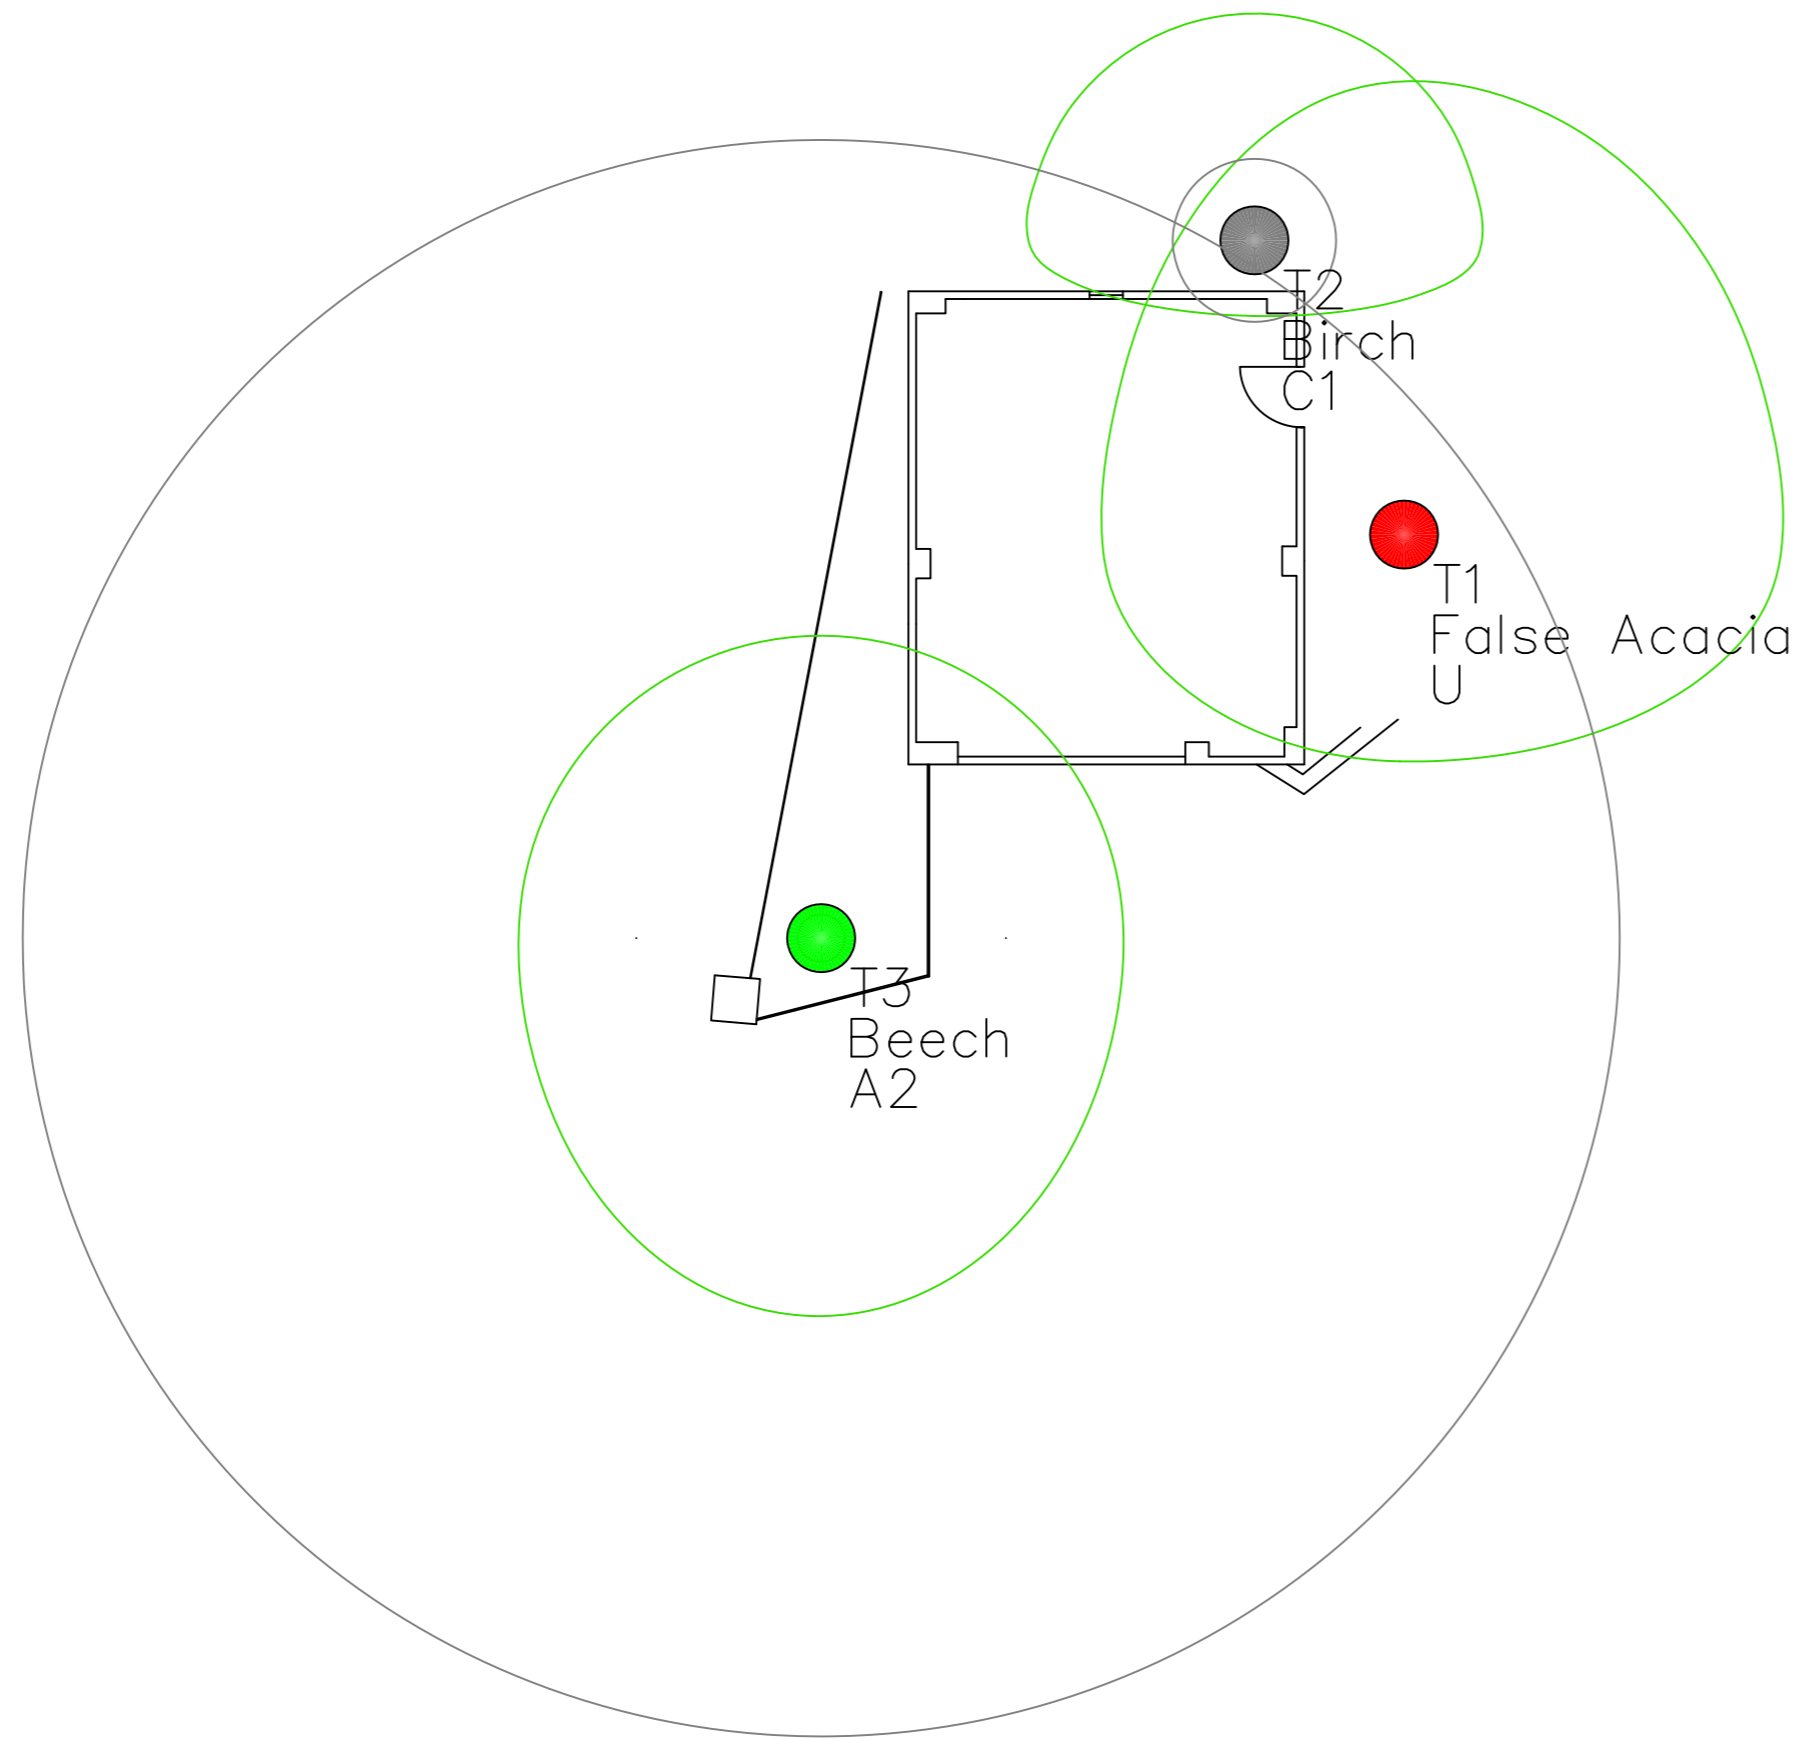
ARBORICULTURAL IMPACT ASSESSMENT PLAN

- 1.3 The principal impact in the current proposals comprises the encroachment of the theoretical RPA of T2 (12.8%) and T3 (9.3%) by the new garage building. Low-invasive foundations (i.e. discontinuous footings with suspended beam(s) / raft between) will be employed, therefore affecting a fractional net area of excavation, relative to the gross footprint / RPA encroachment. Flexibility of footing placement (relative to root location) will be built into the design, with the pit locations trial-excavated by hand under supervision. Subject to these measures, the overall impact is likely to be very low for both trees.

- 6.1.1 The principal impact in the current proposals comprises the encroachment of the theoretical RPA of T2 (12.8%) and T3 (9.3%) by the new garage building. Low-invasive foundations (i.e. discontinuous footings with suspended beam(s) / raft between) will be employed, therefore affecting a fractional net area of excavation, relative to the gross footprint / RPA encroachment. Flexibility of footing placement (relative to root location) will be built into the design, with the pit locations trial-excavated by hand under supervision. Subject to these measures, the overall impact is likely to be very low for both trees.

- 6.1.3 Where the replacement boundary wall passes within the RPA of T3, discontinuous footings shall be employed with flexibility of placement built into the design, such that trial excavated pits containing significant roots / root bundles are infilled and not used, with the footing relocated. A pad and suspended beam specification is proposed.
