ARBORICULTURAL IMPACT ASSESSMENT

**Concrete Access Cul-de-Sac
North of**

**The Hexagon,
Fitzroy Park,
London,
N6 6HR.**

Planning Reference: 2016/3252/P

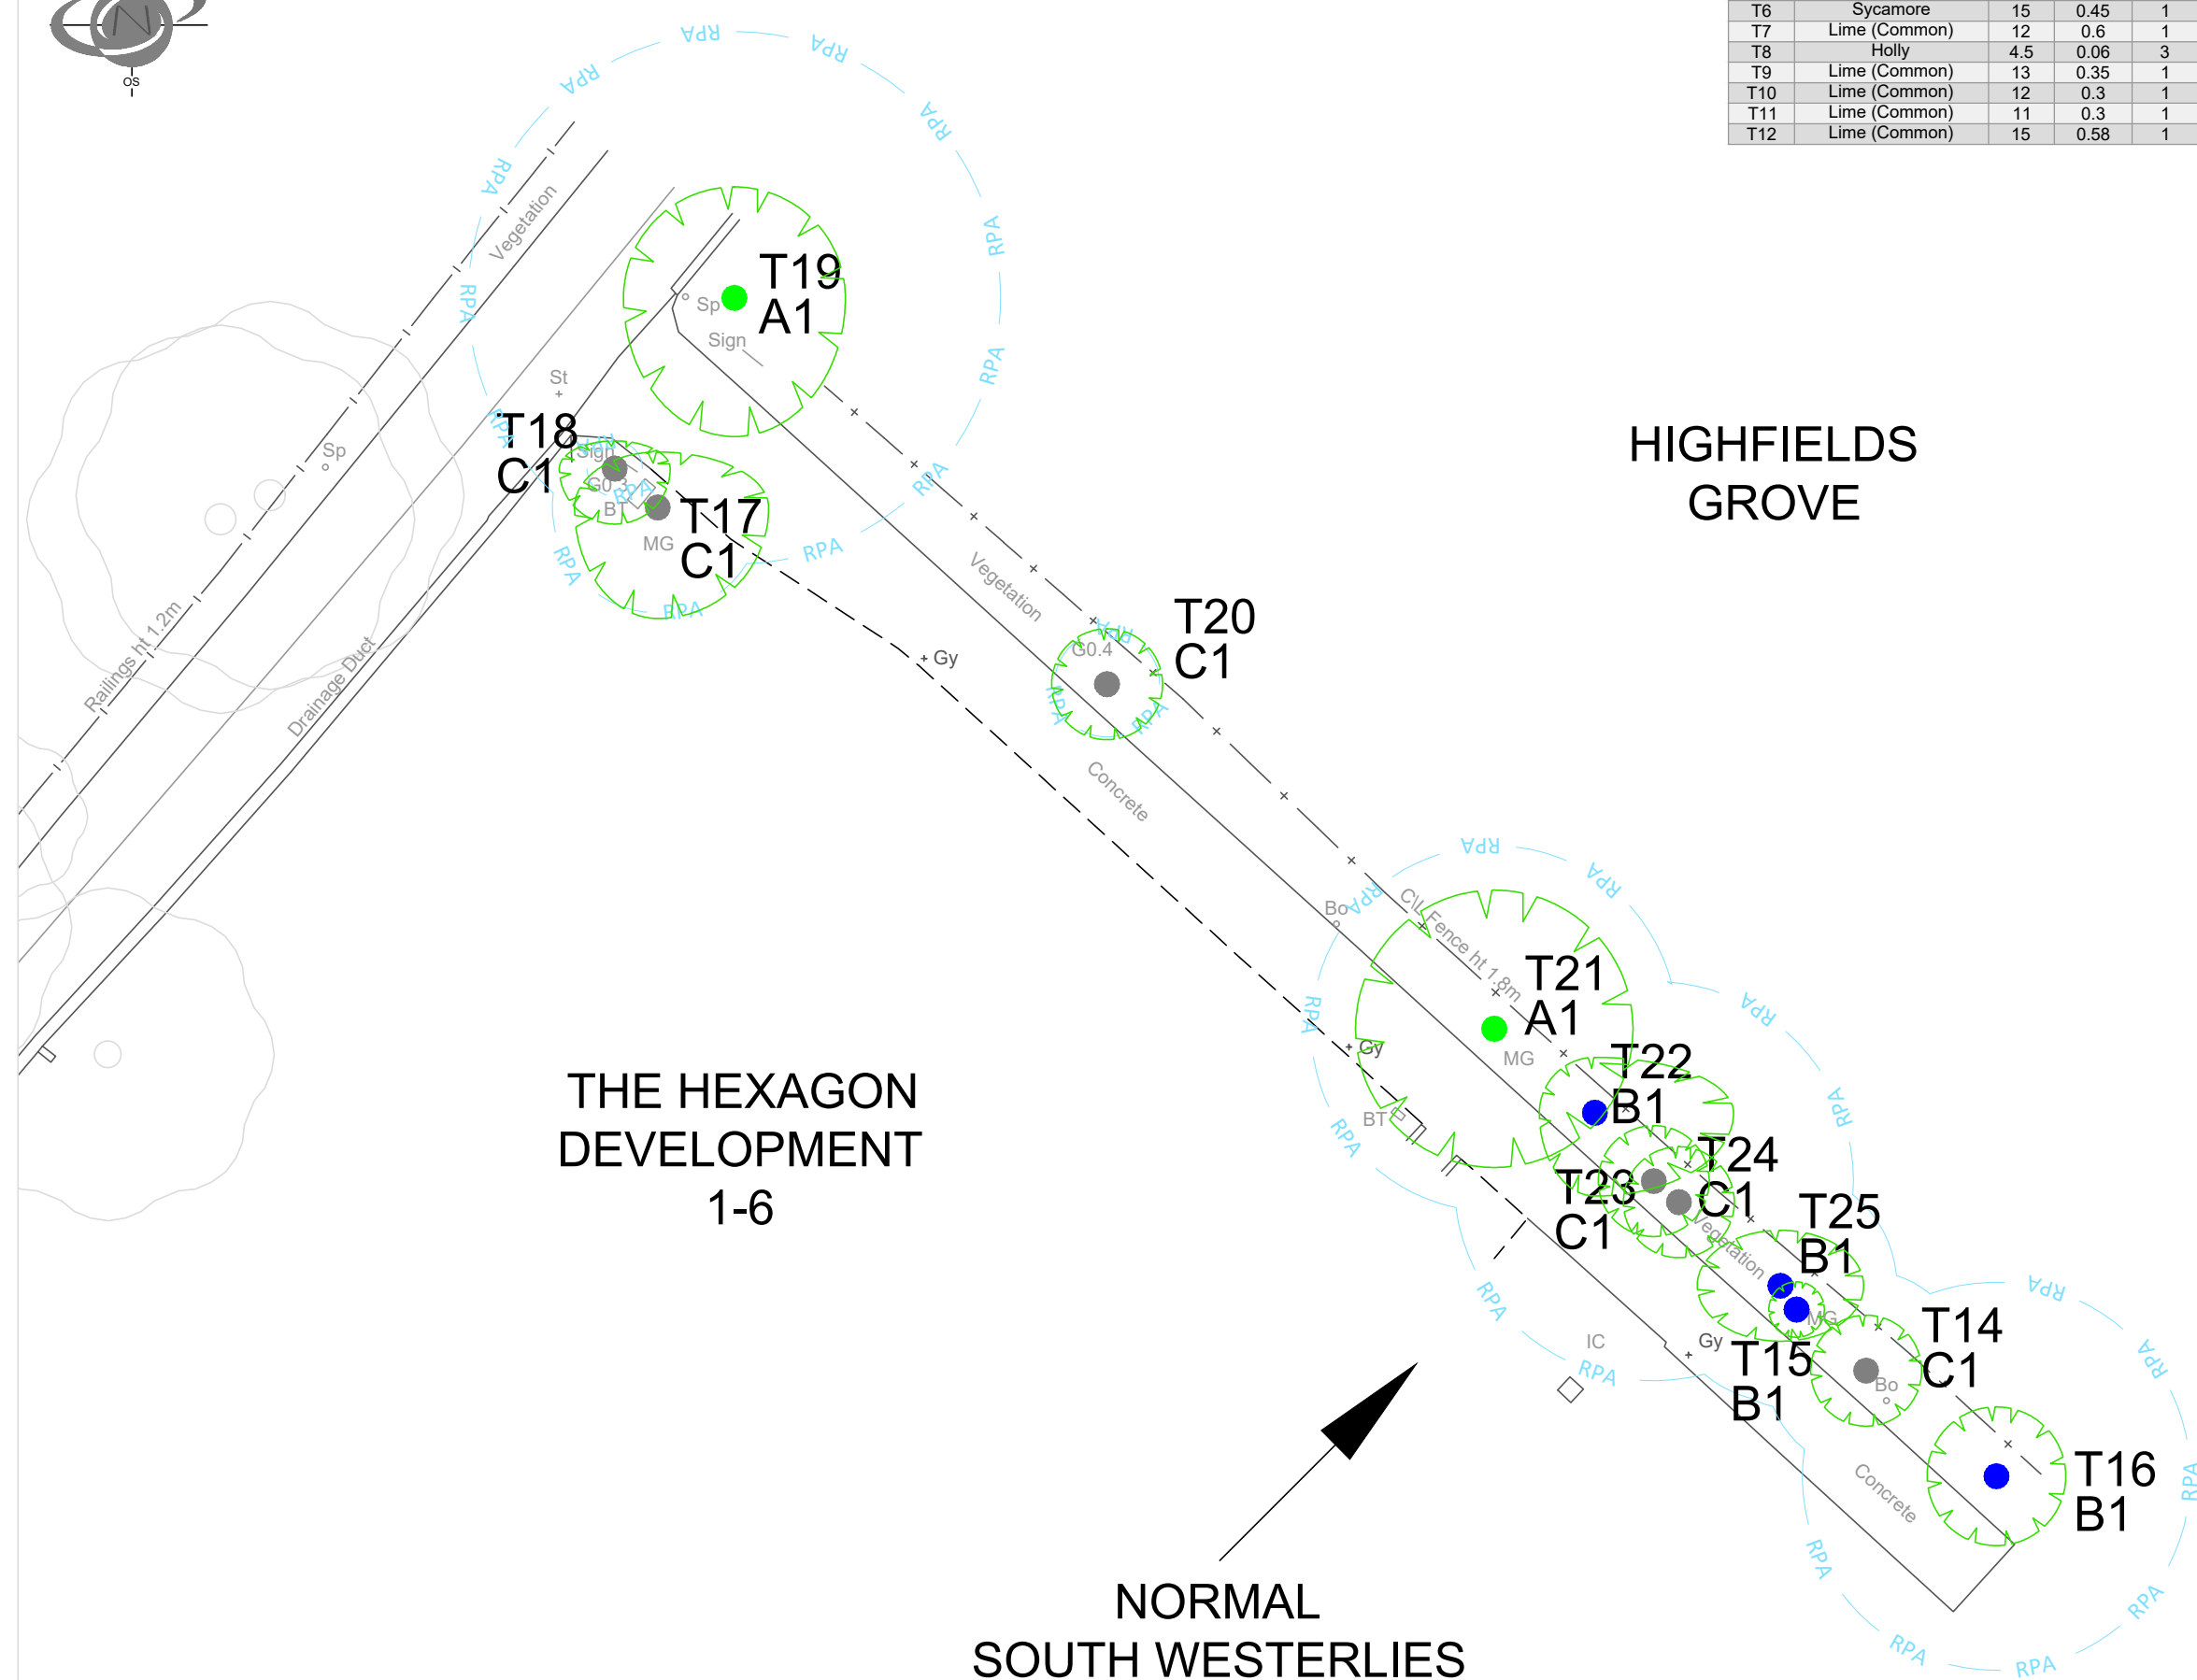
7.2.1 The development will require the installation of a new surface entirely within the RPA of all of the twelve trees surveyed: the LPL survey numbering commences adjacent No. 2 the Hexagon, with two trees in the ownership of No. 2 (T17 and T18).

7.2.7 This process will sever the roots on the windward side of all 10 trees (T19 to T25 and T14 to T16).

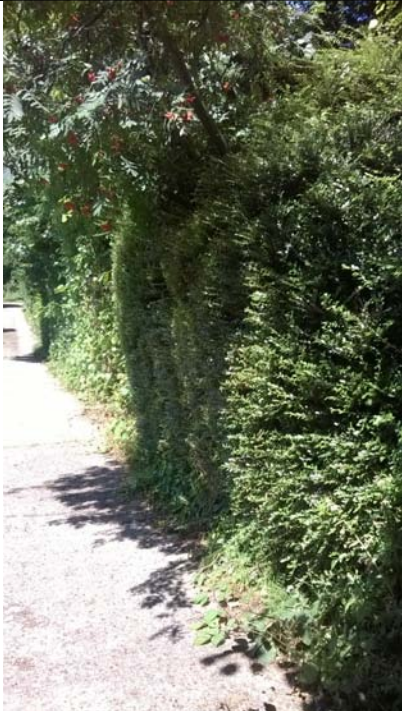
Close managed understorey edge.

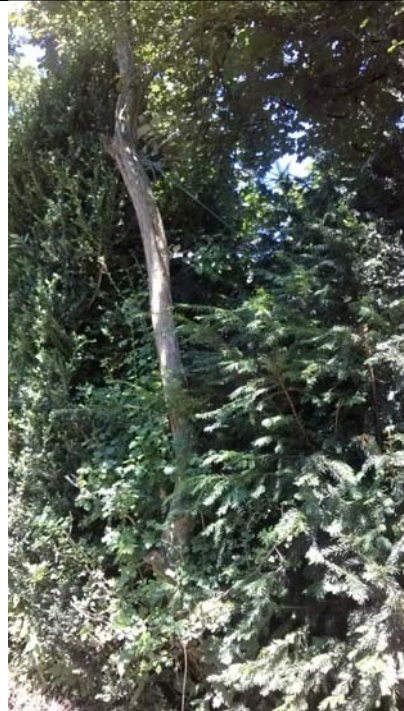
Hawthorn tied back to fenceline.

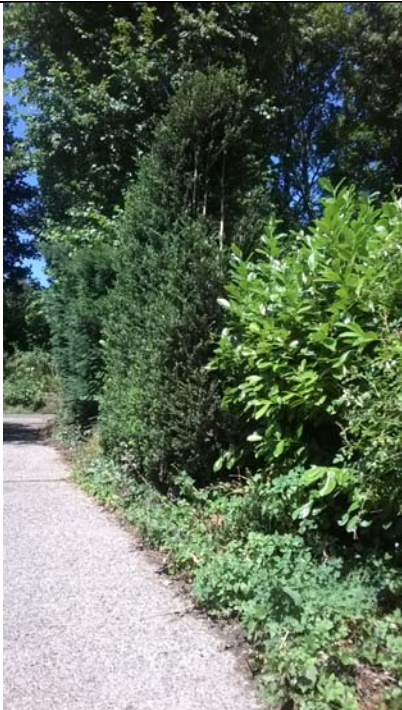
Mixed understorey of Yew, Box and Laurel.

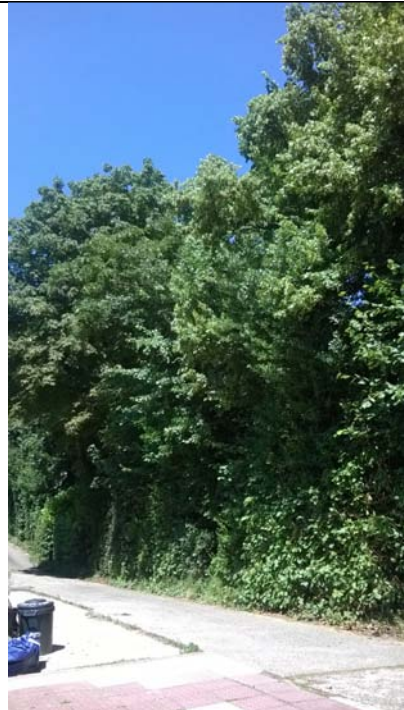
Sycamore and Horse Chestnut left view.

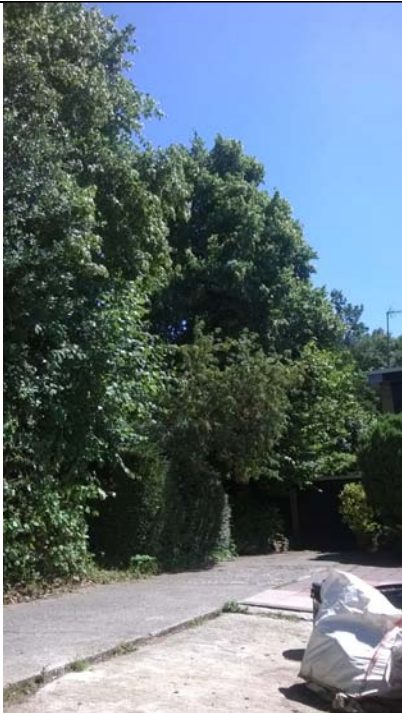
T16 (Lime) centre view.

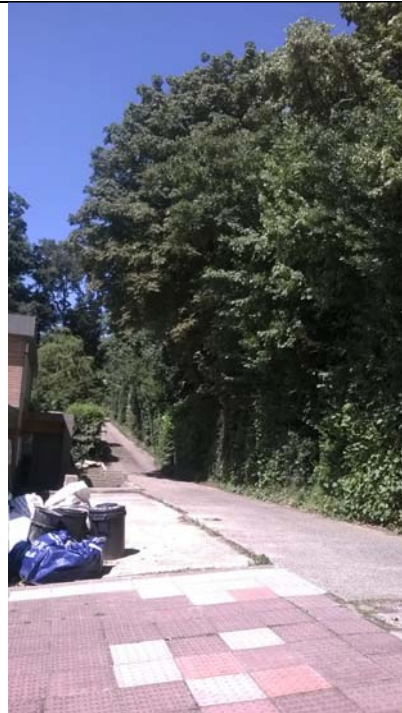
View east to west along The Hexagon.

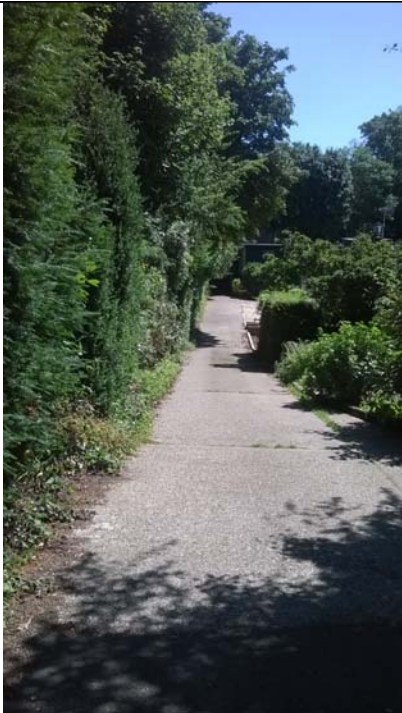
View east.
