Landmark Trees

**ARBORICULTURAL IMPACT ASSESSMENT REPORT
& OUTLINE METHOD STATEMENT:**

Whitestone House
Hampstead
London NW3 1EA

Date: 12th May 2015

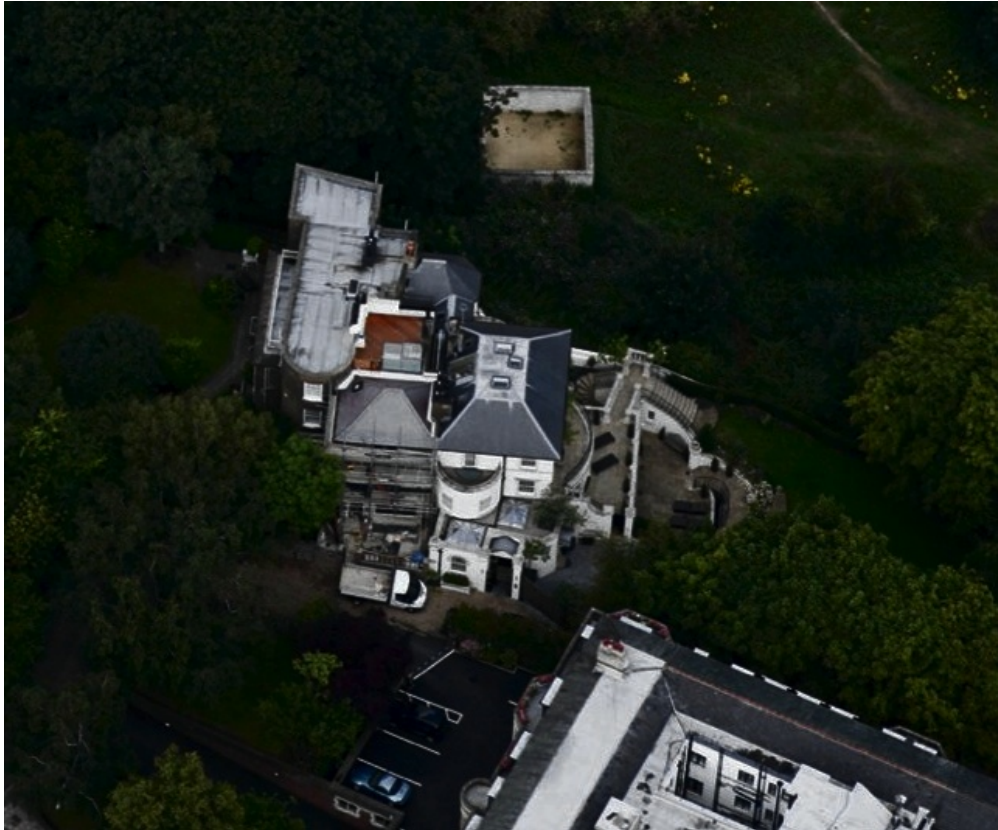
Photograph 1: Whitestone House, Hampstead, London NW3 1EA

- 3.1.1 The site comprises a residential dwelling located at the end of Whitestone Lane. The southern elevation faces Whitestone Lane and the site includes a substantial garden, as well as terraces.
- 3.1.2 The site levels vary with the existing landscaping.
- 3.1.3 In terms of the British Geological Survey, the site overlies the Bagshot Formation (shown in yellow in fig.1 overleaf), typical of Hampstead Heath; the associated soils are generally, more sandy and less shrinkable than the surrounding Claygate member and are readily permeable. Such low plasticity soils are less prone to movement: subsidence and heave. The actual limits of soil series are not as clearly defined on the ground as on plan and there may be anomalies between them. Further advice from the relevant experts on the specific soil properties can be sought as necessary.

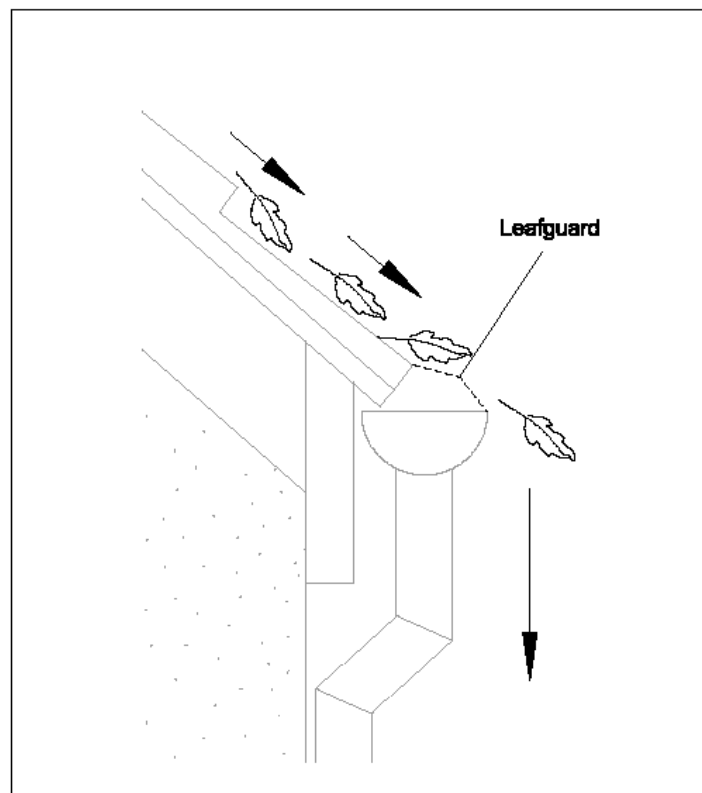
Figure 5: Filtration traps, as shown above, could be fitted on the gutters which can easily be maintained at 2-3m above ground.

- 6.3.5 Nuisance deposition can be mitigated with regular crown cleaning and filtration traps on the guttering (see Figure 5 below).
- 6.3.6 The shading impacts (of retaining any large trees near building) can be mitigated by building design, with the provision of dual aspect windows and choice of room layout. Some minor crown reduction may be necessary, but not such as to impose a burden of frequent, repetitive management.
