28 REDINGTON ROAD LONDON NW3 7RB

Review of planning application 2016/2997/P to Camden Council with respect to 26 Redington Road and Camden development policy DP27.

Report reference G1615-RP-01-E1

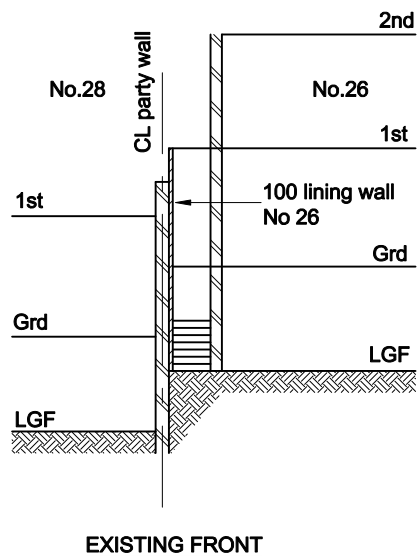
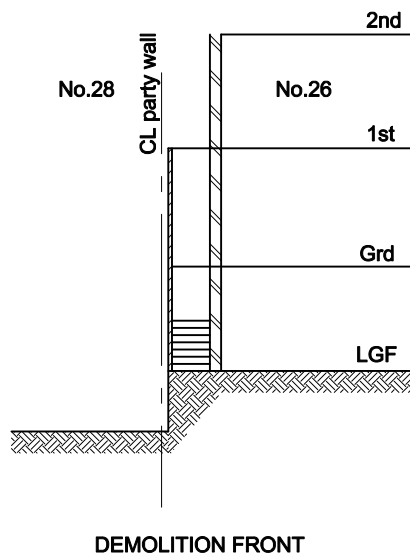
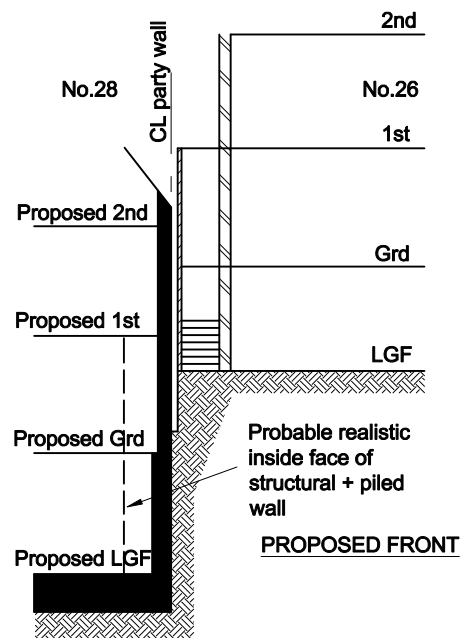
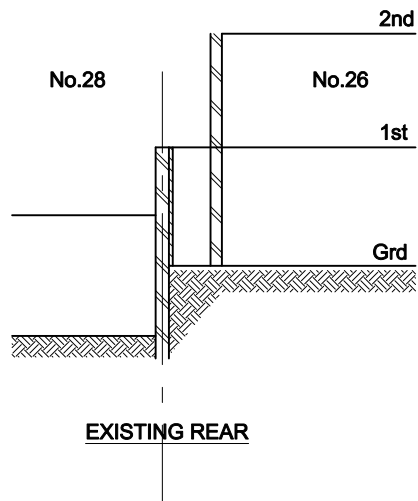
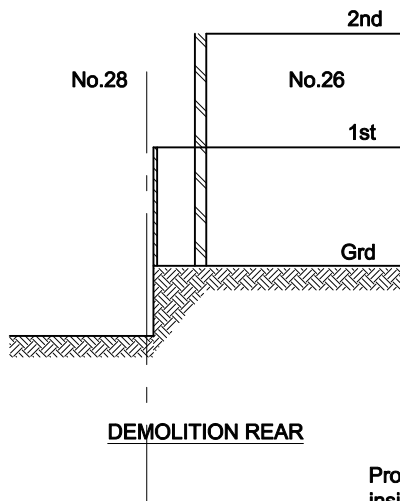
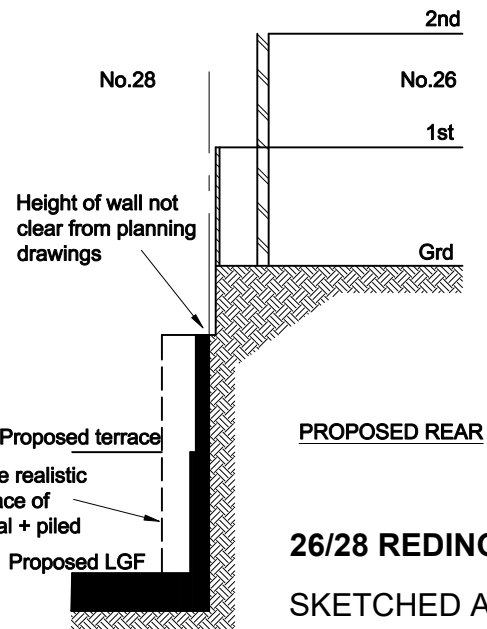
- 30. Figure 1 is in Appendix A.
- 31. The figure illustrates 3 situations at the boundary between Nos.26 and 30; existing, demolition and proposed. Two cases are considered, one near the front of the properties and one at the rear.
- 32. At present, according to the various drawings the boundary wall is astride the property boundary and thus a party wall. 2013/5996/P proposals, which have since been constructed, suggest that a 100mm thick lining wall was built against the party wall. No 26 has lower ground floor rooms in its front left part with stairs rising from these to the ground floor between the original external house wall and the lined party wall.

- 33. Architect's drawings for No 28 show an intention to demolish the existing party wall. Supposing that this could be done without disturbing the lining wall – I have no knowledge of its construction or the method by which it is supported – the 100mm wall remaining would be at considerable risk of being sucked out and demolished in the event of gale force winds. What is more likely is that the thinner wall was lightly tied to the party wall in some way during its construction and that attempts to demolish the much thicker party wall would take the lining wall with it and render parts of No.26 dangerous and uninhabitable.

- 34. Following demolition, the Architect for No.28 proposes to build the retaining wall for No.28 entirely upon the No.28 side of the boundary. As currently intended that would leave a gap between the new wall and the lining wall of No.26 and, at the rear, as far as can be estimated from the drawings, the lining wall is likely to be left exposed above a low terrace in No.28.

37. The form of the retaining wall proposed by the Architect is illustrated by the solid black profiles in Figure 1. At the front of the property it would have to support nearly 2 storey heights of ground below No.26; from the top of the stairs in No.26 to the back of the house, there would be nearly 3 storeys of ground and the building above to support.

39. Even in good ground free of slope instability and high groundwater hazard, the expected outcome would be excessive ground movement and damage of No.26. The ground conditions as interpreted by Dr de Freitas could increase the health and safety hazard for work people to a dangerous level. Designers as well as contractors would need to consider their duties under HSE regulations.

40. The BIA refers to the use of a secant pile wall around the perimeter of the excavation. This would be the normal form of construction in the circumstances but the piles would have to be set in from the boundary sufficiently to provide safe working conditions. The distance varies according to the type and size of pile and the contractor employed. Broken lines on Figure 1 show what might be a reasonably indicative inset of the perimeter wall.

41. As presented the Architect's drawings depict a form of retaining wall construction with a high risk of causing excessive damage to No.26. that could not be ameliorated without change of design. The scheme again fails to satisfy DP27(a)
