### **ARBORICULTURAL IMPACT ASSESSMENT REPORT RELATING TO THE TREES WITHIN, AND ADJACENT TO, NUMBER 62 AVENUE ROAD, ST. JOHN'S WOOD, LONDON.**

FH-JGP-Architects-62-Avenue-Road-London-2011

13<sup>th</sup> July 2011

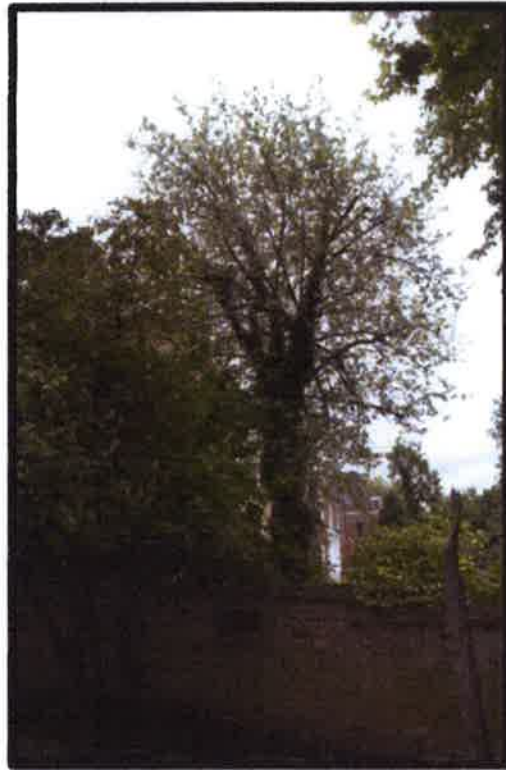
Tree 1: An extremely poor quality Whitebeam (*Sorbus aria*) growing in the front garden of number 60 Avenue Road, approximately 1.0 metre from the south-eastern boundary wall of number 62. It is currently approximately 9.0 metres tall, with an average crown

spread in the region of 7.0 metres. It leans significantly away from number 62 Avenue Road, i.e. into the garden of number 60, and it has a trunk diameter of approximately 350mm. At the time of the inspection on the 13<sup>th</sup> of July, 2011, the tree had a very sparse crown. It has a British Standard 5837 category rating of "C1/R".

**Picture showing tree 1 in the adjacent garden.**

- 9.11 The root system of the very poor quality Whitebeam growing in the front garden of number 60 Avenue Road will have been affected by the foundations of the boundary wall separating the two properties. The wall has cracked, and the only practical way to repair it in its present position would be to remove the tree. In my opinion, there will be few, if any, significant sized roots from the tree encroaching onto the property. The theoretical Root Protection Area of this tree will be skewed by the presence of the boundary wall.

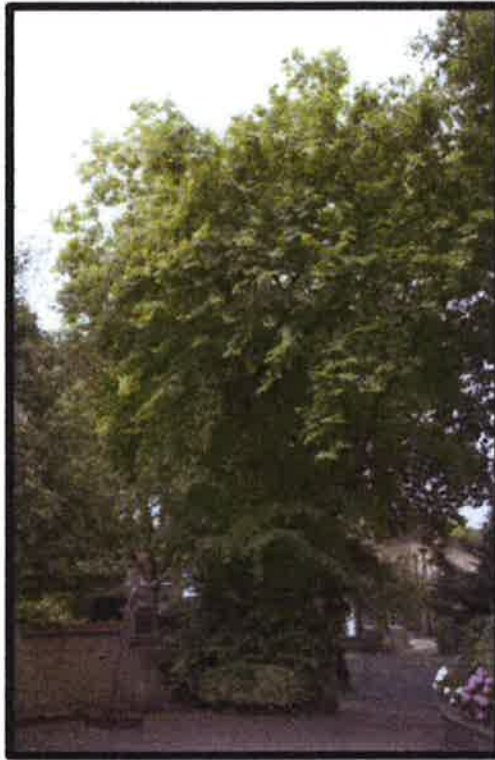
- Tree 2: A poor quality Lime (*Tilia x europaea*), growing on a 1.0 metre high raised area, in the front, southern corner of the property, and beneath the canopy of one of the London Planes growing in the pavement. It is currently approximately 12.0 metres tall, with an average crown spread of 5.0 metres, and a trunk diameter of 318mm. It is being suppressed on the roadside by the growth of the adjacent Plane. The main branches emanate approximately 7.5 metres above ground level, where it has been pollarded in the past. It has a British Standard 5837 category rating of "C1".
- Tree 3: Two large, mature London Planes (*Platanus x hispanica*) growing in the public pavement at the front of the property. They will not be affected in any way by the proposed development, although it will be prudent to physically protect their trunks during the development works.

**Picture showing the Lime tree 2, in the front, left-hand corner.**

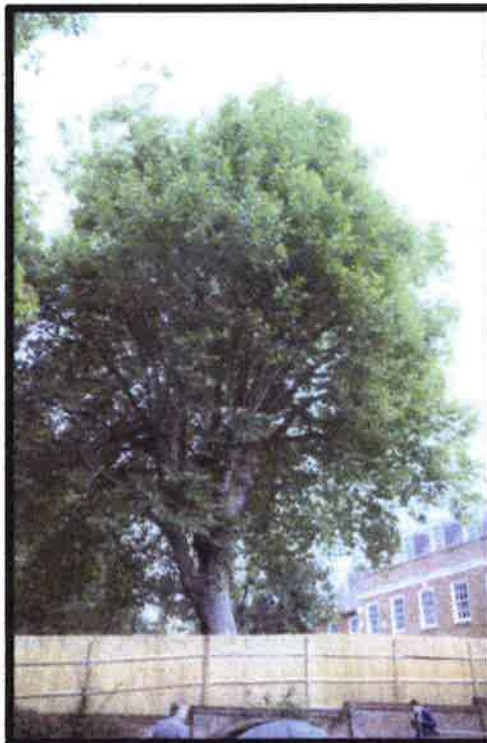
**Picture showing the Plane tree 4 in the adjacent property.**

- Tree 4:** A large, fully mature Plane tree (*Platanus x hispanica*) growing in the front garden of number 64 Avenue Road. It is currently 27.0 metres tall, with a crown spread to the north of 12.0 metres, to the south (over 62) 8.5 metres, to the east 9.0 metres, and towards the west 9.0 metres. It has a trunk diameter of 1123mm, and the main branches emanate approximately 8.0 metres above ground level. The boundary wall is 1.6 metres high. The tree has been pruned in the past, but has a large, spreading canopy. Number 64 Avenue Road is currently being renovated/redeveloped, but no tree protection measures have been installed, and signs of soil movement are visible around the basal trunk. The tree has a British Standard 5837 category rating of "A1".

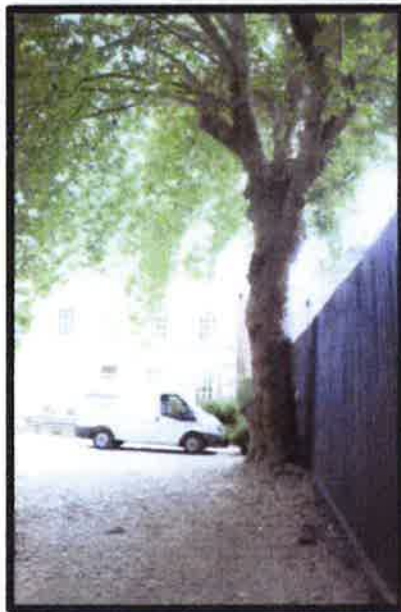
**Picture showing the base of the Plane, tree 4, close to the boundary, and with no physical protection of its roots or trunk.**

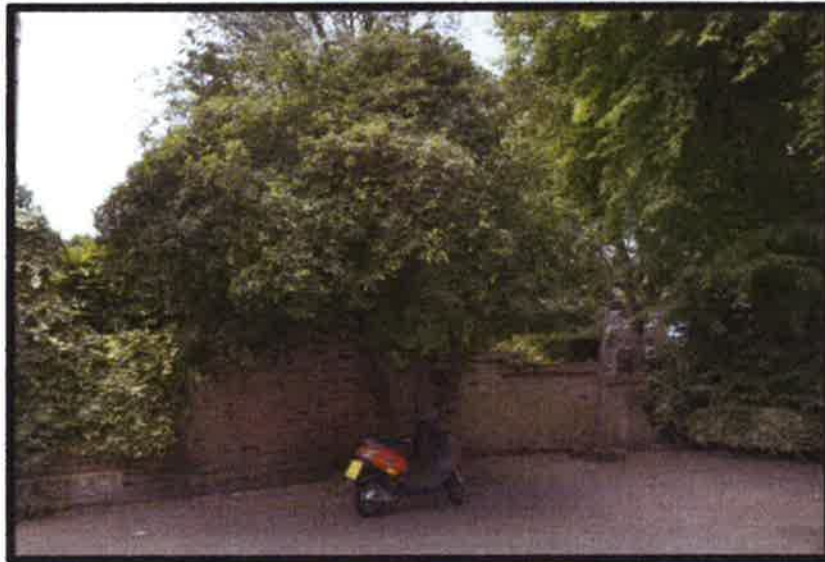
- Tree 5:** This is a large, poor-quality, multi-stemmed evergreen shrub located within the front garden of the property, adjacent to the right-hand (south-eastern) boundary wall (See the picture on the following page). It is currently only 4.0 metres tall, with an average crown spread of 5.5 metres. No British Standard 5837 rating has been given, and it should not be used to affect the proposed development.
- Tree 6:** A row of poor quality Leyland Cypress (*xCupressocyparis leylandii*) hedging running along the front of the property, between

the two entrance gates (See the picture on page 3 of this report). The hedge has a British Standard 5837 category rating of "C2".

**Picture showing the shrub, tree 5, growing adjacent to the boundary wall.**

- 9.15 The shrub growing within the front garden of number 62 Avenue Road will have had its root development affected by the foundations of the boundary wall. However, the plant has no special attributes, and should not affect the development of the site. The dead stump next to the shrub should be removed.

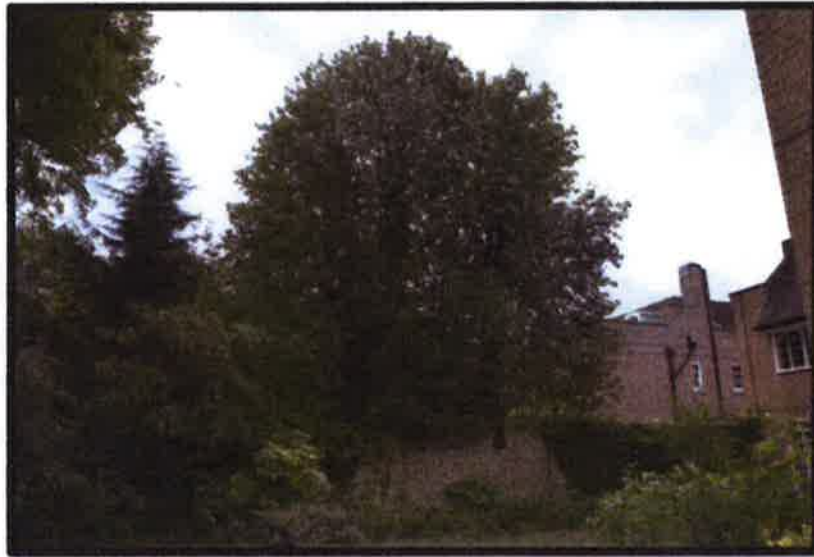
**Tree 7:** This is a fully mature Whitebeam (*Sorbus aria*) growing in the rear garden of number 60 Avenue Road, within 500mm of the northern boundary wall. It is currently 14.0 metres tall, with a crown spread over to the north (over 62) of 1.0 metre, towards the south 4.0 metres, towards the north-east 2.0 metres, and to the east 4.0 metres. It has a trunk diameter of approximately 320mm. The main branches emanate 4.5 metres above ground level, but the tree has been severely pruned (Pollarded) in the past at that height. It has also been topped at a height of between 6.5 metres and 7.0 metres. The tree has a British Standard 5837 category rating of "C1", and should not be used to adversely affect the development of the site.

**Tree 8:** A second Whitebeam growing in the rear garden of number 60 Avenue Road; adjacent to tree 7, and within 500mm of the boundary wall. It is currently 15.0 metres tall, with a crown spread to the north (over 62) of approximately 1.0 metre, towards the south-east 2.0 metres, and towards the west 4.0 metres. It has a trunk diameter in the region of 350mm, and the main branches emanate 4.5 metres above ground level. The tree has been severely pruned (Pollarded) in the past similar to tree number 7. It is

currently covered with Ivy. The tree has a British Standard 5837 category rating of "C1", and should not be used to adversely affect the development of the site.

**Picture showing the two Whitebeams, trees 7 & 8, in the rear garden of the adjacent property.**

- 9.17 Two Whitebeams (T7 & T8) are growing within the rear garden of number 60 Avenue Road, adjacent to the boundary wall. Their root development will have been significantly affected by the foundations of the boundary wall.

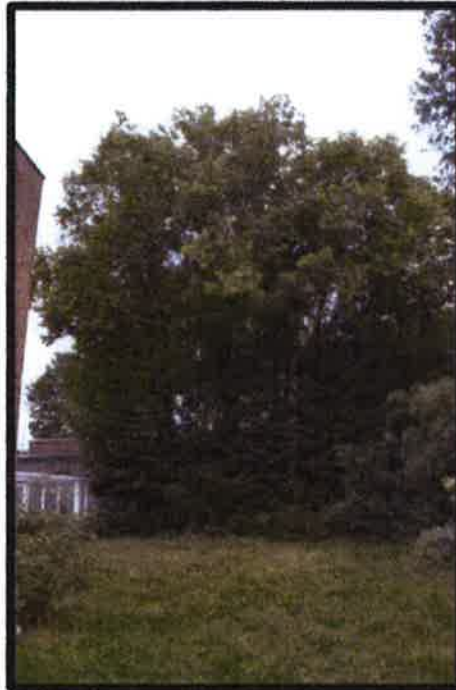
**Picture showing the row of Lime trees, tree 9, along the rear boundary of the property.**

Tree 9: This is a row of 7 Limes (*Tilia x europaea*) six of which are growing within 1.5 metres of the rear boundary wall of the garden. The second tree from the left is located 2.5 metres from the wall. The trees are up to 22.0 metres tall, with average crown spreads over the garden of 7.0 metres. The main branches emanate 6.0 metres above ground level, and the trees have been severely pruned (Pollarded) on a number of occasions. Epicormic growths are present on the main trunks. The largest trunk diameter is 423mm (the second from the left is 382mm). Other than the second tree from the right, which is effectively dying and has a British Standard 5837 category rating of "R", the remainder have British Standard 5837 category ratings of "C2".

10.10 As the row of Limes (T9) is located close to the rear boundary of the site, it is recommended that their theoretical Root Protection Areas be increased by 2.0 metres on the garden side, i.e. to provide a greater protection area.

- 16.6 It is recommended that the Root Protection Area of the row of Limes in the rear garden be extended by 2.0 metres to provide an increased buffer zone from any excavations.
- 16.7 If any excavations will be within the theoretical Root Protection Areas of the trees, it is recommended that site investigations are carried out to assess the actual encroachment of roots from the adjacent properties.

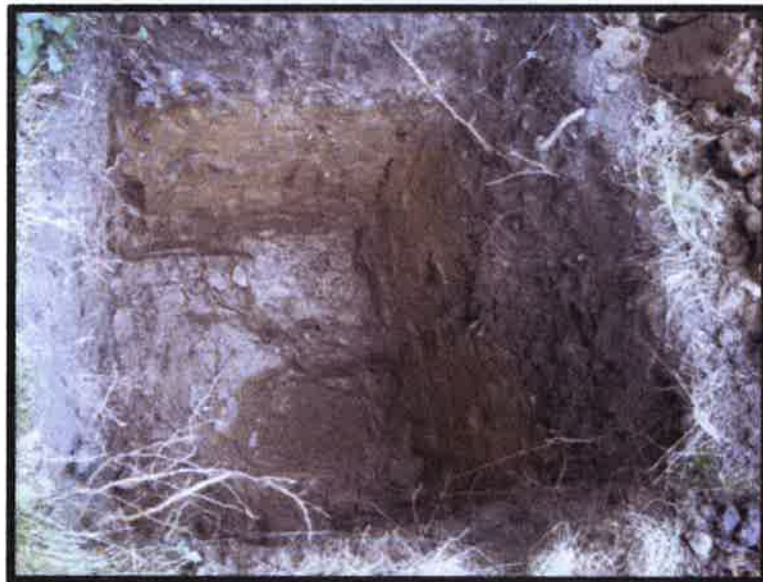
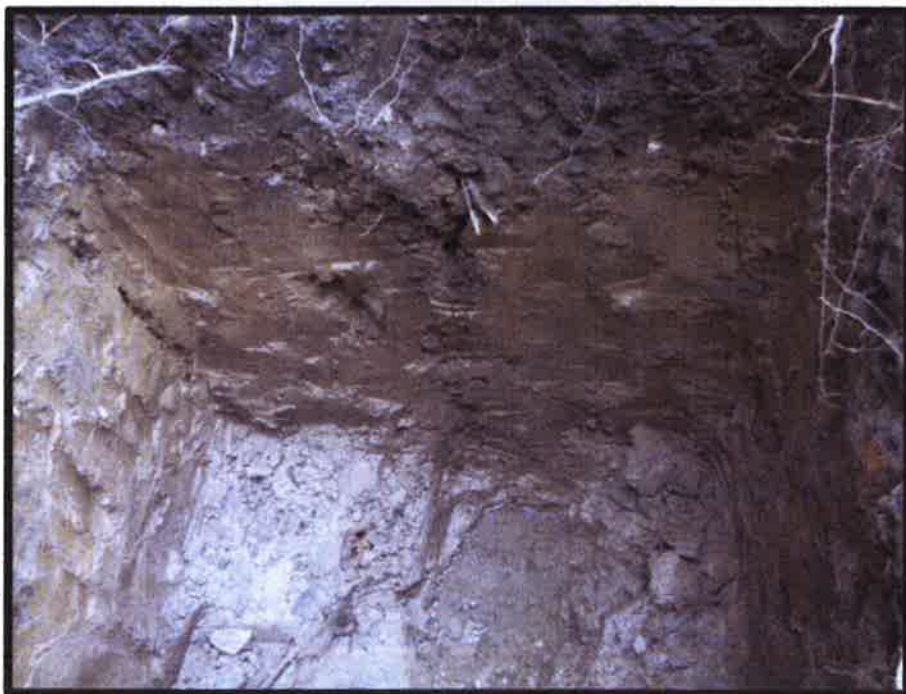
**Picture showing the sides and base of trial pit 1.**

**Close-up picture of Trial Pit 1 showing no significant root growth.**

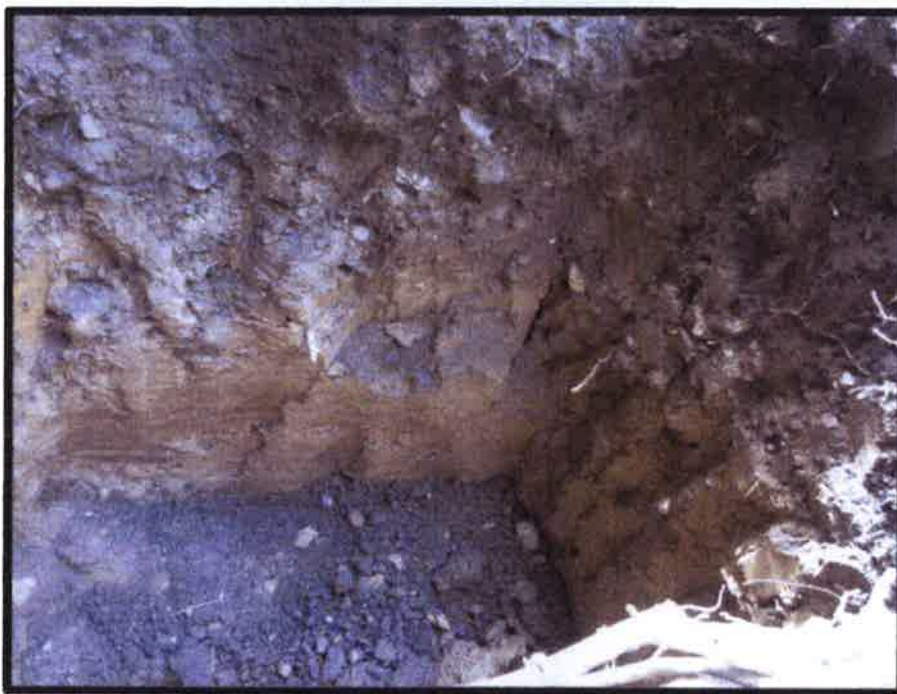
**Picture showing the bottom and sides of Trial Pit 2.**  
**(Note no significant roots in the profile).**

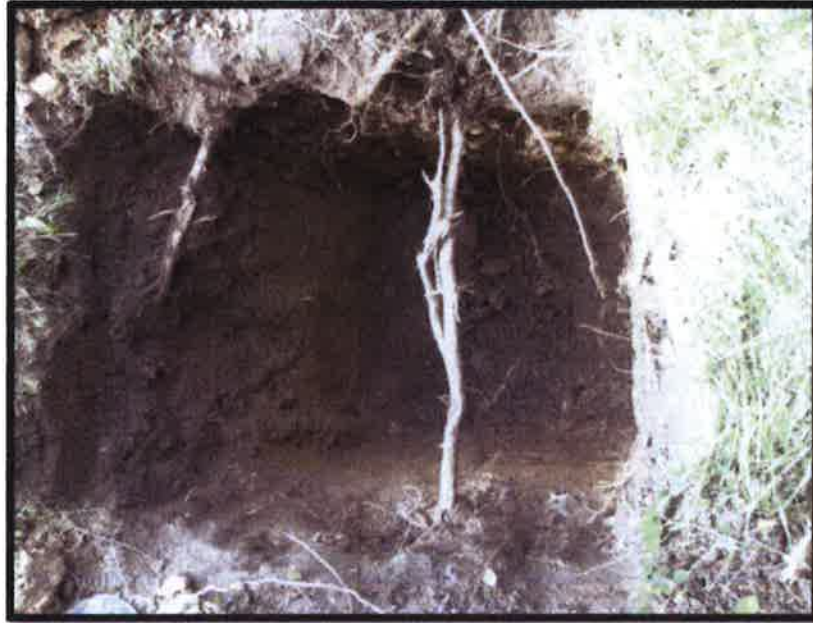
**Picture showing Trial Pit 2, containing 2 roots of approximately 25mm to 30mm diameter, within 300mm of the soil surface. These roots will not have emanated from the Whitebeams.**

- 9.18 The site investigations indicate that there are no significant roots of the Whitebeams in the rear garden of the property.
- 9.19 The row of Limes along the rear boundary will have had their roots affected by the foundations of the adjacent wall. The majority of their roots would be expected to be within the rear garden of the property.
