Arboricultural Feasibility Report

The Bourne Estate, EC1N.

Higgins Construction

02.08.16

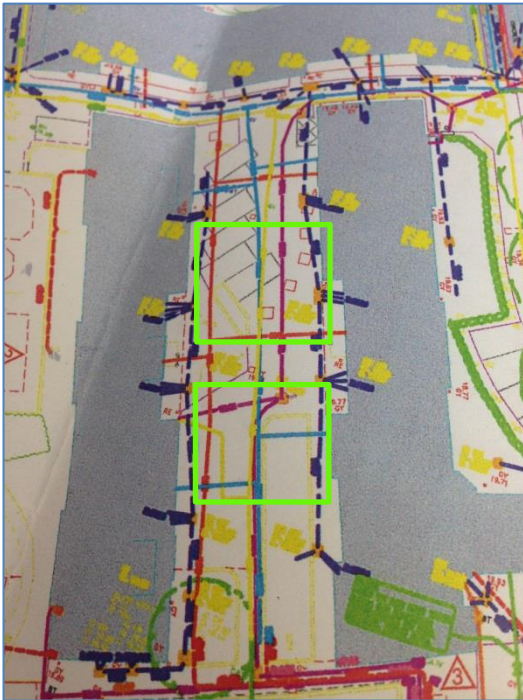
Original landscaping plan with 2no. 18-20cm girth Turkish hazel trees.

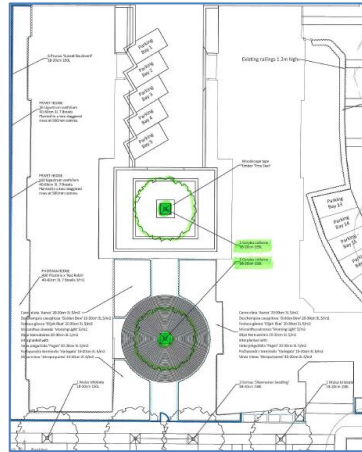
Updated landscaping plan with two parallel specimens within the planting locations to sit either side of services.

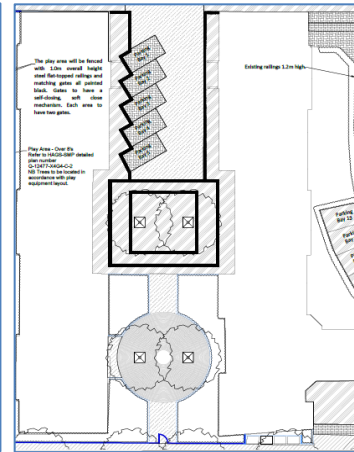
- 2.1.4 The two proposed planting locations have service lines running both centrally within the planning locations, and intersecting the position with 'T' junctions.

Location with existing service runs and indicative tree planting locations within the lime green boxes.

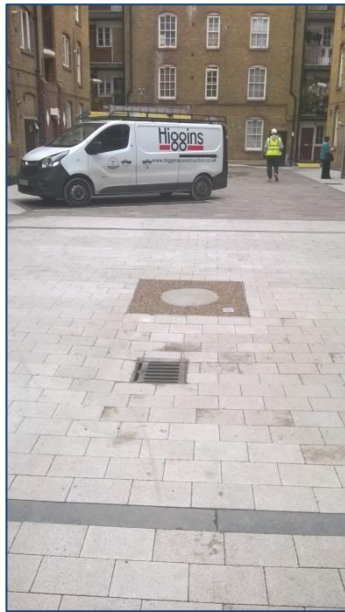
Photo 1: Proposed tree location 1 (north).

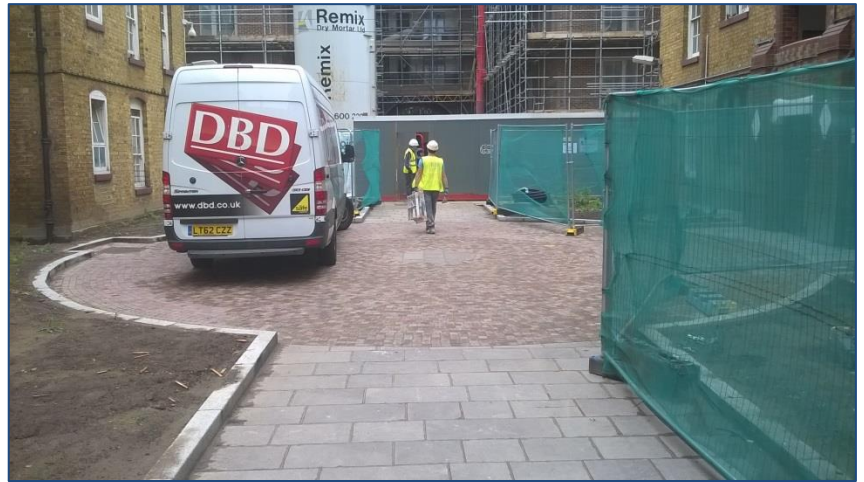
Photo 2: Proposed tree location 2 (south).

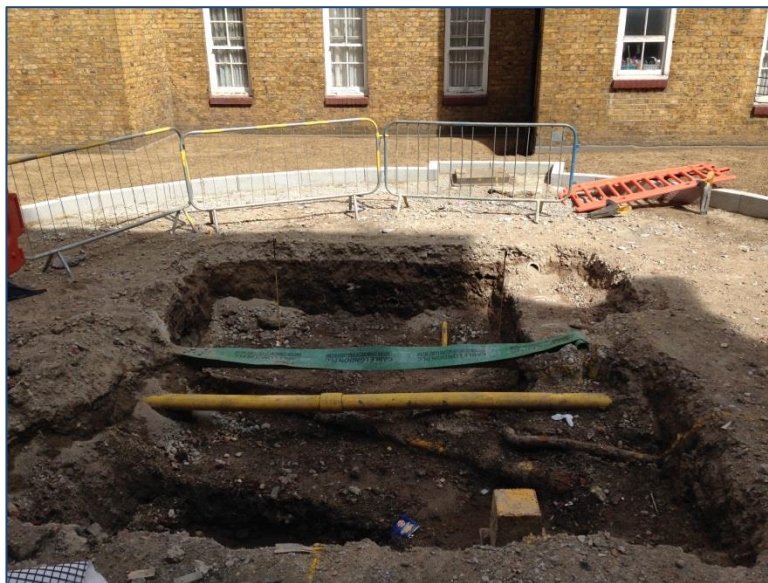
- The services are shallowly located within the first 500mm below existing ground level. This the minimum depth of substrate required for healthy tree establishment. The majority of the rooting area will be occupied by the services, causing limited root growth and poor establishment.
- Even if the services were adequately shuttered to prevent root damage to the runs from intertwined growth, future maintenance of the services would likely cause significant root damage and unnecessary constraint to maintenance operations.
- Following the extensive utility works involved in installing this number of services in the location there is a high likelihood that the substrate is compacted, void of organic matter and nutrient deficient with an unbalanced pH level. The sum of these factors creates an environment which is unsuitable for tree establishment.

Photo 3: Service at 300mm below existing ground level of planting location 2.

- 4.1 Due to the shallow nature of existing surfaces, intertwining root growth posing a constraint on future service maintenance works and the assumed poor quality of the substrate; it is not feasible to plant proposed trees in the location.
- 4.2 A more viable option would be to emplace large planters in the locations within an incorporated bench/seating structure, which would allow the proposed trees greater substrate quality, water percolation/gaseous exchange, and protection from the surroundings.
- 4.3 In a large planter 1.8m x 1.8m x 1m deep the species choice is still viable and establishment of the tree achievable. To ensure successful establishment the planter will require a root-guying stem to increase stability of the tree, an aeration system or gravel base layer and watering regime within the first year at least.
