## **TREE SURVEY, ARBORICULTURAL IMPACT ASSESSMENT AND TREE PROTECTION PLAN**

A report to accompany a planning application for the demolition of the existing detached dwelling and construction of new detached house on an extended footprint with basement at 81 Avenue Road, London NW8 6JD

*30 September 2015*

MDA reference D08

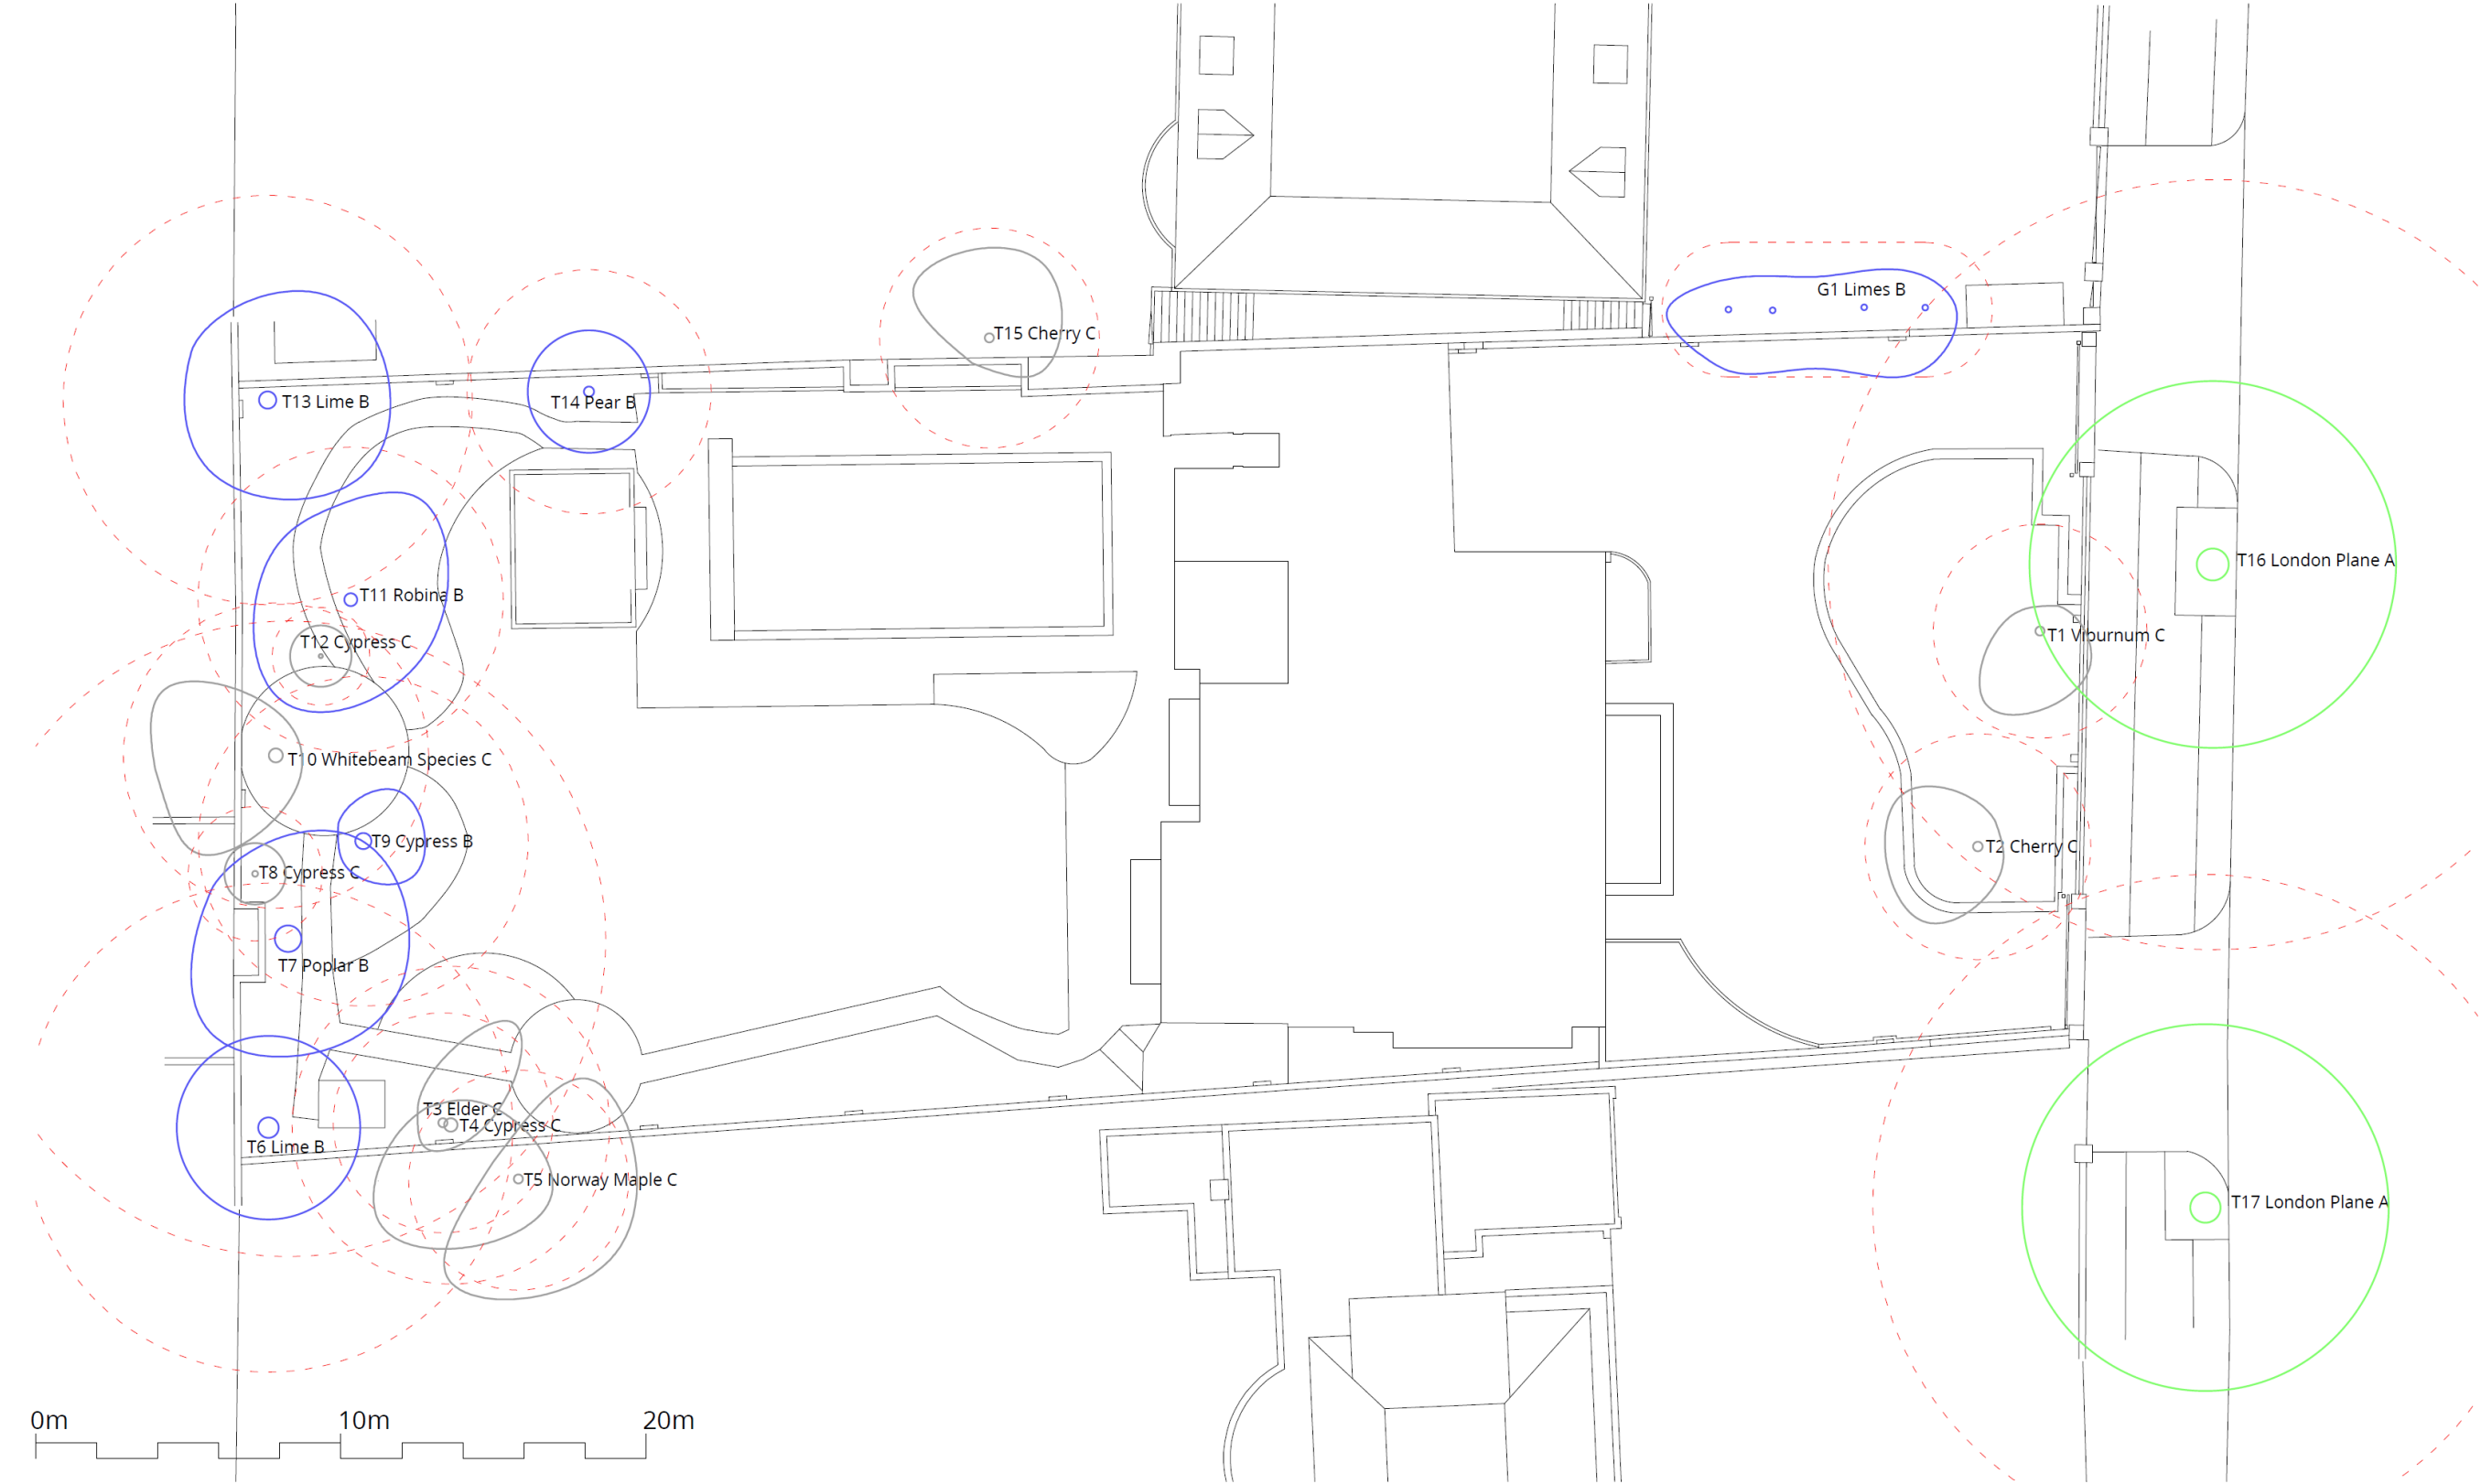
APPENDIX MD2

- 2.3 The site survey drawing appended at **MD2** shows the positions of the trees surveyed and gives a reasonable indication of their comparative branch spreads. The drawing has been colour coded as follows:

Tree constraints plan showing existing plot layout with tree numbers, BS5837: 2012 colour codes (A – Green, B – Blue, C – Grey, U - Red) and root protection areas (dashed circles)

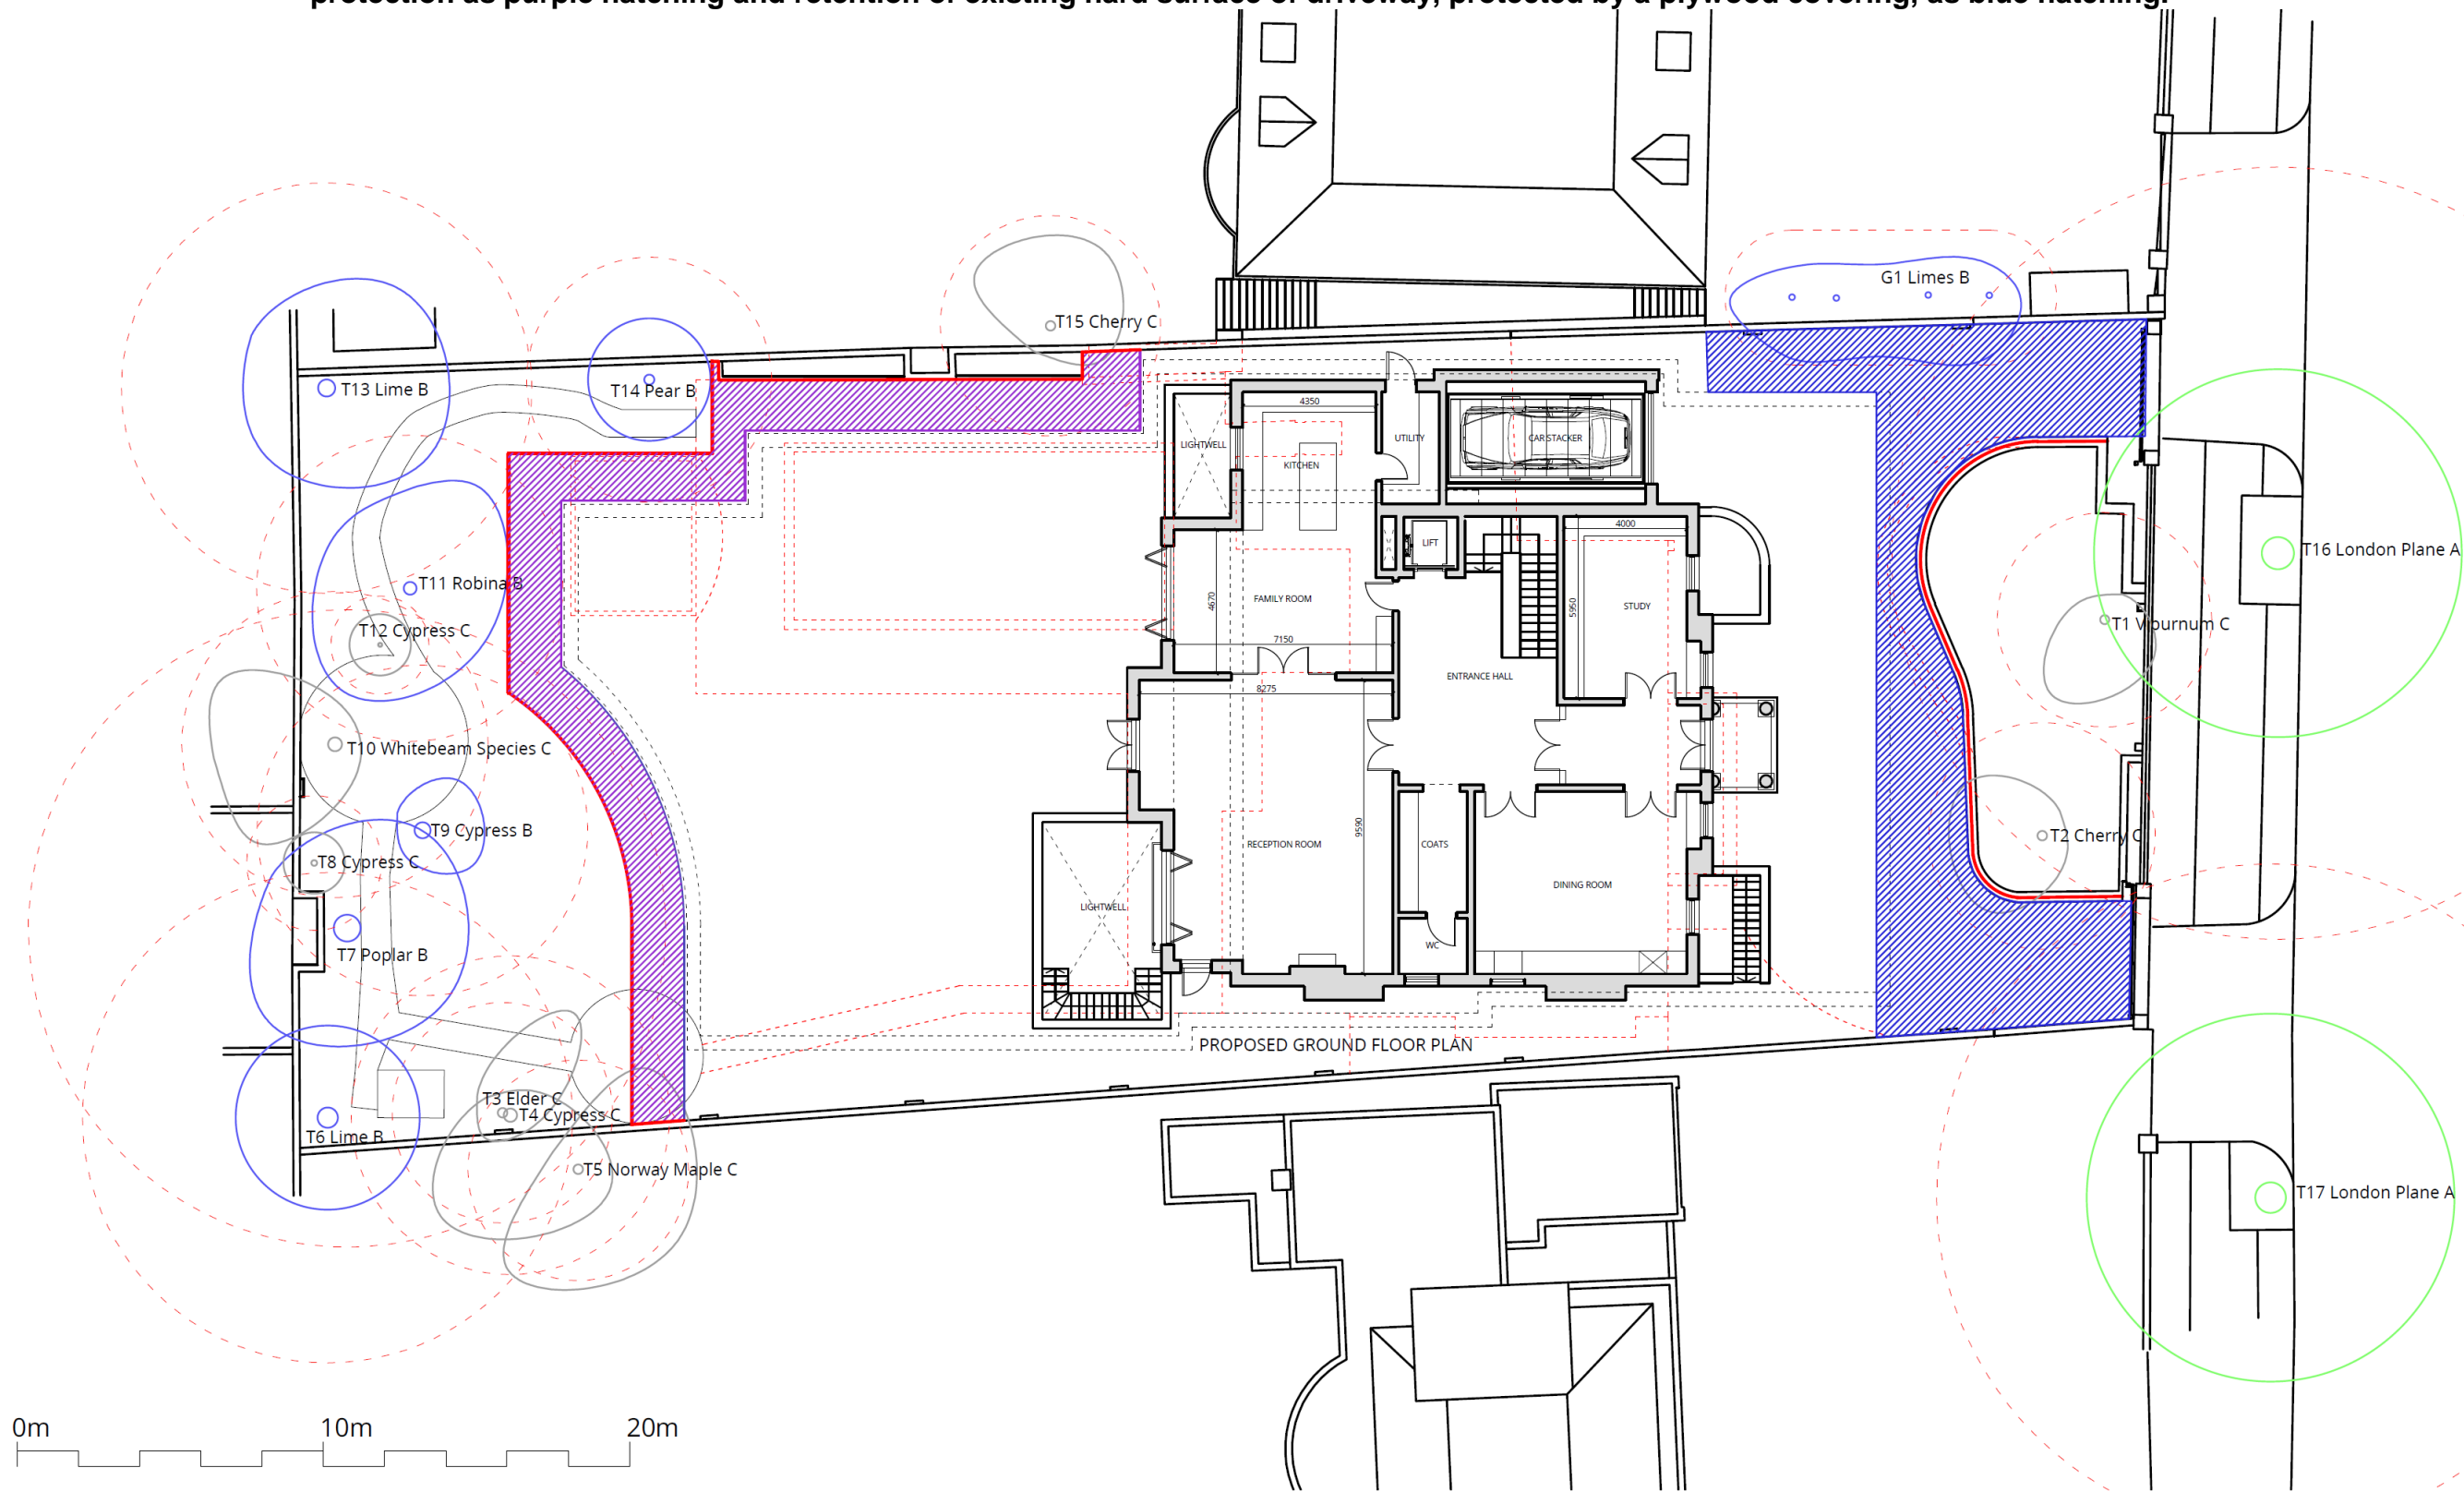
APPENDIX MD4

Tree protection plan (ground floor) showing retained trees, tree numbers and root protection areas (dashed circles). The location of protective fencing is shown as red lines, ground protection as purple hatching and retention of existing hard surface of driveway, protected by a plywood covering, as blue hatching.

- 5.3 Tree protection will comprise of 2 m tall fencing installed in the positions shown at **MD4/MD5** before materials are delivered to site or construction commences. The fencing will consist of a scaffold framework, well braced to resist impacts, with vertical tubes spaced at a maximum interval of 3 m (Figure 2). Onto this, weld mesh panels or 2 m high shuttering board will be securely fixed with wire or scaffold clamps. Weld mesh panels alone on unsecured rubber or concrete feet will not be used as these are not resistant to impact and are too easily removed by site operatives. An alternative system of bracing which does not require a scaffold framework is shown in Figure 3. Fencing will define a construction exclusion zone (CEZ).

- 5.7 For the duration of development the driveway in the area hatched blue in the tree protection plans (**MD4/MD5**) will be covered with a continuous layer of heavy plywood sheets cut so that they fit together in a continuous layer. Sheets will be joined together using wooden battens as illustrated in Figure 7.

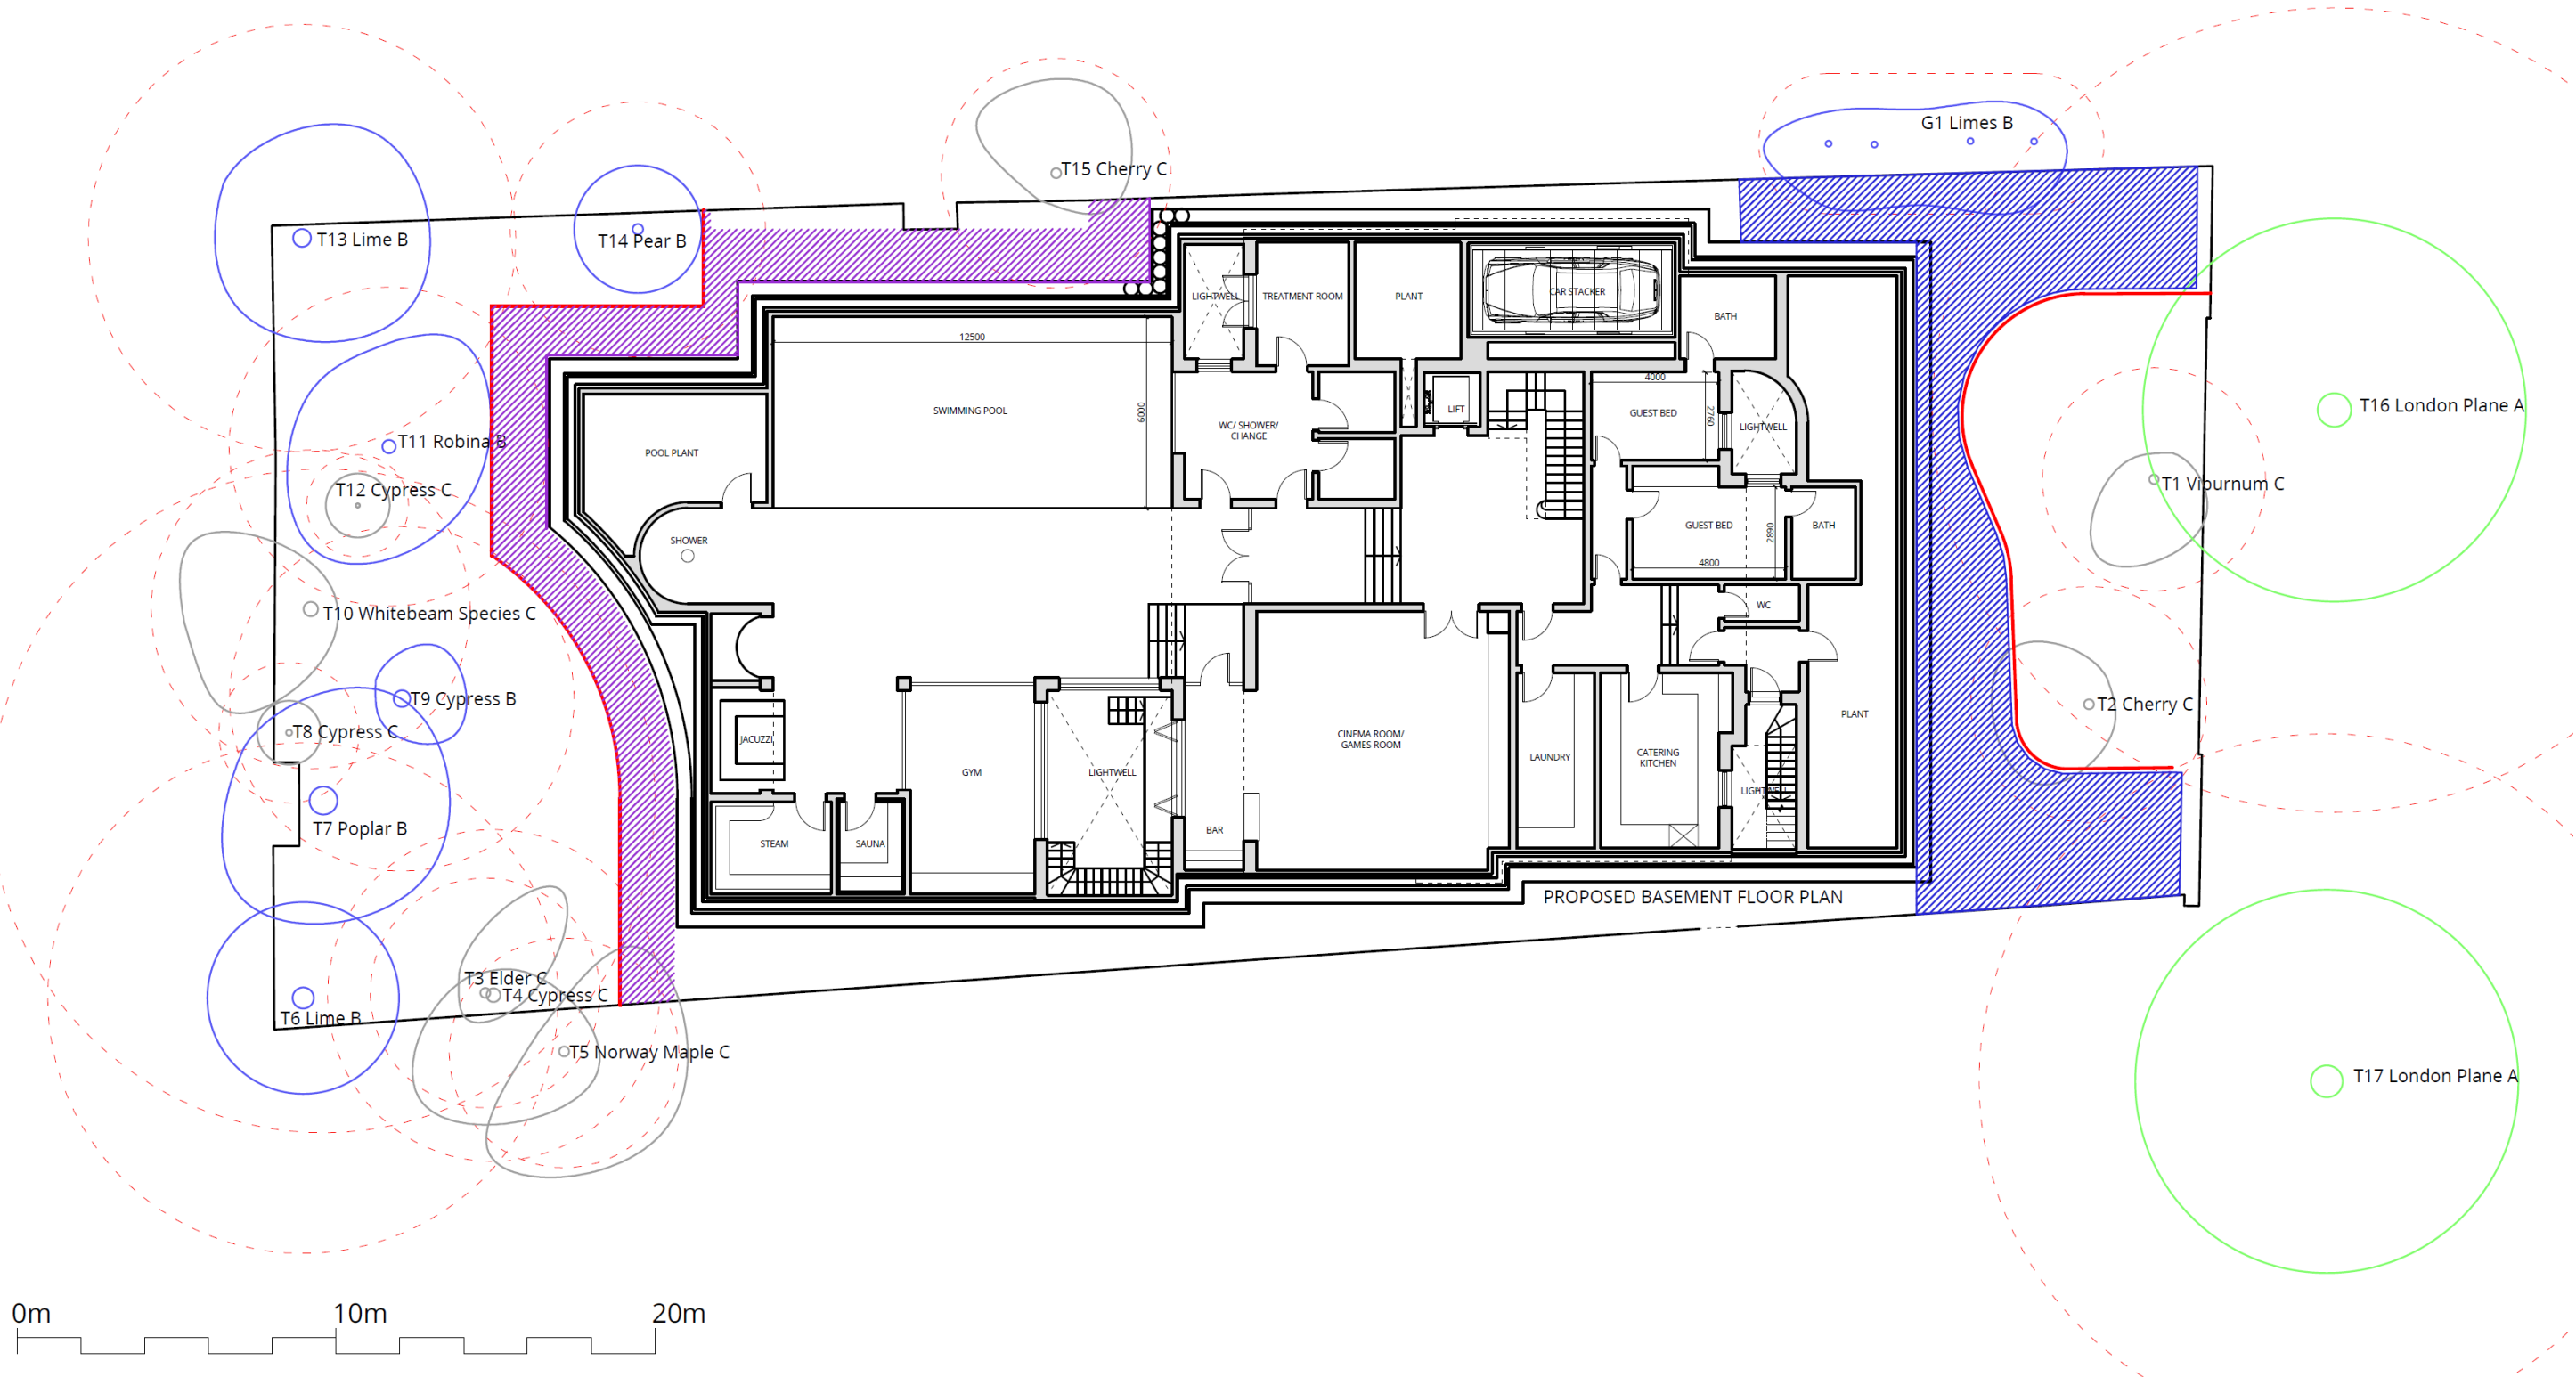
APPENDIX MD5

Tree protection plan (basement floor) showing retained trees, tree numbers and root protection areas (dashed circles). The location of protective fencing is shown as red lines, ground protection as purple hatching and retention of existing hard surface of driveway, protected by a plywood covering, as blue hatching.
