## FURTHER INVESTIGATION REPORT:

42 Avenue Road

Ref: GMT\_42AVR\_PCS\_01a Date: 12<sup>th</sup> September 2016

Carry out Resistograph Decay detection on the main stem of various species at the above address.

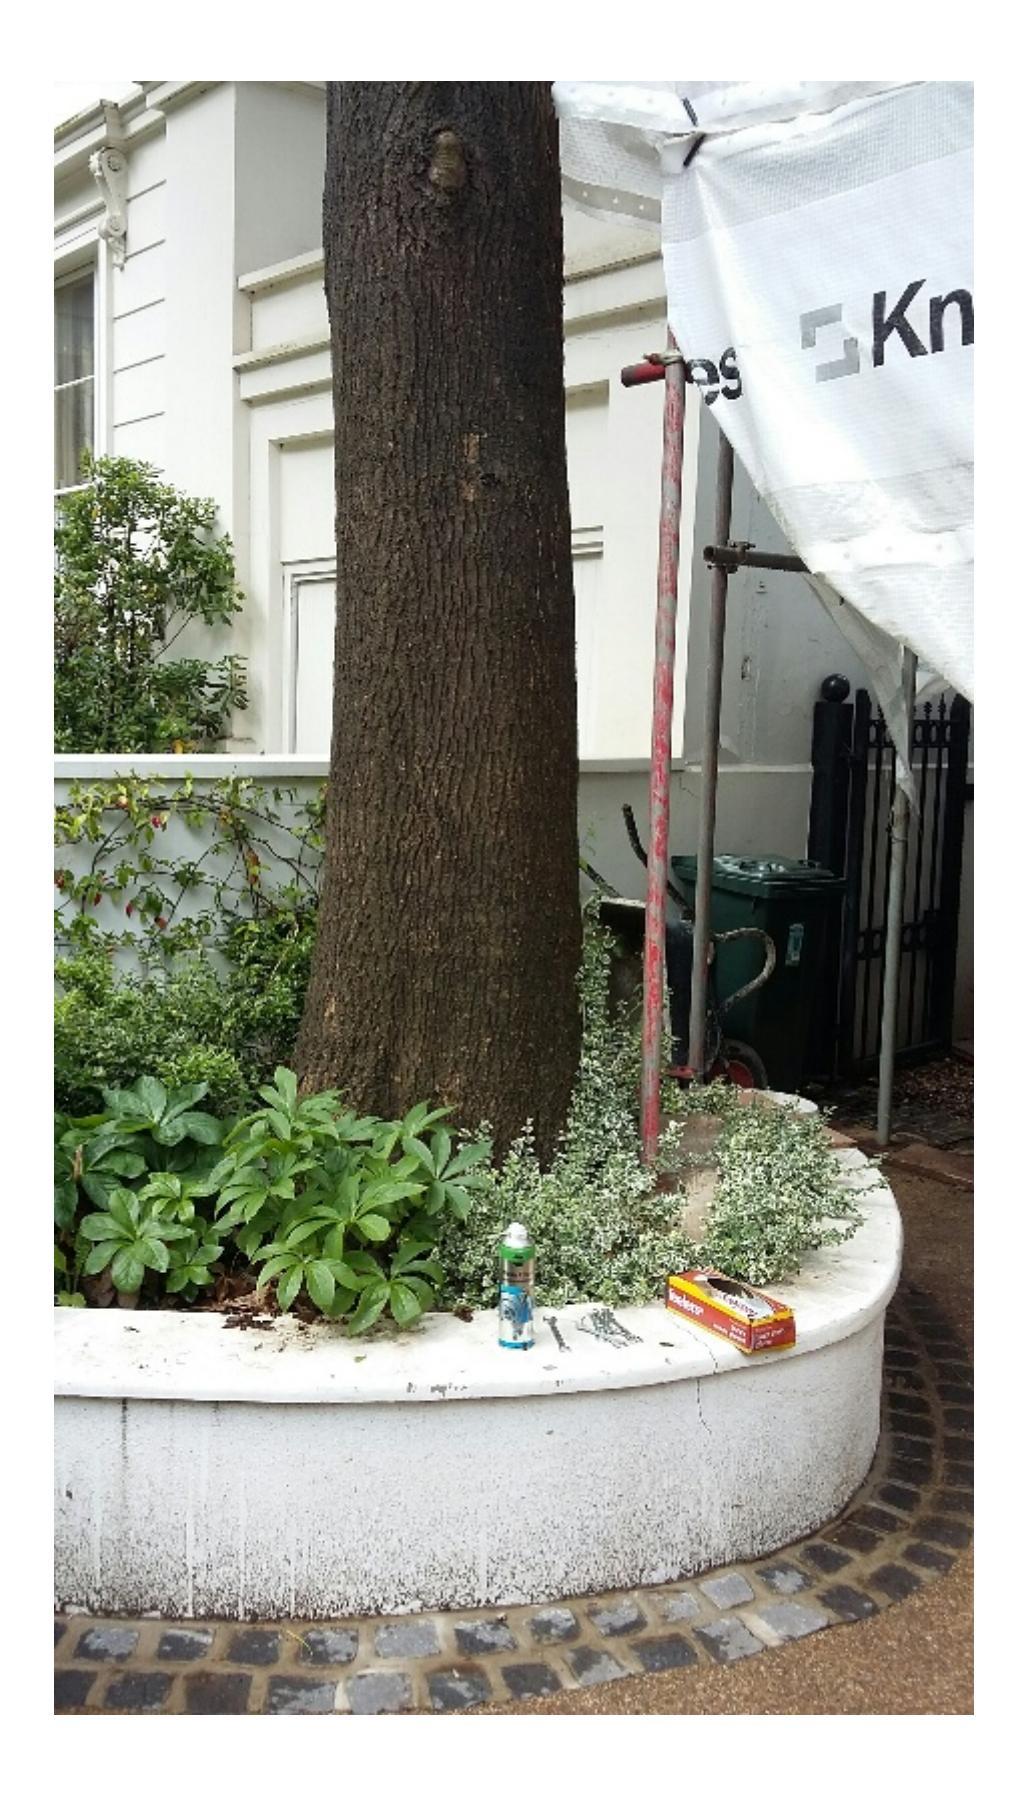
Picture 1.

#### Tree 1 . Species: Common Ash (*Fraxinus excelsior*)

Height: 19m Diameter at 1.5m above ground level (agl) 610mm

The Tree is situated in a raised bed in the front garden of the property. The building is 2 metres to the northeast, with the property boundary 1 metre to the west. A new driveway was laid within 1 metre of the tree 5 years ago, and the soil levels were changed at the same time. There is some apical dieback, and sparseness in the crown, most likely caused by the disruption to the root system. The stem of the tree appears structurally sound, with no sign of fungal brackets.

The structural integrity of the ash tree (T1) is fine, although the recent excavations may affect its long-term viability. There are currently no signs of overwhelming decline.

Re-inspect annually for next 3, or if the tree shows signs of progressive deterioration. Review inspection period after 3 years, if no recommendation to fell.

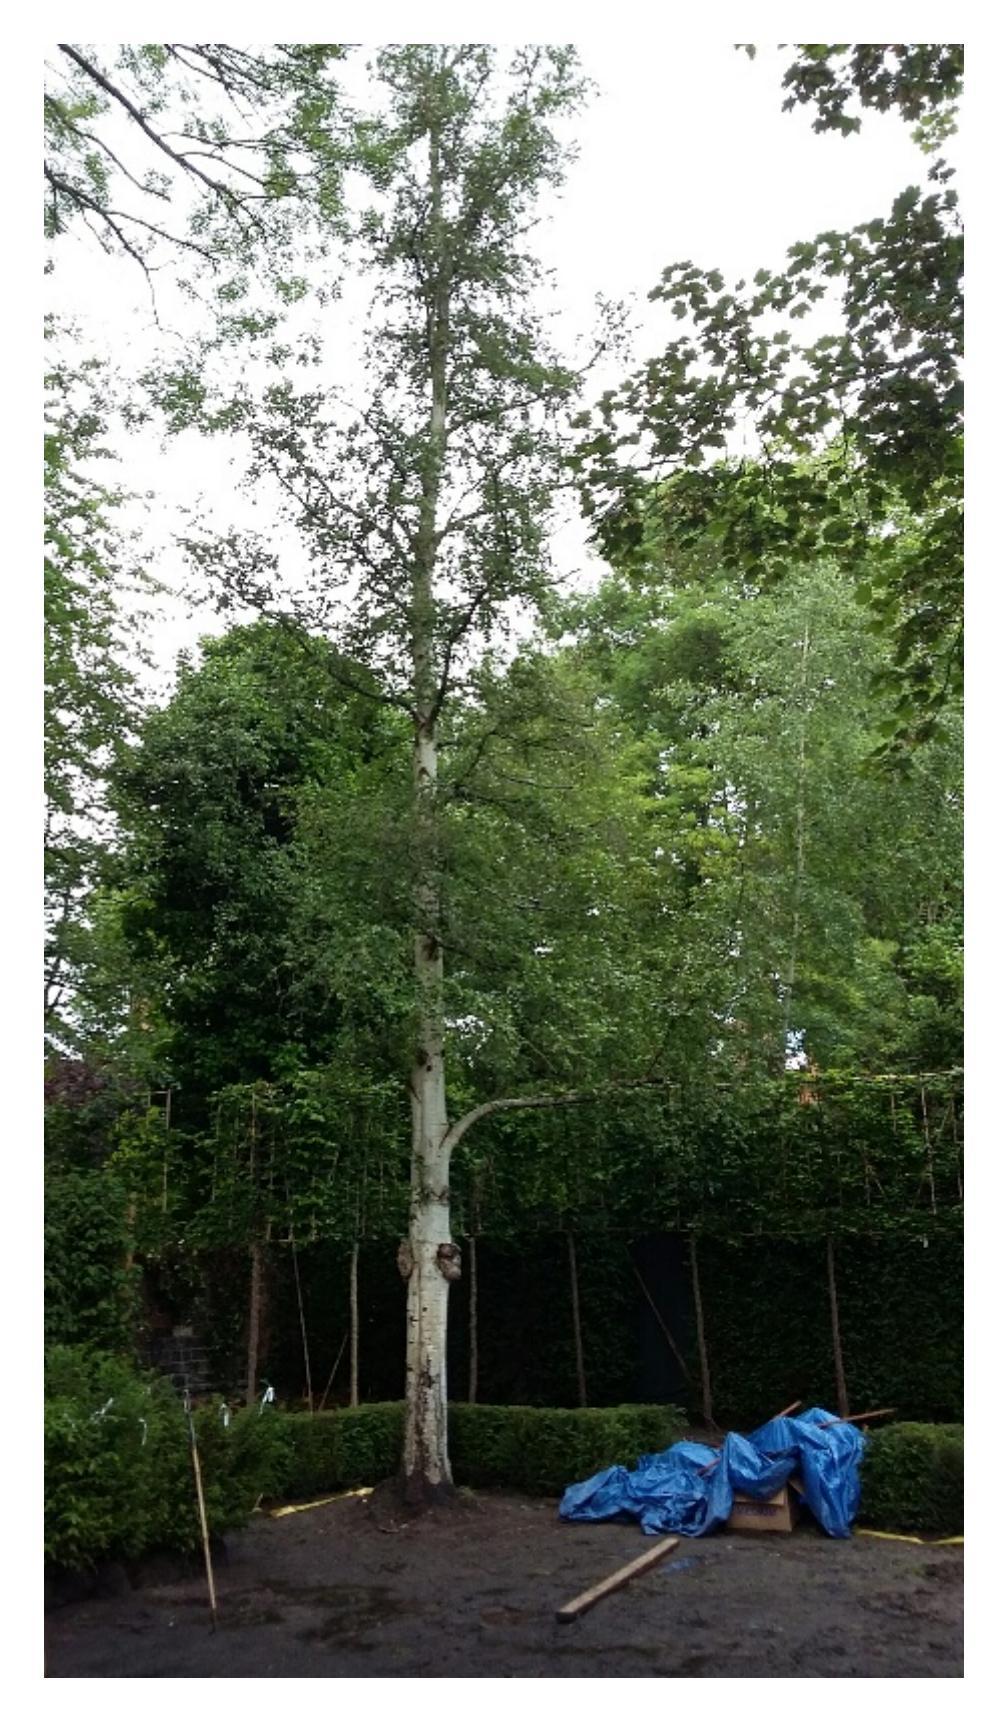
Tree 2. Species. Downy Birch (Betula pubescens). Height 15m, Diameter at 1.5m agl 300mm.

<u>General observations</u>: The tree is situated in the back garden of the property. There is deadwood in the crown, with some apical dieback. There are two galls at 2 metres above ground on the main stem, occupying more than 75% of the circumference, with substantial decay: a c. 10cm diameter column running down the stem (offset slightly north of centre) through the northern gall. There are further bark wounds and decay at ground level. The roots have been cut by excavation works to create subterranean accommodation 1 metre from the tree.

<u>Conclusion</u>. Although the decay in the gall does not necessarily exceed safety thresholds (max. 70% of radius), the overall picture is one of multiple dysfunction: substantive decay in stem and roots: the latter evinced in the crown dieback. Galls can also cause structural problems when occupying more than 75% of the tree's girth. Root disturbance so close to the base has caused the tree to rapidly decline, and undermined its stability. The tree is a relative short-lived, pioneer species with little investment in defence mechanisms.

**Recommendation.** Fell, and plant a replacement in a more suitable (boundary) position.

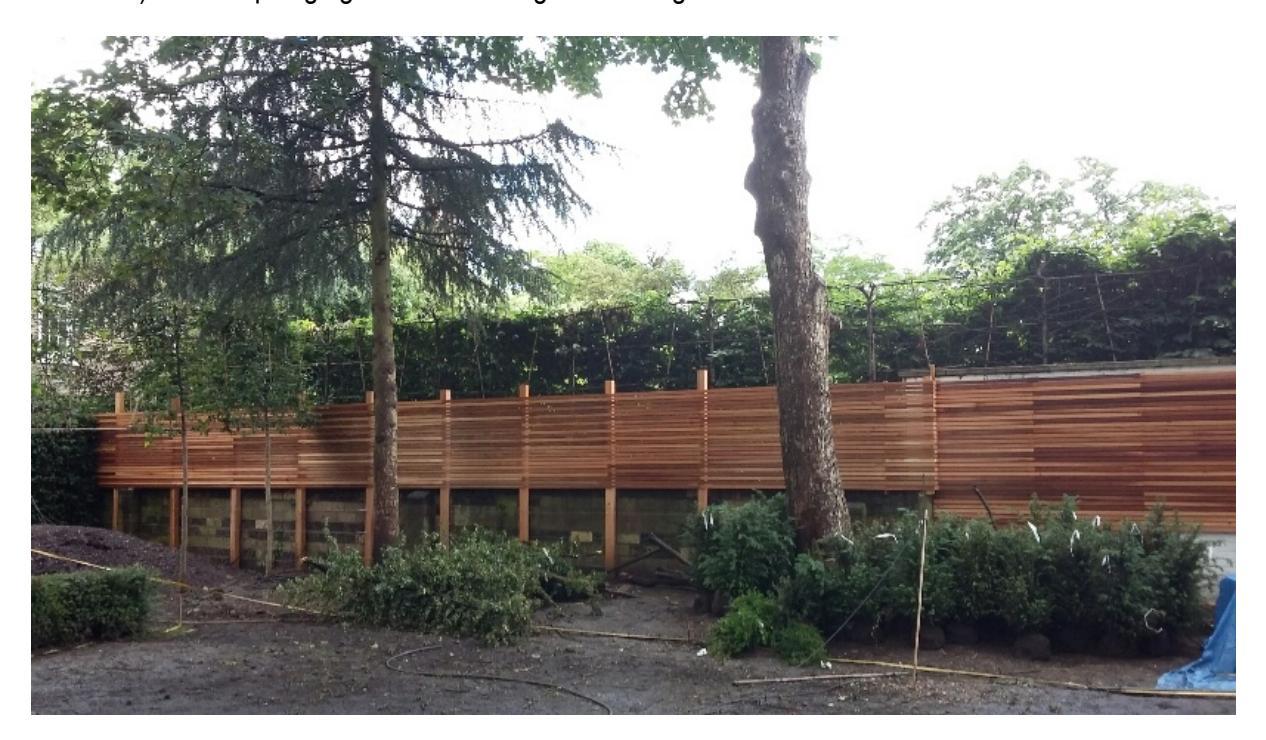
Tree 3 and 4 (left & right, respectively).

Tree 3. Species. Cedar Deodar (Cedrus deodara) Height 9m. Diameter at 1.5m agl 285mm.

<u>General Observations</u>: This is a semi-mature tree that shows no signs of distress, apart from being suppressed by the adjacent sycamore, which has made the crown unbalanced.

Tree 4. Species. Sycamore. (Acer pseudoplatanus). Height 15m. Diameter at 1.5m agl 500mm.

**General Observations:** This tree has a large bark wound at ground level, with some signs of decay. There are numerous old pruning wounds on the stem. The crown appears fine, with leaf and bud as expected for the species. As stated above, it is suppressing the younger cedar (T3) and lawn.

**Recommendation:** This still young tree is not really suitable for the location, and so might be felled and replaced with a more suitable species / specimen in an appropriate position. Alternatively, the dominant sycamore T4 (see below), suppressing its crown could be felled to favour the cedar, but this would entail felling a more mature tree, which might attract local opposition. Were the cedar kept, it would lend itself more than the sycamore to progressive lifting of the canopy (removal of lower branches) to avoid plunging the immediate garden into gloom.

**Recommendation:** This tree is again not ideal for the location, and though in this case mature, could be felled and replaced with a more suitable / ornamental species to allow more light into the garden, and so promote the cedar and lawn. The local authority and freeholders are likely to require more concrete reasons for allowing the felling of a mature tree, and due consideration of pruning / thinning the canopy may be a more realistic expectation.

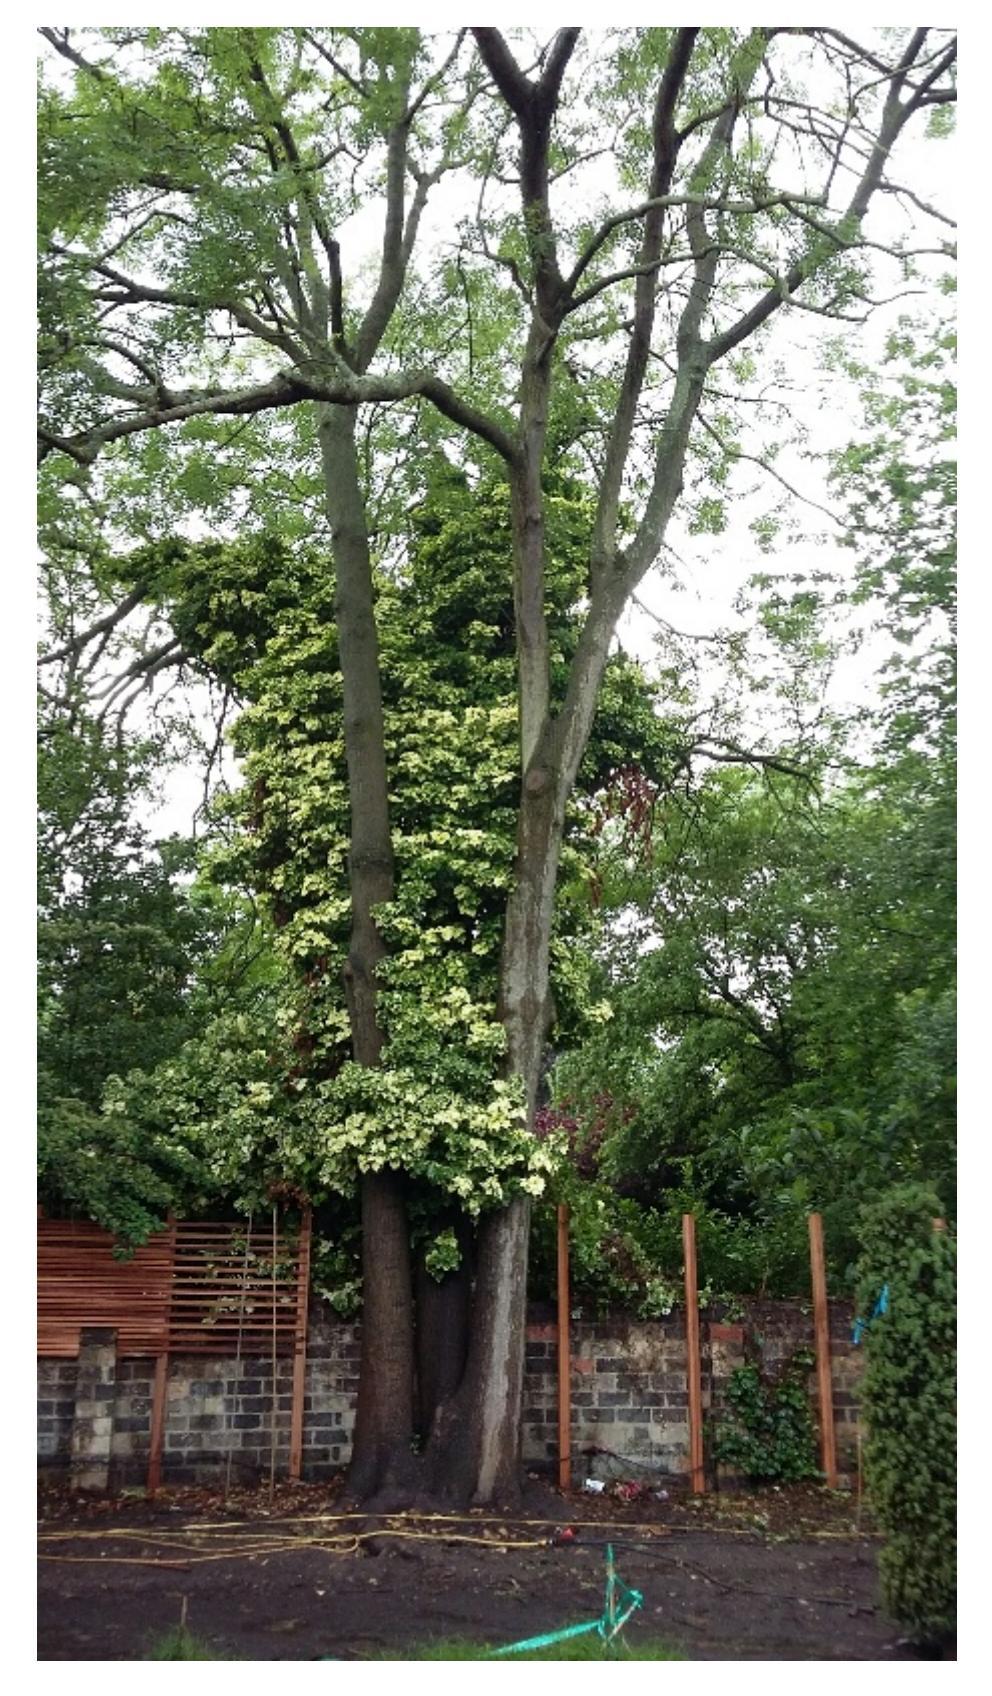
Tree 5.

<u>**Tree 5. Species.**</u> Common Ash. (*Fraxinus excelsior*). Height 23m. Diameter at 1.5m agl 2x 500, 1x 400mm. This tree is identified as T10 in the original survey.

<u>General Observations</u>: This is a large mature tree, trifurcated at 0.5metre. There is substantial deadwood throughout the crown, and a large limb over the neighbouring property. There is also a substantial limb in contact with the building. The stems have no signs of fungal brackets. The excavations for the property extension are 4 metres from the stem, and could have caused the dieback.

**<u>Recommendation</u>**: Remove all deadwood throughout the crown, and reduce the crown from the building and over the adjoining property by 2-3m.

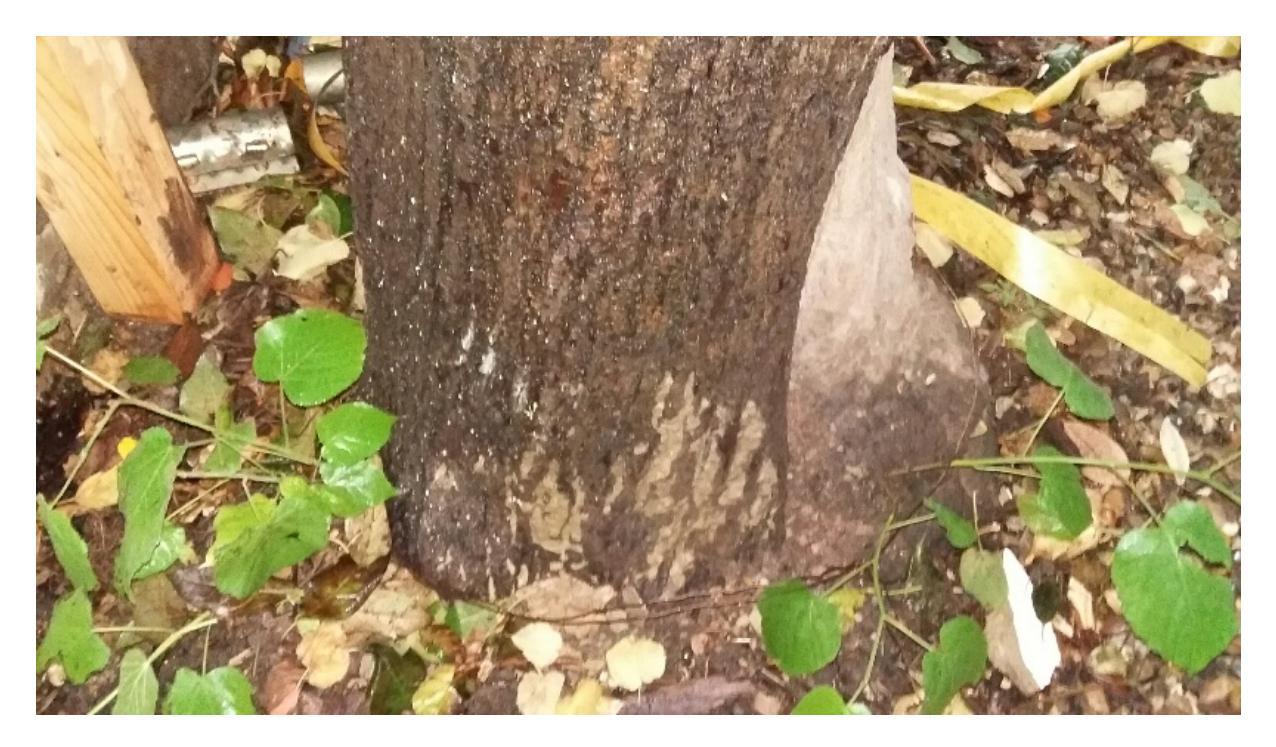
Tree 6. Species Common Lime (*Tilia europea*). Height 5m. Diameter at 1.5m agl. 250-400mm.

<u>General Observations</u>: These comprise a line of 4 pollarded Lime trees, planted in the very narrow passageway between number 42 and the neighbouring house. T17 and T18 have been reported to us (by Modern Arrboriculture) as having cinder fungus (*Kretzschmaria deusta*) on their lower stems, and certainly have a consistent residue at the base (see photo below), though no fungus apparent at the time of our visit.

**Recommendation.** The Resistograph reading indicates that the stems (if not roots) are currently sound. However in the light of their unsuitable location, reports of the cinder fungus suggest that removal and replacement with a more suitable species in a more suitable location should be considered. If a new landscape proposal is being put forward and there is to be a clear out of unsuitable trees, then it would make sense to tackle everything at one stroke.

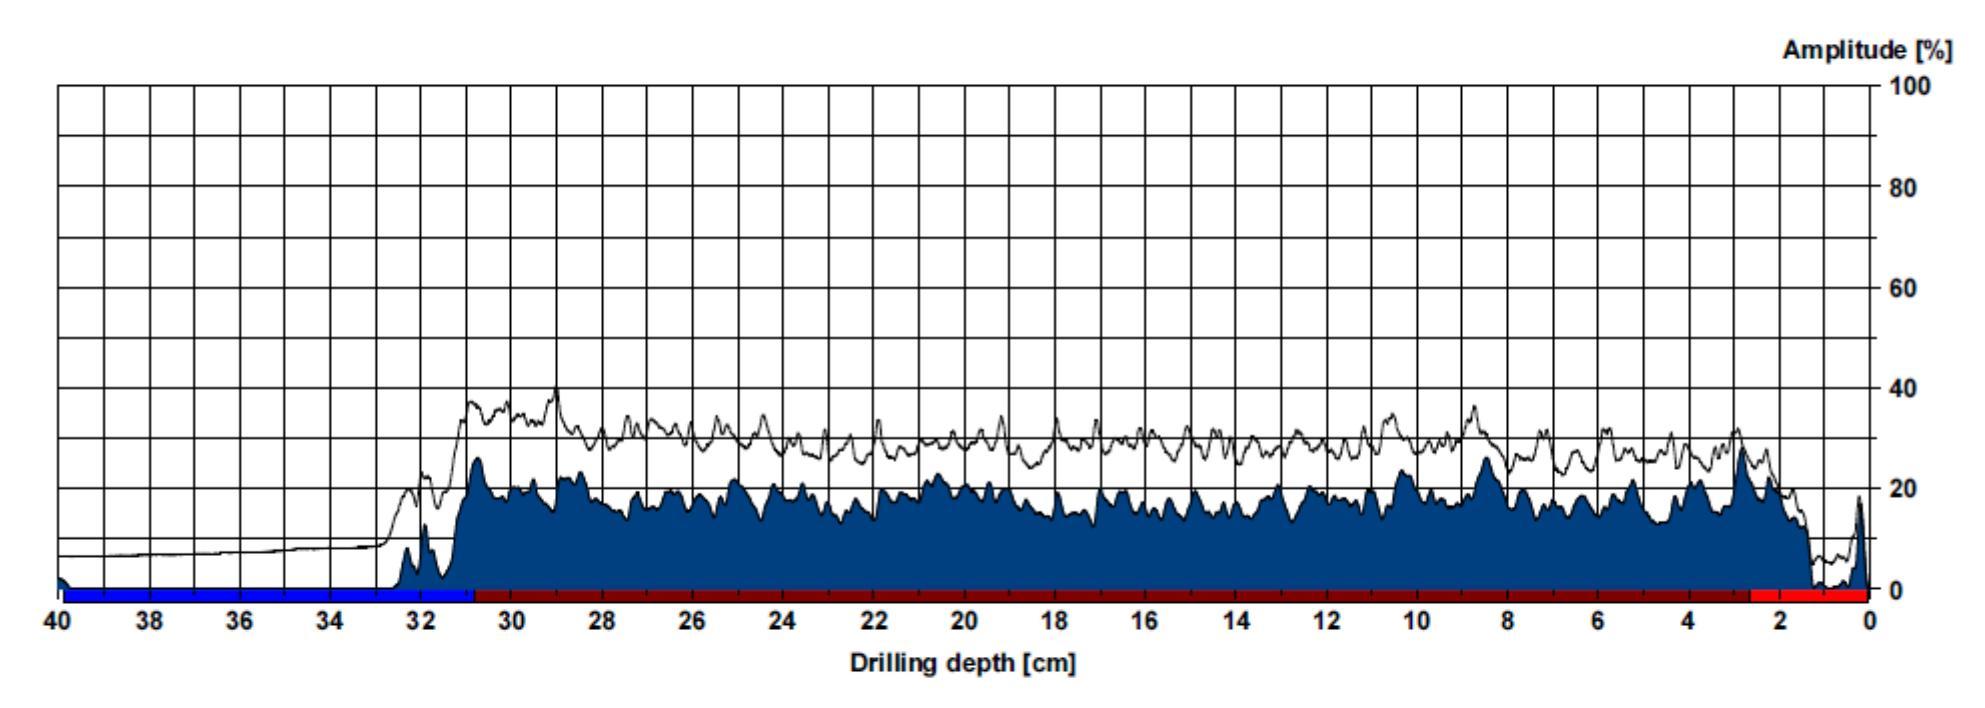
Both the birch and lime Resistograph traces below, show an apparent cavity at 30-35cm, this is not the case, as the drill had actually passed right through both stems.

Measurement no.	: 17	Needle speed	: 2500 r/min	Diameter	:
ID number	: 42 AVENUE BIRCH30N	Needle state	:	Level	: 30,0 cm
Drilling depth	: 40,00 cm	Tilt	:	Direction	: North
Date	: 20.06.2016	Offset	: 87/289	Species	: Birch
Time	: 14:32:44	Avg. curve	: off	Location	: 42 Avenue
Feed speed	: 100 cm/min			Name	: Kim Dear

From	0,1 cm	to	2,7 cm	Bark
From	2,7 cm	to	30,8 cm	Good wood
From From From From	0,0 cm 0,0 cm 0,0 cm 0,0 cm	to to to	0,0 cm 0,0 cm 0,0 cm	Cavity

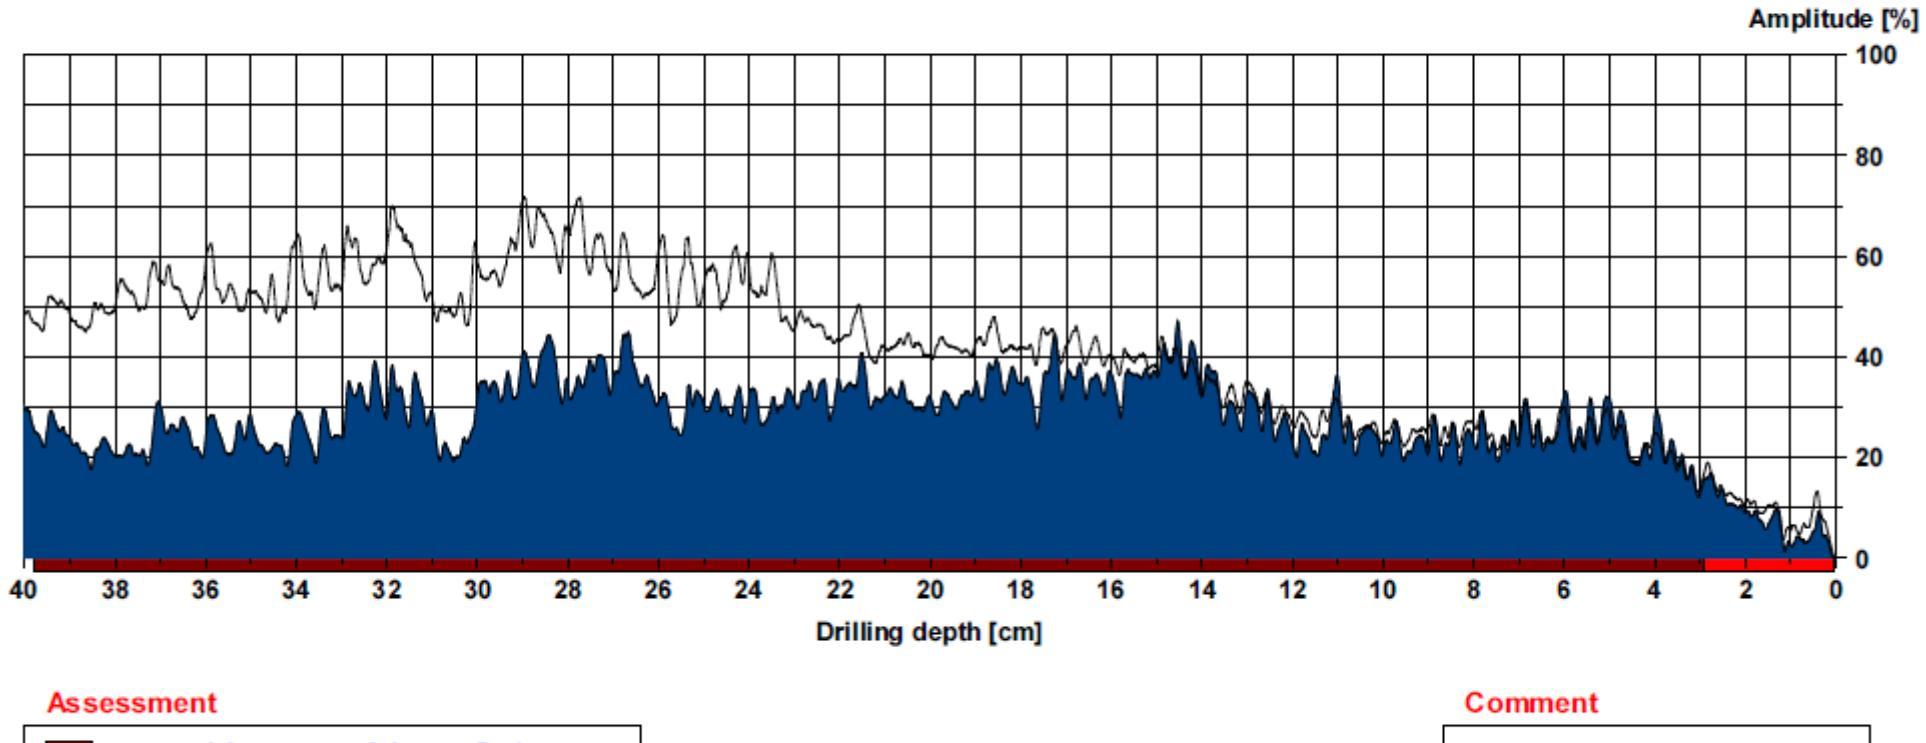
Measurement no.         : 20         N           ID number         : 42 AVENUE ASH20E         N           Drilling depth         : 40,00 cm         T           Date         : 20.06.2016         O           Time         : 14:52:18         A           Feed speed         : 100 cm/min         A	Needle speed : 2500 r/minNeedle state :Tilt :Offset : 69/266Avg. curve : off	Diameter : Level : 20,0 cm Direction : East Species : Ash Location : 42 Avenue Name : Kim Dear
---	--	---

From	0,0 cm	to	2,9 cm : Bark
From	2,9 cm	to	39,8 cm : Good wood
From	0,0 cm	to	0,0 cm :
From	0,0 cm	to	0,0 cm :
From	0,0 cm	to	0,0 cm :
From	0,0 cm	to	0,0 cm :
