3. The Existing Building

3.4 Historic analysis - Key Traits

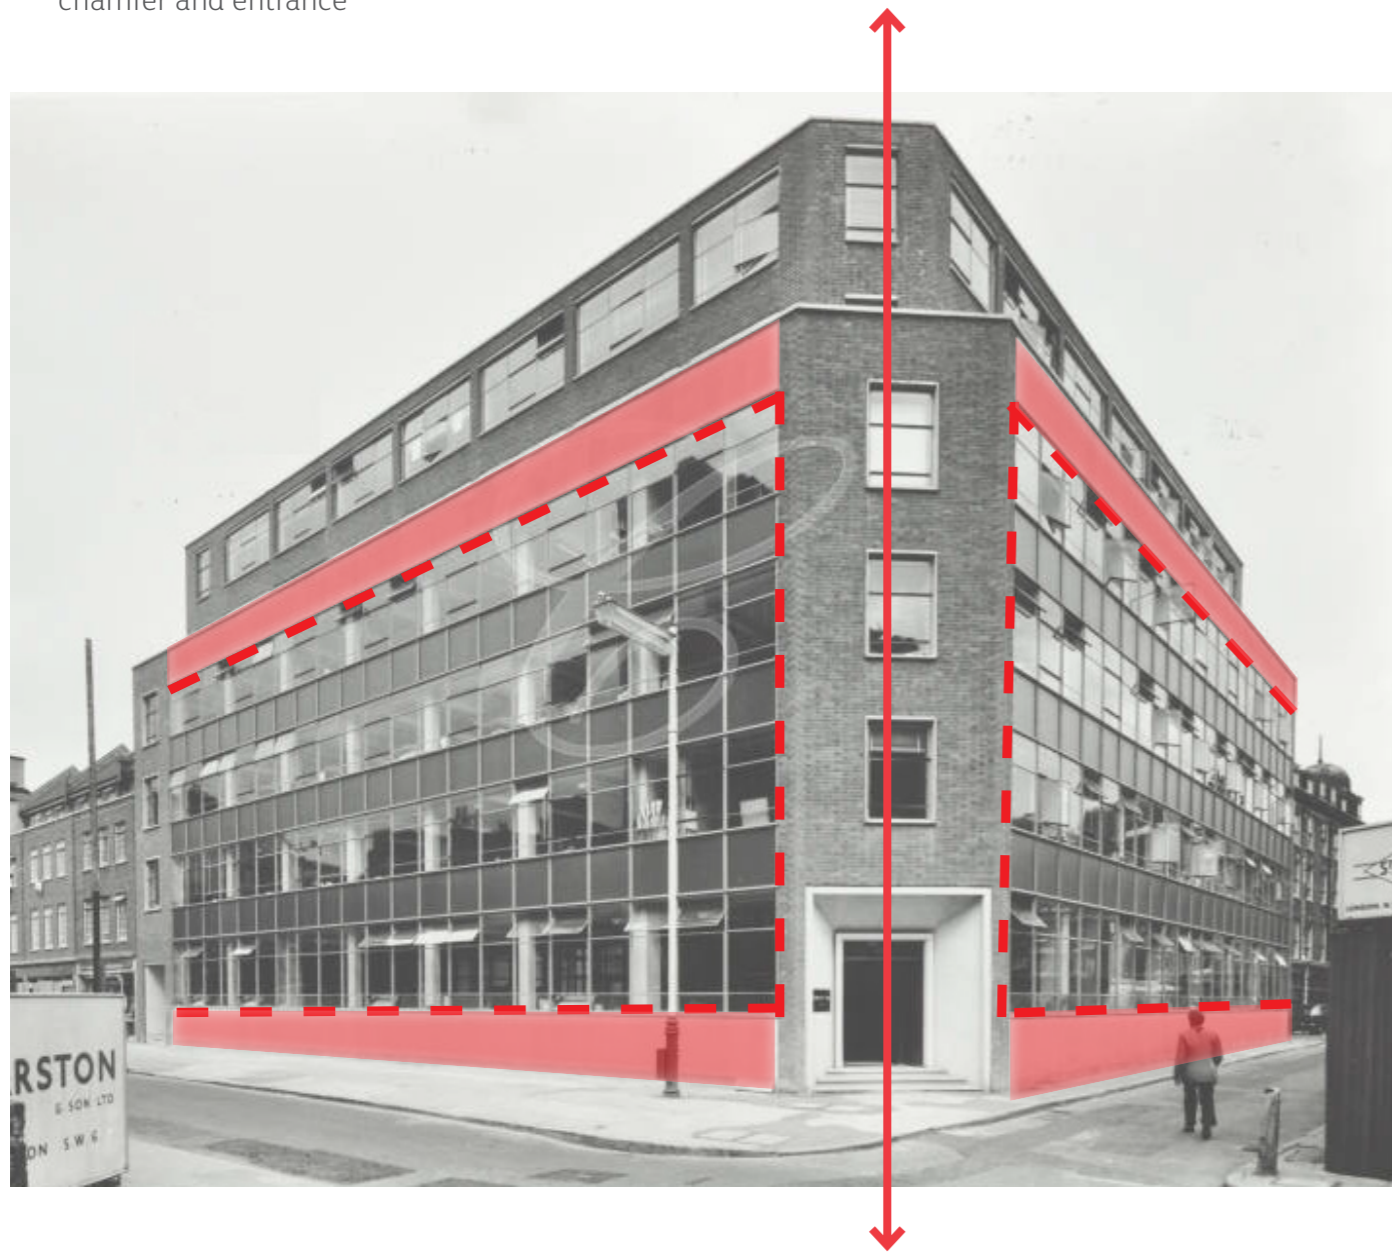
Original Entrance

- Corner building with a corner entrance
- Entrance exaggerated/highlighted with sloping jams
- Corner entrance aligns with fenestration above
- Rendered plinth on the flanking wings emphasises the chamfer and entrance

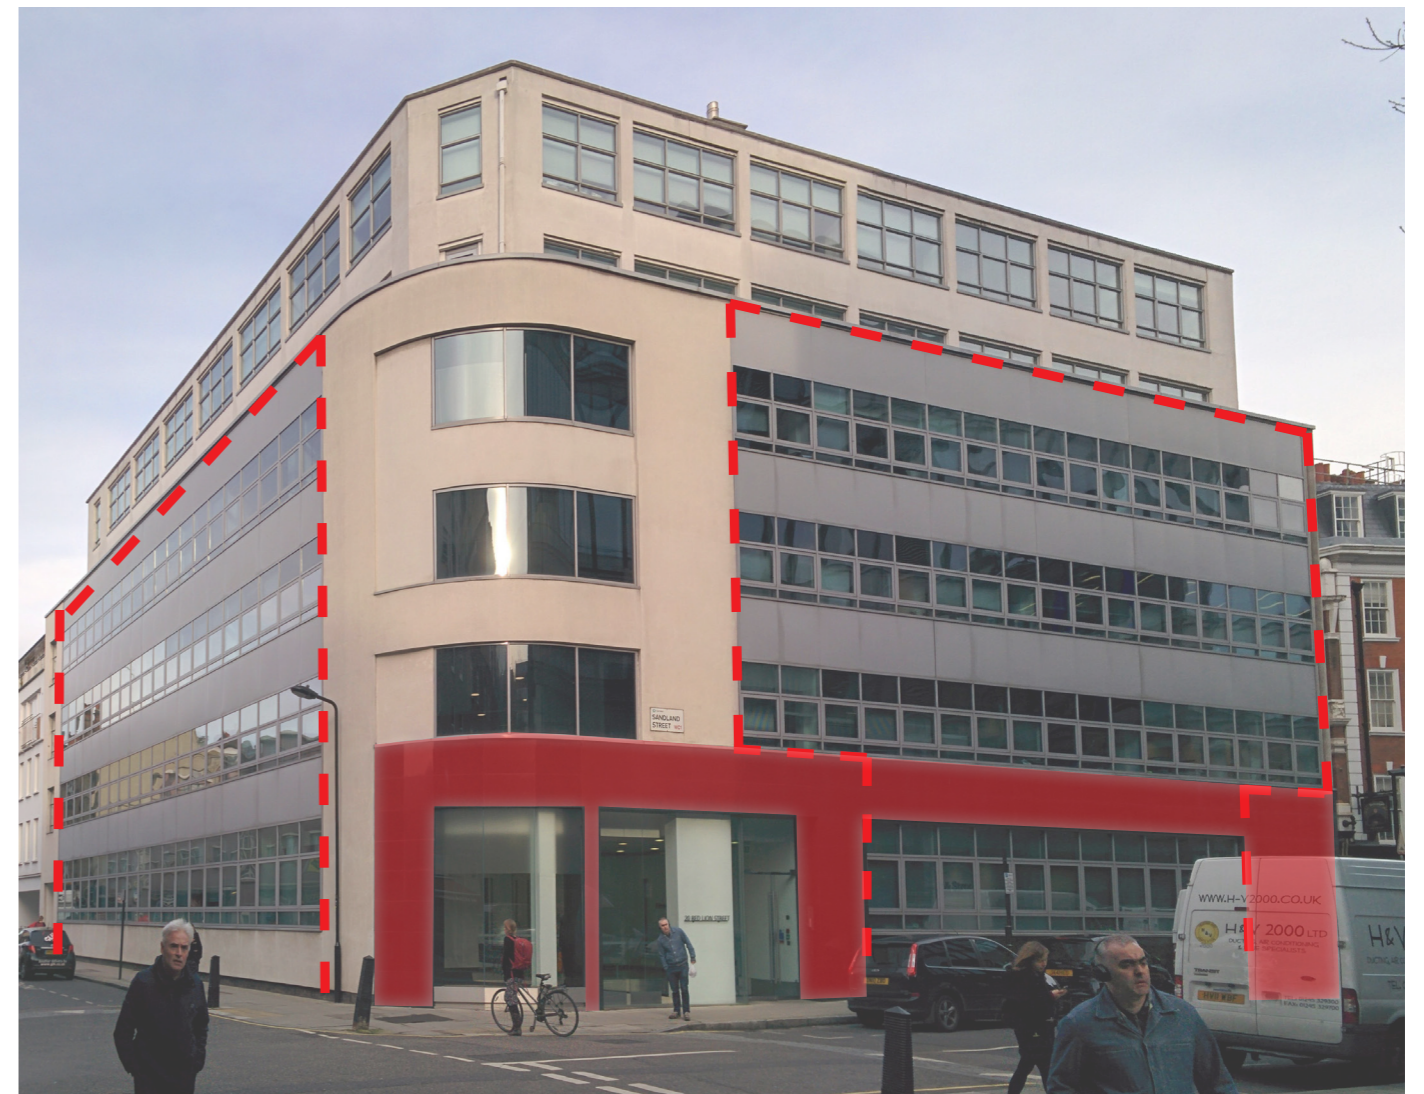
Present Entrance

- Entrance shifted onto Sandland Street - confusing as the buildings name is 20 Red Lion Street
- Bias towards Sandland Street is further exaggerated by the addition of an applied stone finish and new curved windows on the Sandland Street elevation
- Plinth is lost as the whole facade is rendered.

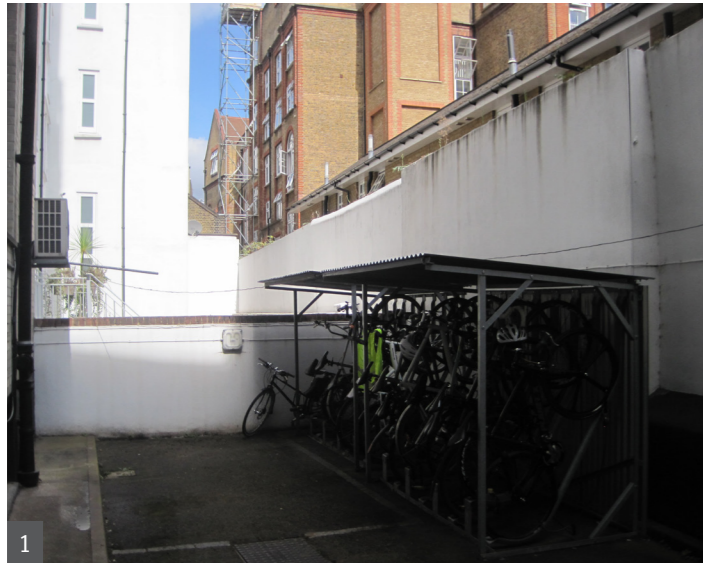
1. Existing cycle shelter

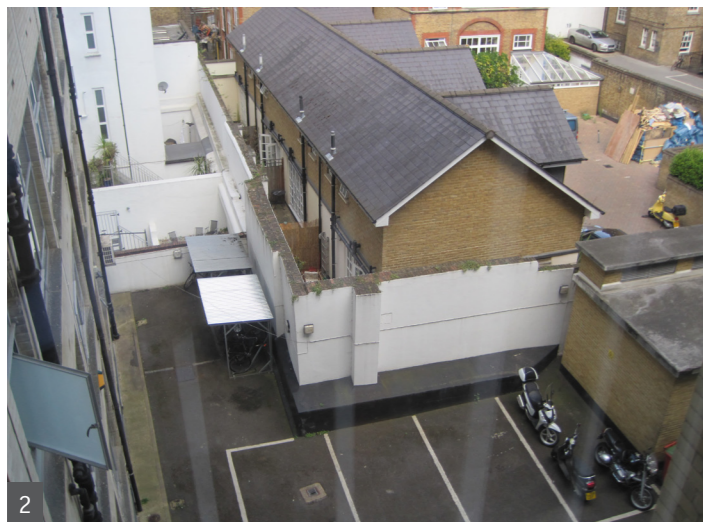
- Unused parking spaces
- No access from reception to car park - access only from external stair to basement.
- Both wings of the office floors have continuous single glazed windows onto the car park

2. View of carpark and cycle park from staircore

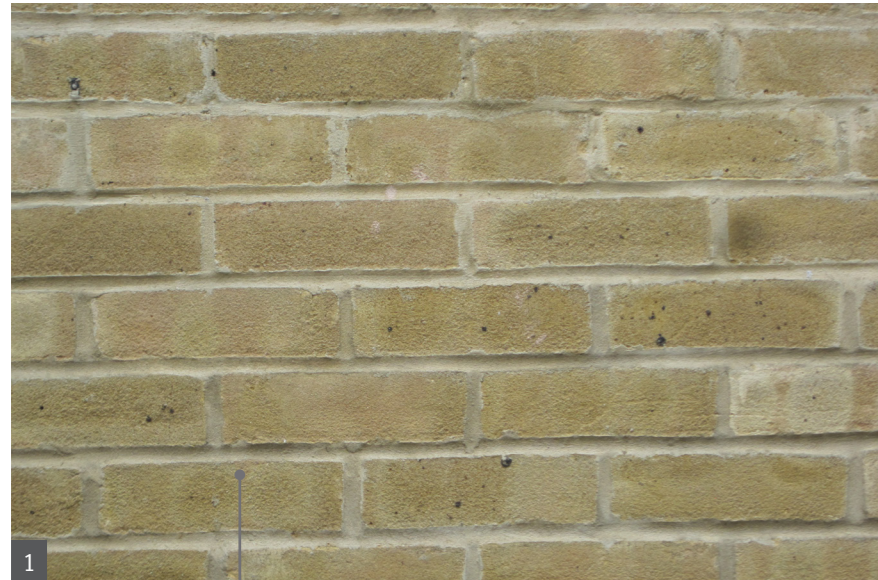
Calcium silicate bricks

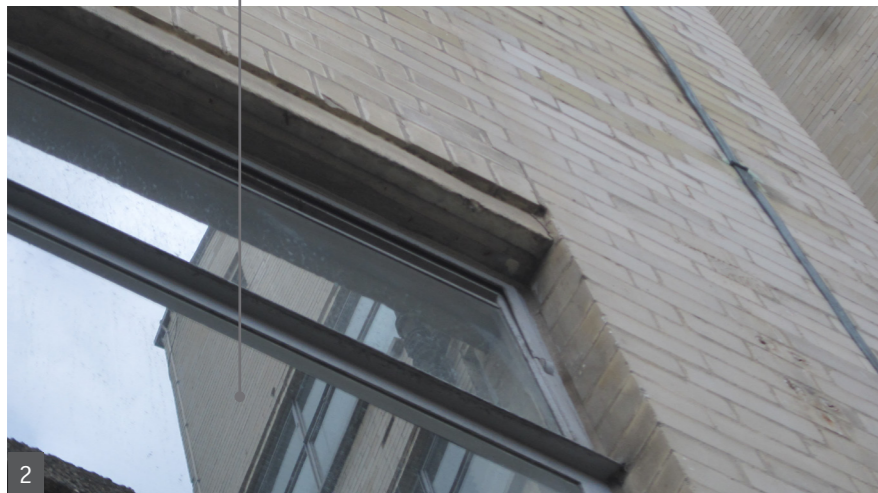
Punched crittall windows
