ARBORICULTURAL IMPACT ASSESSMENT REPORT
BS 5837:2012 'Trees in relation to design, demolition and construction.
Recommendations'

79 Dartmouth Park Hill

For the garden room

DATE: 03.10.16
OUR REF: SHA 242

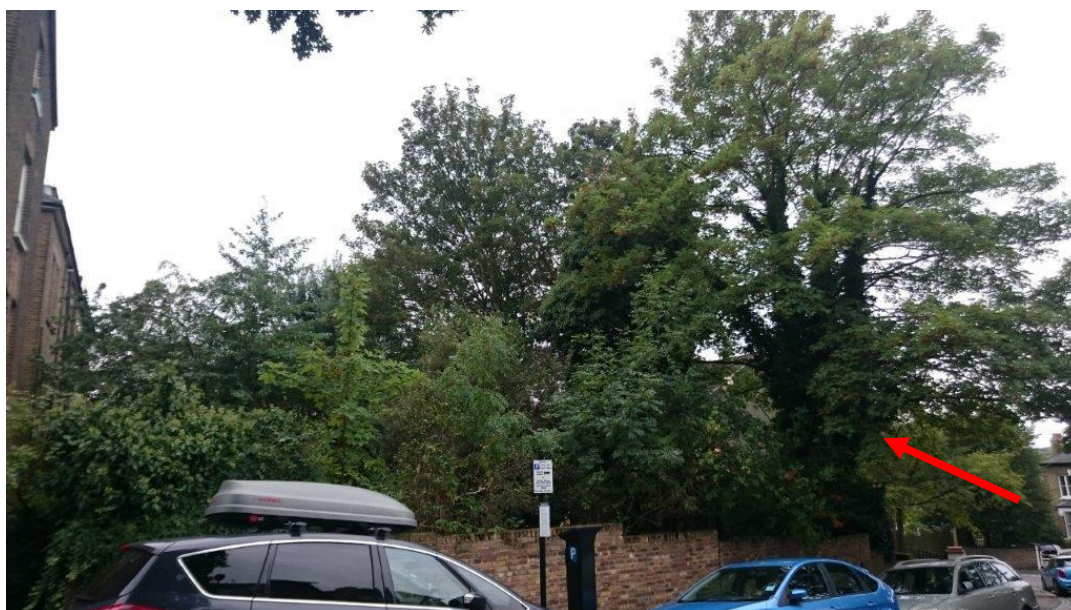
Photo 1 view from Dartmouth Park Avenue. The dominant tree, T9, is shown arrowed.

This mature tree is the best tree in the rear garden, and provides a visual amenity to the garden and Dartmouth Hill Avenue (see photo 1). It is approximately 12m tall with a crown spread of 5m. It has a densely ivy clad trunk which prevents a full inspection of the structure of the tree. It also has a slightly lower vitality than is typical for its age and species. I recommend that the ivy is severed and removed when dead, and that the tree is re-inspected to see if there are any structural defects.

growing up T9 is severed and ultimately removed, and that the tree is then re-inspected.

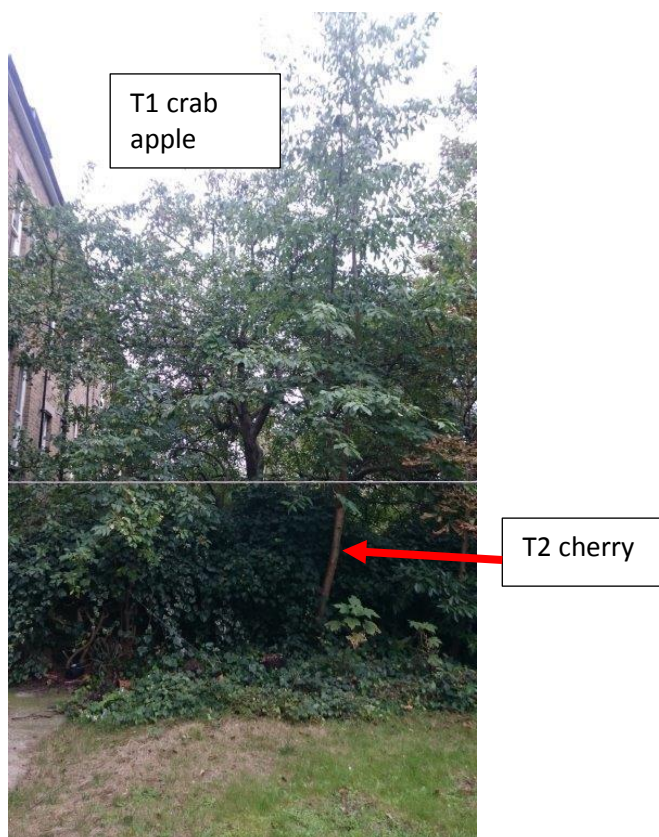
This is a mature crab apple in a reasonable condition, growing close in the neighbouring garden, next to the boundary. The crown overhangs the site by up to 2m.

Photo 2 of T1 crab apple and T2 cherry, looking south

Arboricultural impact assessment: The root protection area will be unaffected, but the crown will need to be cut back to clear the scaffolding. The branches to be cut back would be relatively slender. I recommend that the minimum amount is pruned back, and that the work is carried out to suitable growing points.

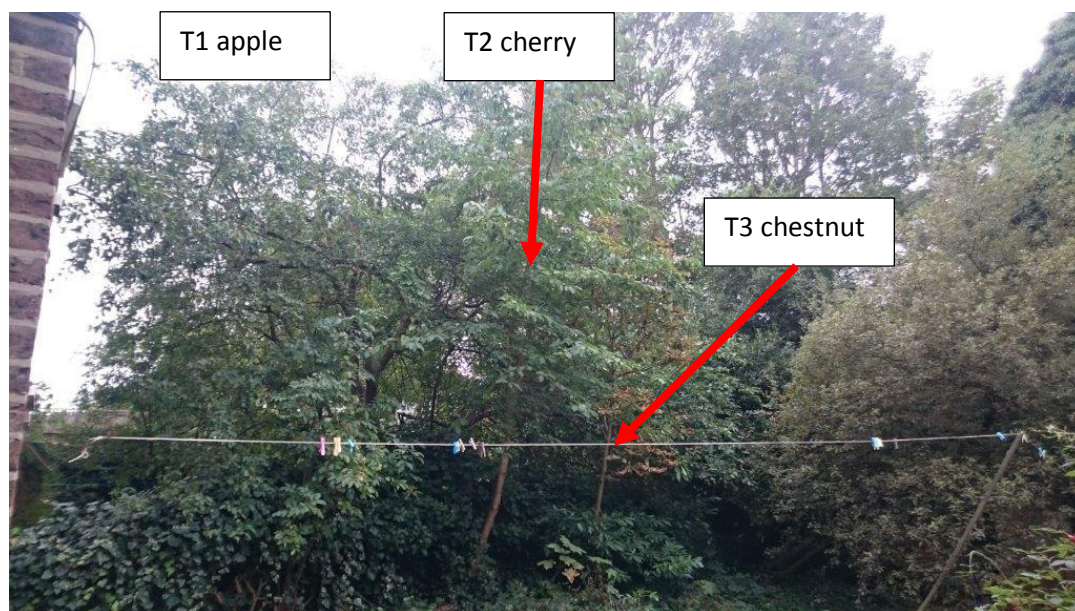
These are two young self-sown trees that will outgrow their situation. I recommend their removal irrespective of the application.

Photo 3 of T1 crab apple and T2 cherry and T3 horse chestnut, looking south

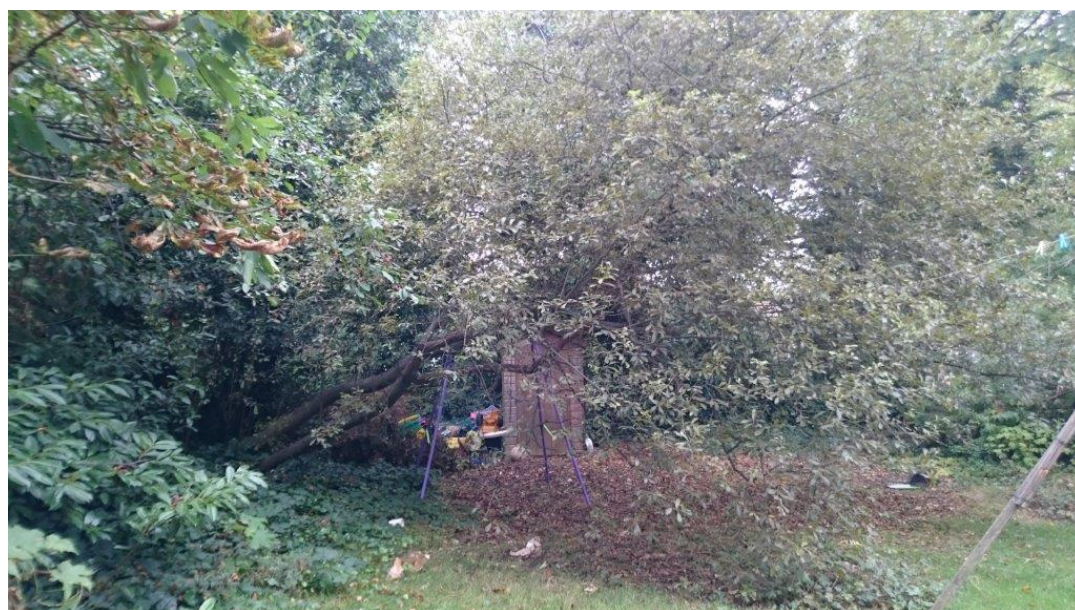
This tree leans very heavily east as it has partly fallen and has a child's swing beneath. It should be felled for safety reasons, irrespective of the proposal.

Photo 4 of T4 looking west. Note the severe lean.

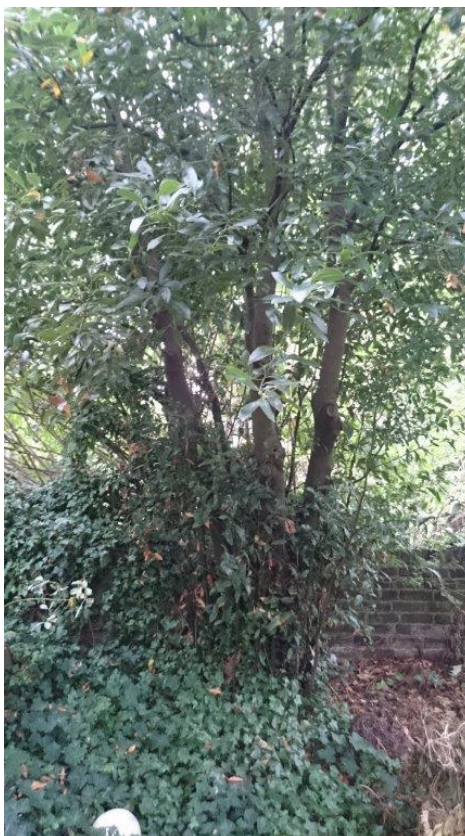
This early mature tree is multi-stemmed and in a reasonable condition. It is slightly suppressed by neighbouring trees, and it provides limited visual amenity.

Photo 5 of T5

Arboricultural impact assessment: No impact (for the extension) however, the tree will be protected during works. The tree will be removed to facilitate construction of the garden room.

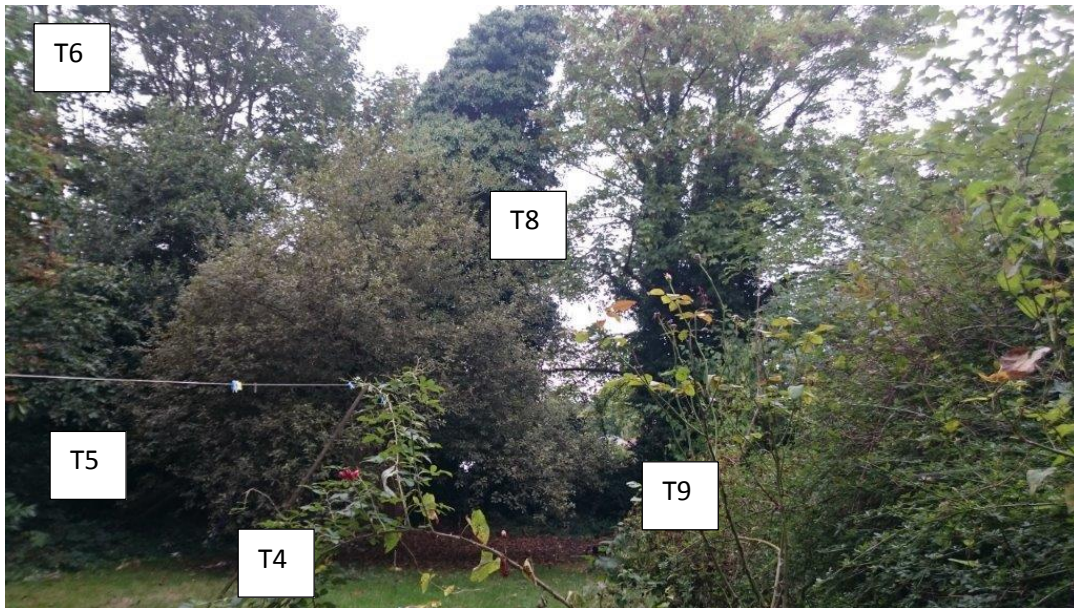
T6 is a mature tree growing offsite, close to the boundary. It is densely covered in ivy and the lower part of the trunk is obscured by vegetation. A full assessment could not be made due to lack of access and the vegetation covered the tree.

T7 is on site, close to T6. It is smaller than T6, and is almost completely covered in ivy, with just a small amount of growth on the top.

Photo 6 of T4 – T9 looking west

This tree is dead and entirely covered in ivy (see photo 6). It should be felled for safety reasons irrespective of the proposal.

Arboricultural impact assessment: The tree T7 will be removed to facilitate construction of the garden room and care will be taken constructing the foundations for the garden room near T6 in accordance with the method statement at appendix six.

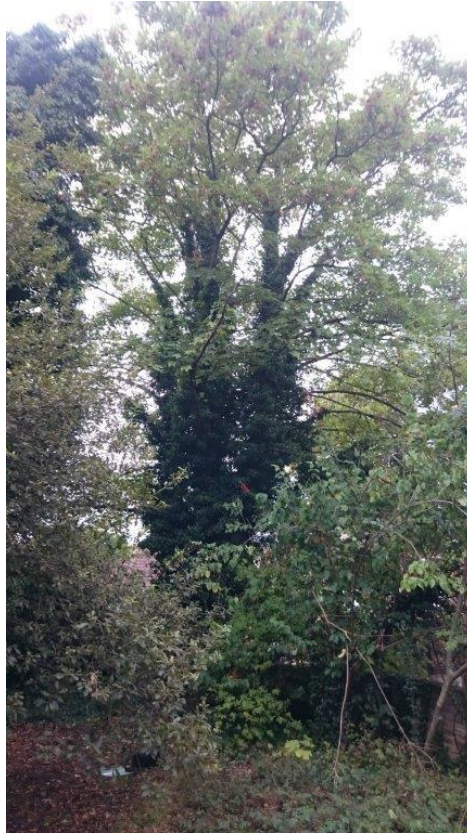
Photo 5 of T9 looking towards the north-west corner of the garden

Arboricultural impact assessment: The garden room is on the outer edge of the root protection area of the tree (by 0.5m at the maximum point), and as a precaution, the foundations will be constructed in accordance with the method statement at appendix six.
