Project: 1604 - 11 Prince Albert Road

Heritage Statement

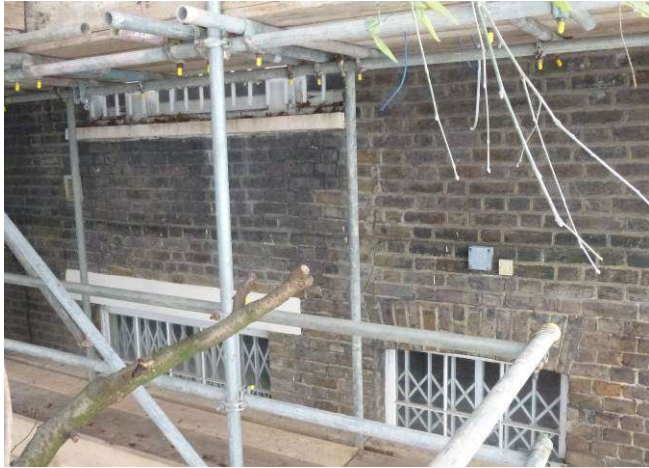
Photo 8: Rear façade with cracking and movement

24	All facades	Mechanical repair of various masonry structural defects: cracks in brickwork, failing lintols, corroding embedded metal etc. refer to the Structural Engineer's drawings K1914/13 and K1914/14 for details	To resolve various structural issues and ensure the long term integrity of the historic building. The structural engineer has determined via monitoring that there is no ongoing movement.	Repairs (internal stitching lintols or helibar) will be concealed once complete.
25	All facades	New discrete lead flashings to copings and profile tops.	To ensure proper shedding of rainwater.	No adverse impact.
26	All facades	Where inappropriate modern bricks have been used for local remedial works in the past, these will be removed and new traditional imperial stock bricks inserted	As noted in Crown Estate Specification, bricks of different types (e.g. traditional stock bricks vs modern bricks) have different movement characteristics which can cause cracking when they are used together inappropriately.	To ensure long term stability.

24. Remedial works to masonry facades

The existing structure has been reviewed by our structural engineer. The repair proposals are shown on the following drawings:

- Wolff Architects' drawing 1604-PL-**221** and 1604-PL-**231**.
- Kashec structural engineering drawings K1914-**13** and K1914-**14**

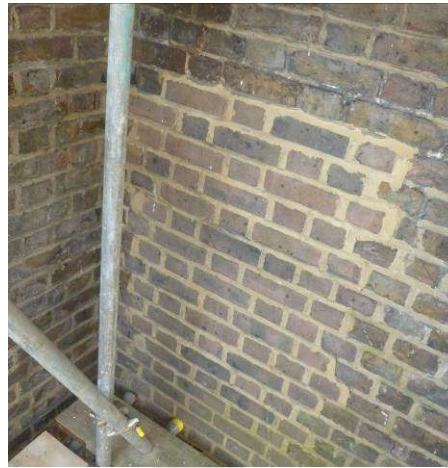
Photo 9: Poor modern repointing.

27	Rear facade	Skilled repointing of the entire rear brickwork façade in traditional lime mortar to a slightly recessed profile, which will visually unify the building.	Existing pointing is failing generally, and has been subject to numerous local cement patch repairs of indifferent quality with modern weatherstruck profiles, all of which detract from the building's aesthetic value, and impede the passage of moisture and restrict movement, accelerating the decay of the brickwork.	The required mechanical repairs (above) will cause this repointing to be required to a wide areas.

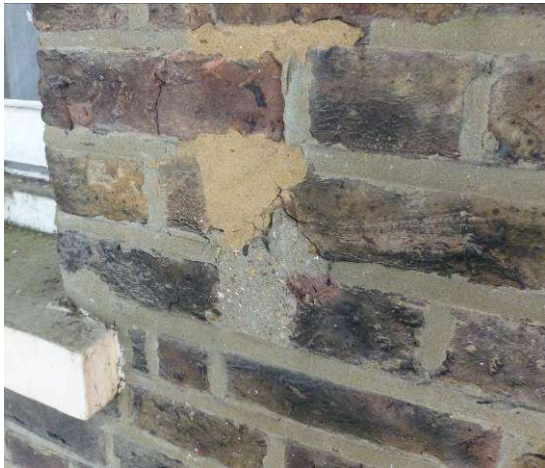
Photo 10: Various poor modern remedial pointing.

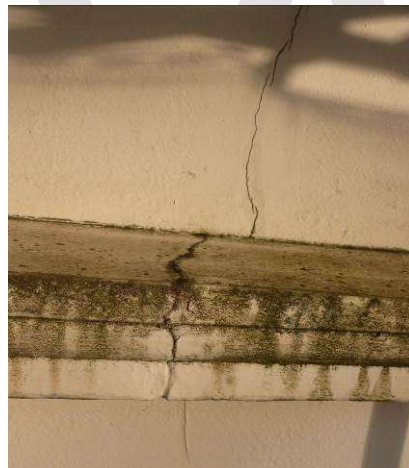
Photo 11: Crack to façade moulding

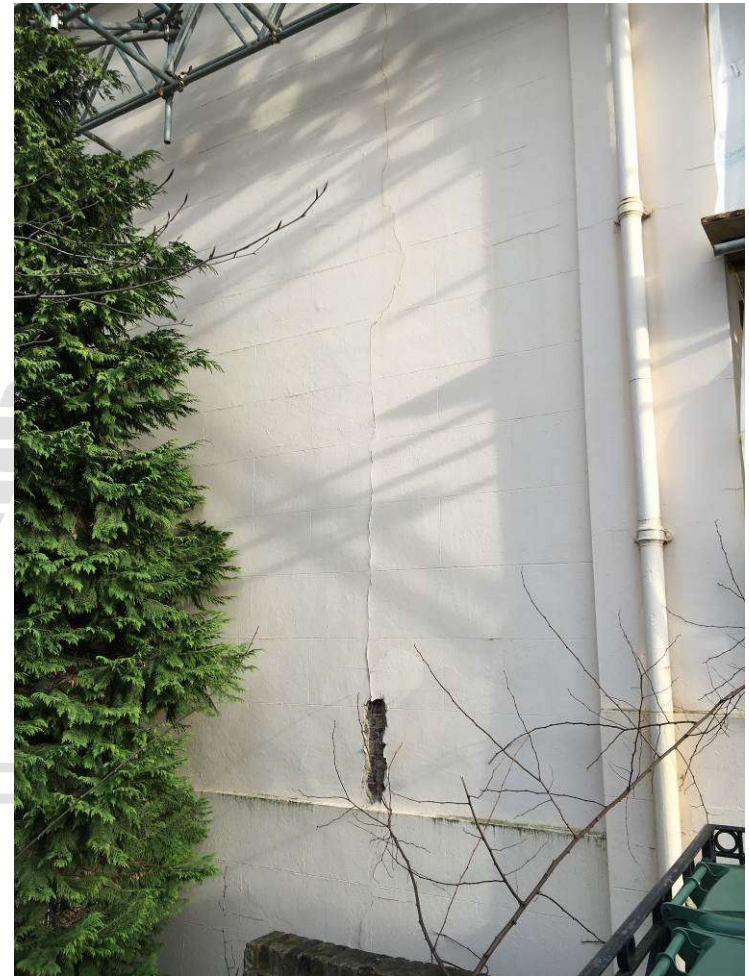
Photo 12: Full height structural cracking, through bricks and modern render.

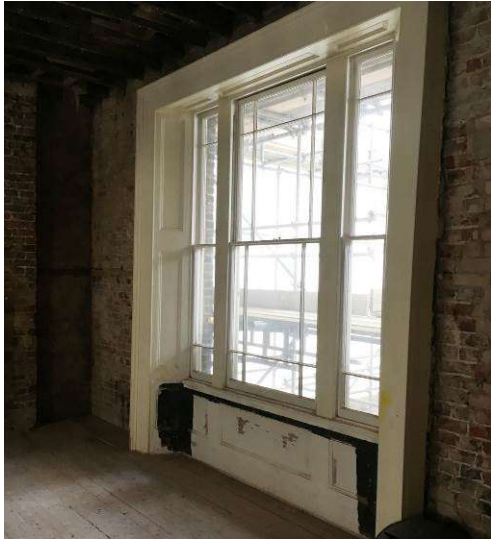
Photo 13: sash window and surround, first floor

22	All floors	Careful in situ repair refurbishment and redecoration of existing single glazed sash windows by specialist. See also item 9.	To ensure timber, protective coatings, and mechanisms remain in good order without undue loss of historic fabric.	Ensuring the existing fabric remains in good order.

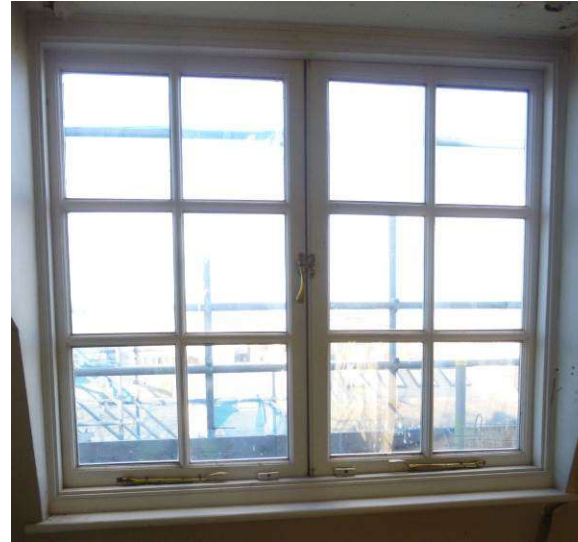
Photo 15: modern double-glazed dormer window third floor

8	Roof	Replacement of defective 'Velux' rooflight to rear with a conservation style rooflight of similar size.	Replacement of defective building component and incremental improvement of overall aesthetic.	No impact on historic fabric.
9	Third Floor	Replacement of 4 existing modern double glazed casement dormer windows with new,	Existing modern windows are of poor quality and degraded condition.	No impact on historic fabric.

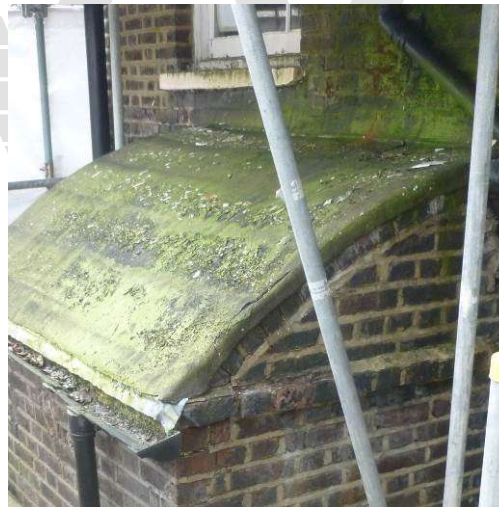
Photo 17: Failed modern asphalt to rear curved roof

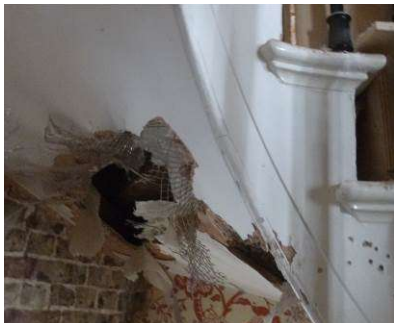
Photo 19 (bottom left): staircase opening up (approved by conservation officer) underway showing modern EML and plastic behind gypsum plaster.

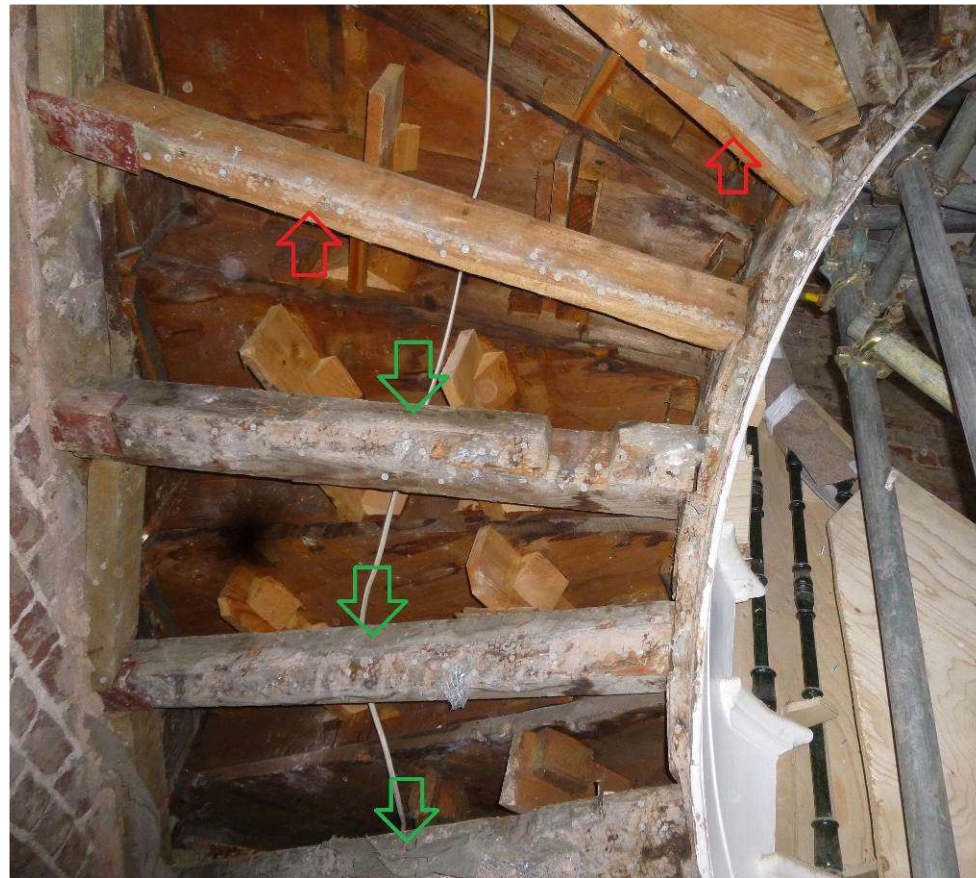
Photo 20 (right): exposed staircase structure to sagging timber winders, showing historic (green) and modern (red) structure, together with inadequate metal connections to wall. See also drawing 701.

27. Stabilisation of the cantilevered timber staircase

The existing structure shown in the photographs in appendix D has been reviewed by our structural engineer. A discrete repair methodology has been developed, as shown on the following drawings;

- Wolff Architects' drawing 1604-PL **701**.
- Kashec structural engineering drawings K1914-**03** and K1914-**04**

This involves stainless steel plates resin-anchored into the masonry and concealed behind new wall linings, each with an angle section pre-fixed to it, set so as to sit beneath each existing cantilevering timber and provide suitable support. The earlier metal repairs would be removed as redundant; the new repair would be concealed behind a new curved plaster soffit formed to the original line, and minimal loss of historic fabric would result.

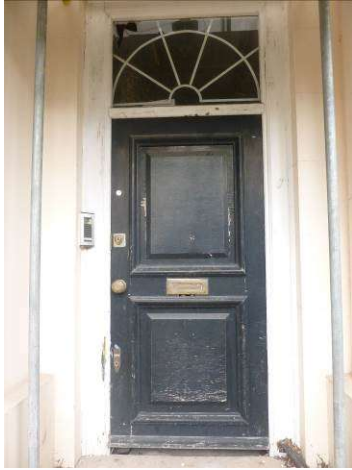
Photo 22: Front door

30	Front door	Replacement of existing modern front door and plastic fanlight above with more appropriate traditional panelled door and fanlight (to match neighbouring property).	The existing front door, whilst a panelled design, is of lightweight modern softwood and composite board, which raises concerns about both durability and security. The fanlight above is plain with adhered plastic radial glazing bars, alluding to a more ornate design but clearly inappropriate.	11 Prince Albert Road is one of a pair with its neighbour, as mentioned in the Listing description, therefore matching the new door and fanlight to the existing design of its neighbour seems highly appropriate.
31	Lower Garden (shed area)	New external plant concealed behind attenuated louvre screen, To suit proposed heating cooling and ventilation design for the building.	The proposed location is discrete and unsighted from public viewpoints, and removes the existing corrugated-iron roofed shed.	No adverse impact on the setting of the listed building. No loss of significant fabric.

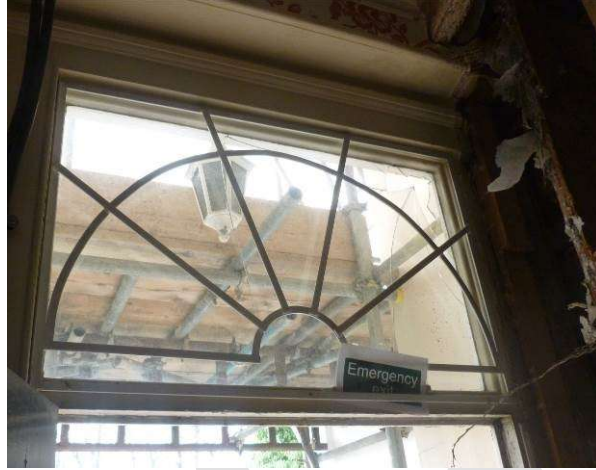
Photo 23: Existing plastic faux fanlight over front door.

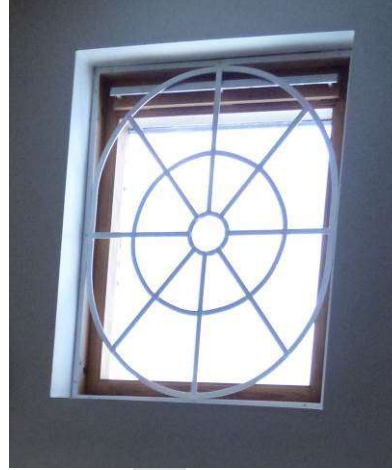
Photo 24: Existing modern rooflight

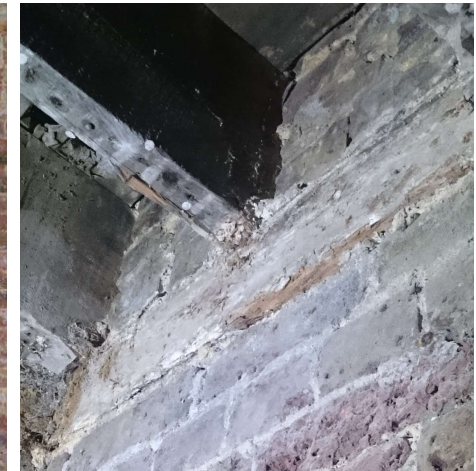
Photo 28: Evidence of rot, lower ground floor.

17. Investigation of embedded historic timbers for fungal and insect attack.

The exact methodology is to be agreed with a specialist, but would generally be in accordance with Historic England guidance e.g. as *Ridout, B: Timber Decay in Buildings (2013, Taylor & Francis)*. It may involve careful temporary removal of individual bricks or use of probes.
