OMC Associates

BSi 5837 Tree Survey for Development

CLIENT:	Mr H Lansdown
CONTACT:	Alan Morris - AMA
SITE:	R/O 27 Leighton Road, London, NW5
OUR REF:	1073/CJO/2009
YOUR REF:	
DATE OF REVISION:	20 September 2016

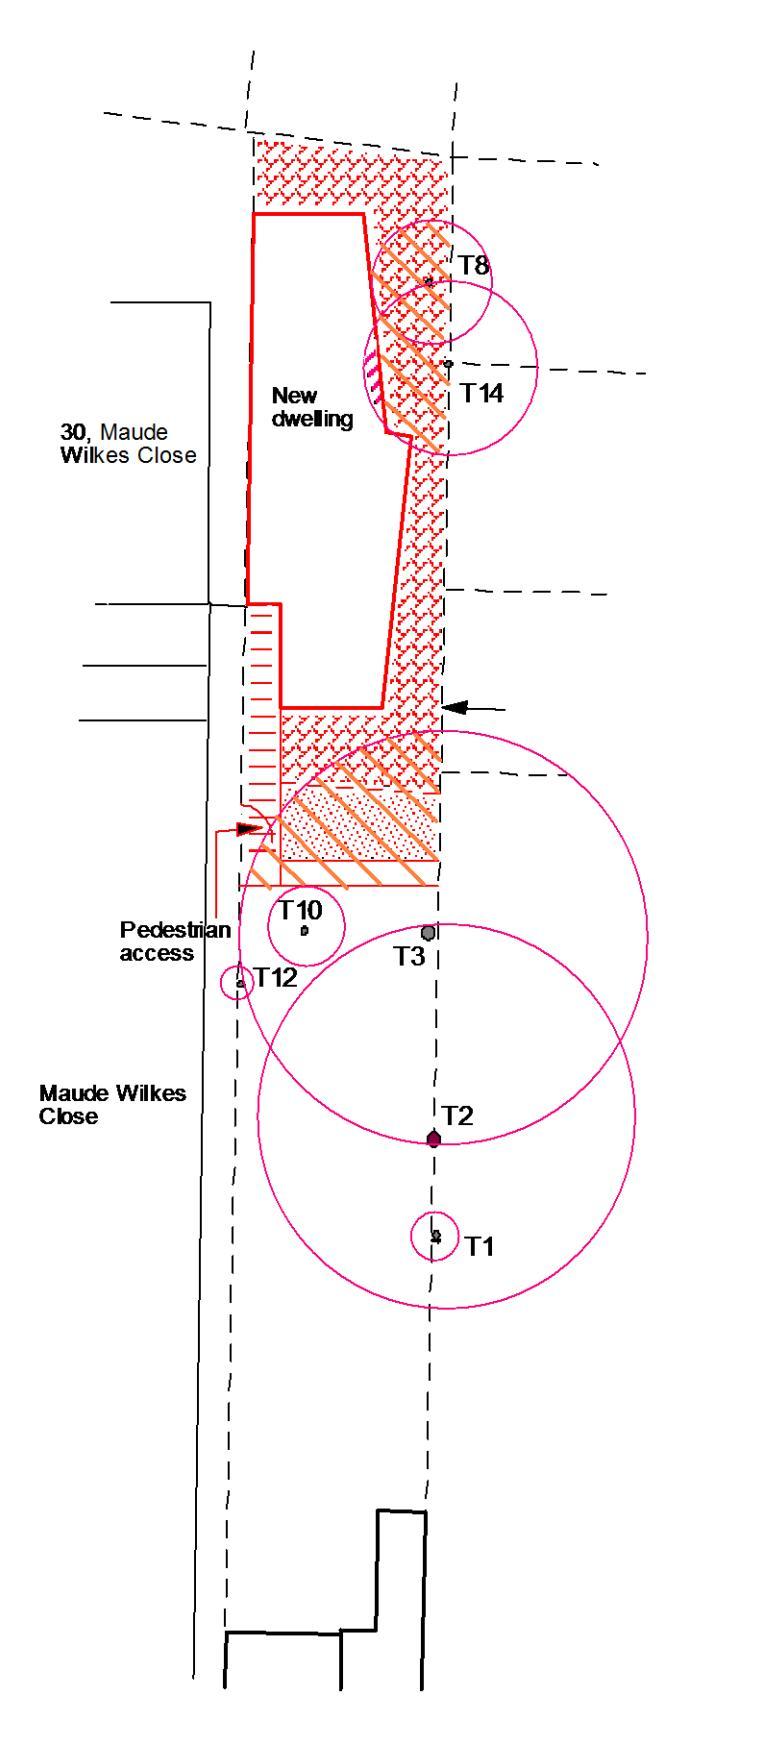
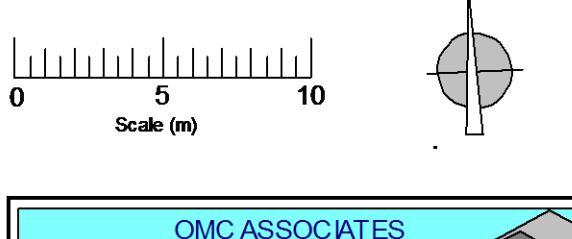
w	OMC ASSOC ATES T: 01223 842253 ww.omc-associates.co.uk					
SITE: OUR REF: CLIENT REF: SCALE: DATE:	R/O 27 Leighton Road, Lor 01073RP 1:200 on (on A3 -Subject 20 September 2016	ndon, NW5 to pdf distortion				
Tree Constraints Plan

On the basis of T8 & T14 being retained, the only impact of the development would be the incursion of the new hardstanding within their RPAs, which currently comprises open ground. In the case of T8 this represents 65% of the RPA and withT14, 40%. If not constructed appropriately this could give rise to damage types D3 & D6 described in Section 3.1. An encroachment of the proposed dwelling upon a peripheral section of T14's RPA is noted but this, at an estimated 6% of its RPA is deemed negligible, particularly in view of the vitality of the tree. This is illustrated in the TCP in Appendix 2.

Nominal Root Protection Area (RPA) (Also indicates potential encroachment of general building activity)

Encroachment of dwelling upon RPA - Does not include general operational areas

Encroachment of hardstanding upon RPA

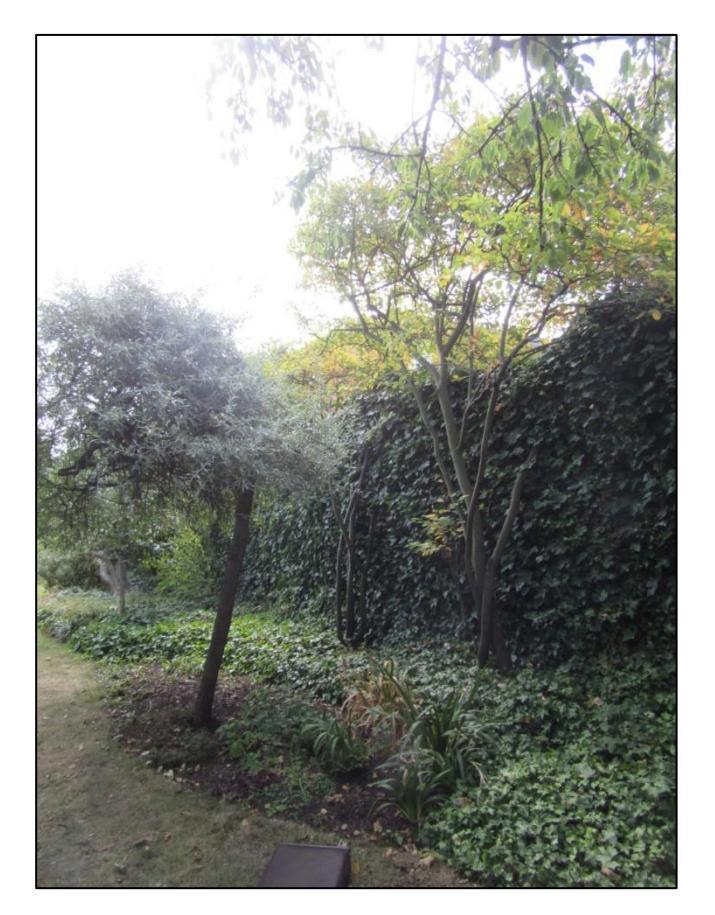
Eastern boundary looking north, T4 in foreground
