Flat 8 Inverforth House  
Historic Report, Design and Access Statement.

Additional Information - Ceiling Significance.  
Assessment of the Grade II listed building, including a schedule of significance.

June 2016

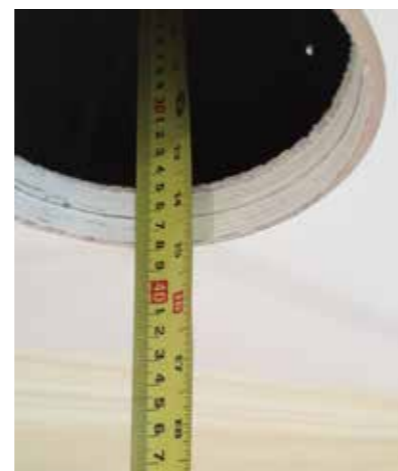
Current Master Ensuite Non Original  
Double Plasterboard Ceiling.

The Master Ensuite Ceiling is of two layers of plasterboard as a result of the 1990's refurbishment.

Both of these ceilings are non original.

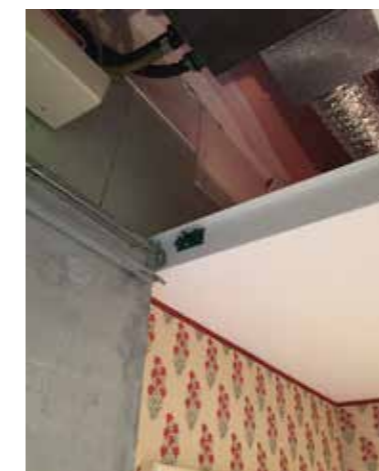
Current Master Dressing Room Non  
Original Ceiling Void.

The ceiling to the Master Dressing Room has been lowered, as seen on Camden planning permission dated 8th of March 2004, to accommodate an air conditioning unit.

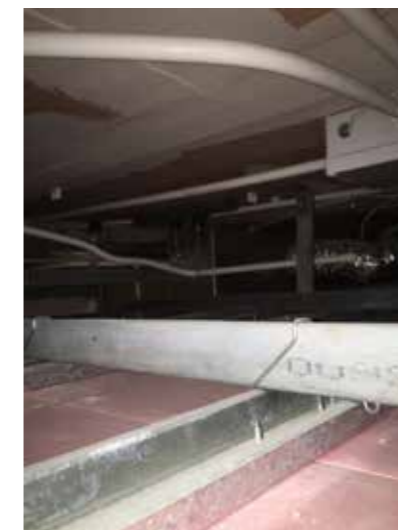
Current Dining Room Non Original  
Ceiling Void.

The present layout of the Dining room has been altered. The ceiling has been lowered to accommodate air conditioning and other mechanical kit. As such the surrounds to the doorways onto the terrace have been slightly obscured. This ceiling was added in the 1990's refurbishment.

The image opposite displays the void within the current ceiling. At the top the secondary ceiling is visible with the double layered plasterboard ceiling below.

This ceiling is non original.

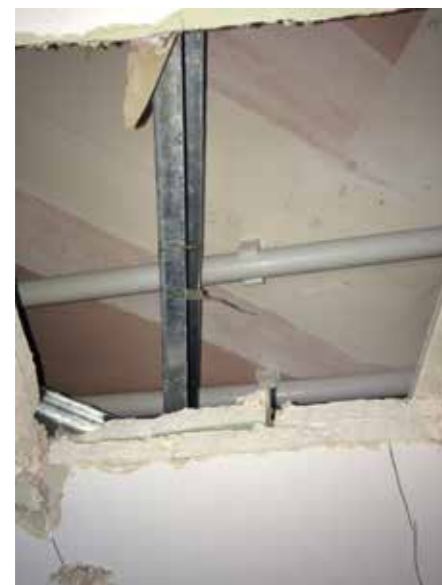
The Main Hallway and Secondary Hallway ceilings are both of two layers of plasterboard with a voided secondary ceiling above. This modern construction of each ceiling indicates the replacement of the original ceilings in the 1990's refurbishment.

Both of these ceilings are non original.

Current Secondary Hallway Non Original Ceiling Void.

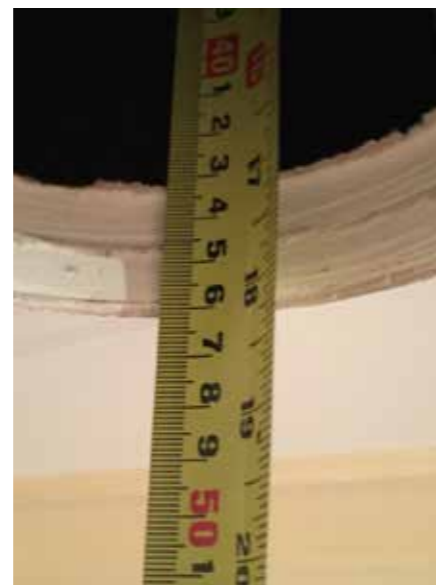
Current Hallway Non Original Double Plasterboard Ceiling.

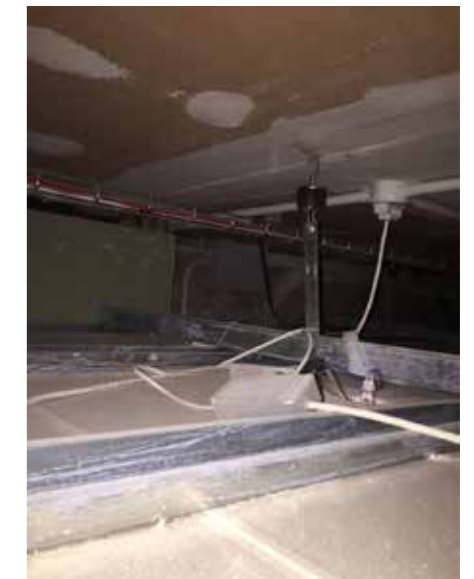
The ceiling to the kitchen is constructed of two layers of plasterboard with a voided secondary ceiling above. This modern construction indicates the ceiling was replaced in the 1990's refurbishment.

This ceiling is non original.

Current Ceiling Void to Kitchen.

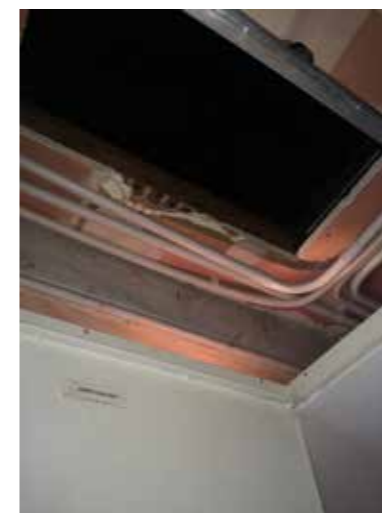
The extensive alterations in the 1990's refurbishment saw the ceiling replaced with a double layered plasterboard ceiling with voided secondary ceiling and further loft space above. This can be found in each room.

The ceilings to each of these rooms is non original.

Current Access Hatch to Bedroom 2.

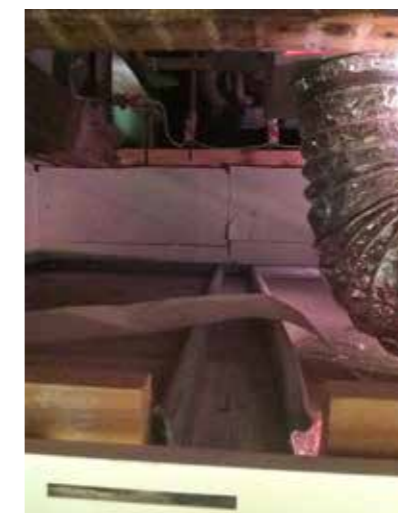
Current Ceiling Void to Bedroom 3  
Ensuite.
