Ground and Project Consultants Ltd

43 Burghley Road, London, NW5 1UH: Preliminary Slope Assessment Report

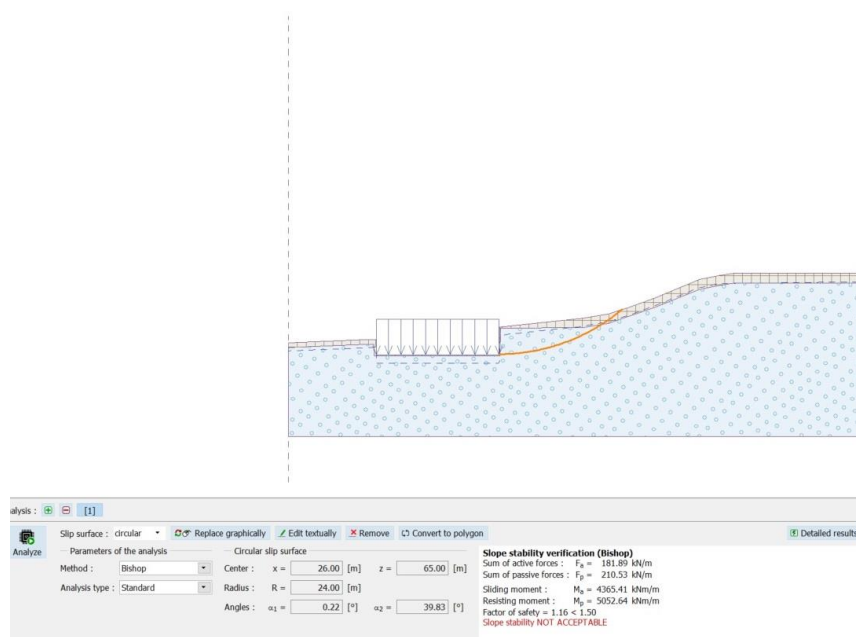
The analysis results give an unacceptable factor of safety for the slope of 1.16. Whilst this value should not be regarded as absolute, the slope should be regarded as unsafe with the basement construction in place.

Figure 1: No groundwater lowering

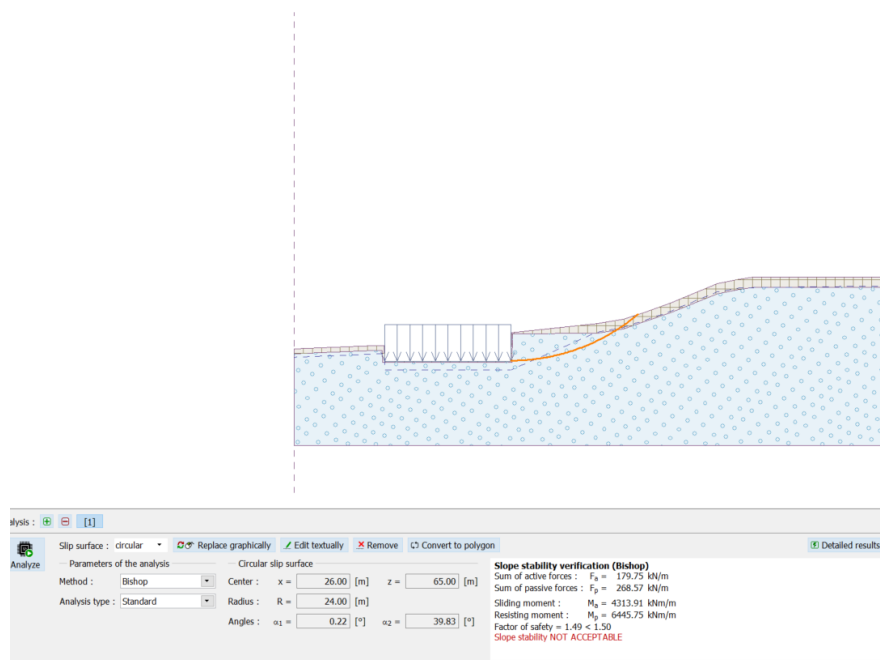
Brief analysis has shown that by lowering the ground water table immediately behind the property, by say the use of counterfort drains, has two benefits:

Analysis shows that this improves the factor of safety to 1.63, i.e. a 40% improvement.

Figure 2: Groundwater lowering

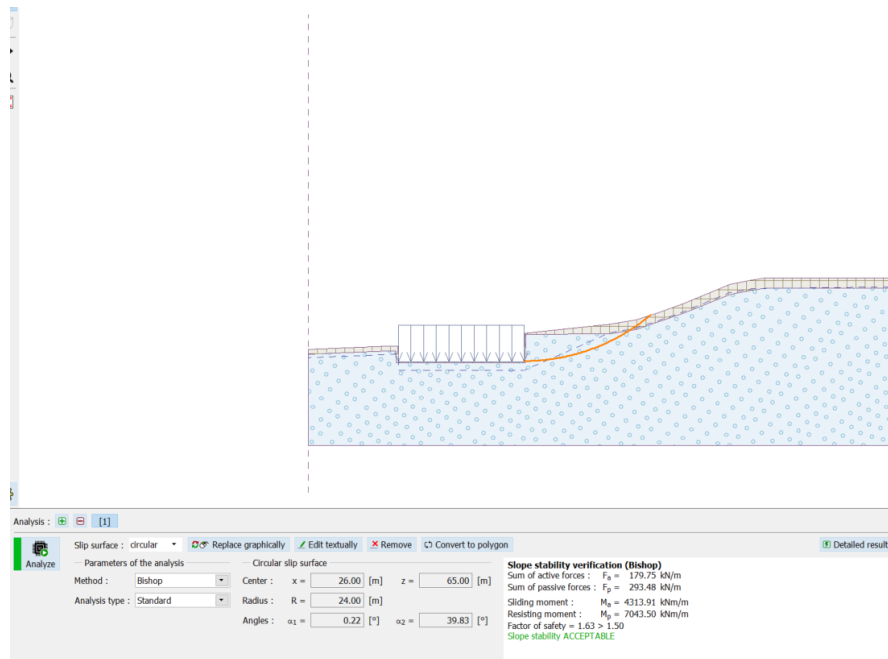
Figure 2: Groundwater lowering and enhanced soil strength

The construction of a basement at the property show that there is a potential risk of instability due the removal of soil load form the toe of the slope. The use of drains to lower the groundwater in the rear garden area and the introduction of granular drainage material itself is likely have a beneficial effect on slope stability.

It is recommended that a walkover survey of the slope is undertaken, particularly as vegetation dies back in the late autumn/ winter. The disturbed samples taken during the last phase of investigation should be tested for water content and atterberg limits. Ideally undisturbed samples should be taken and tested for undrained shear strength and effective stress parameters. In addition the installation of a piezometer in the slope would be useful to gain more confidence in groundwater levels.

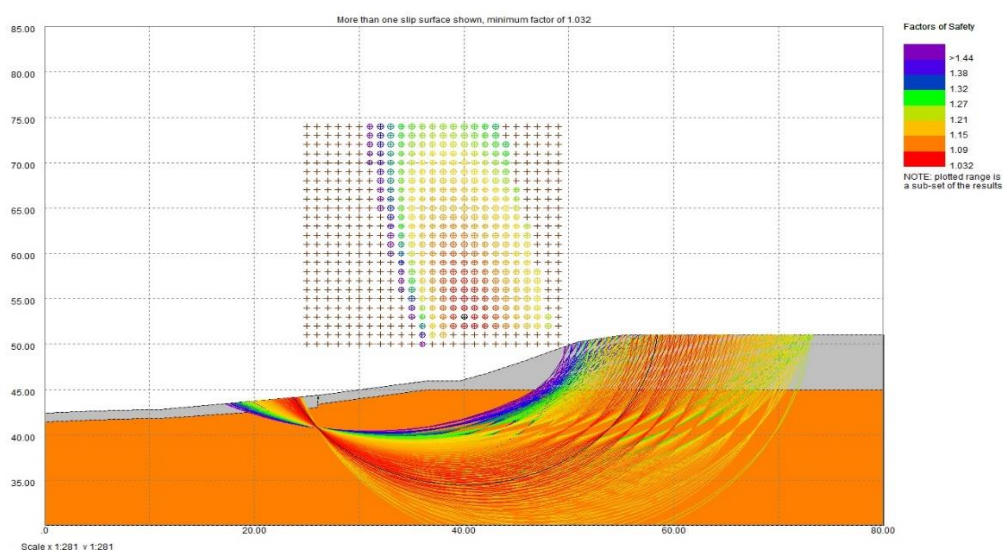
Figure A: No basement, Common Point at rear basement floor

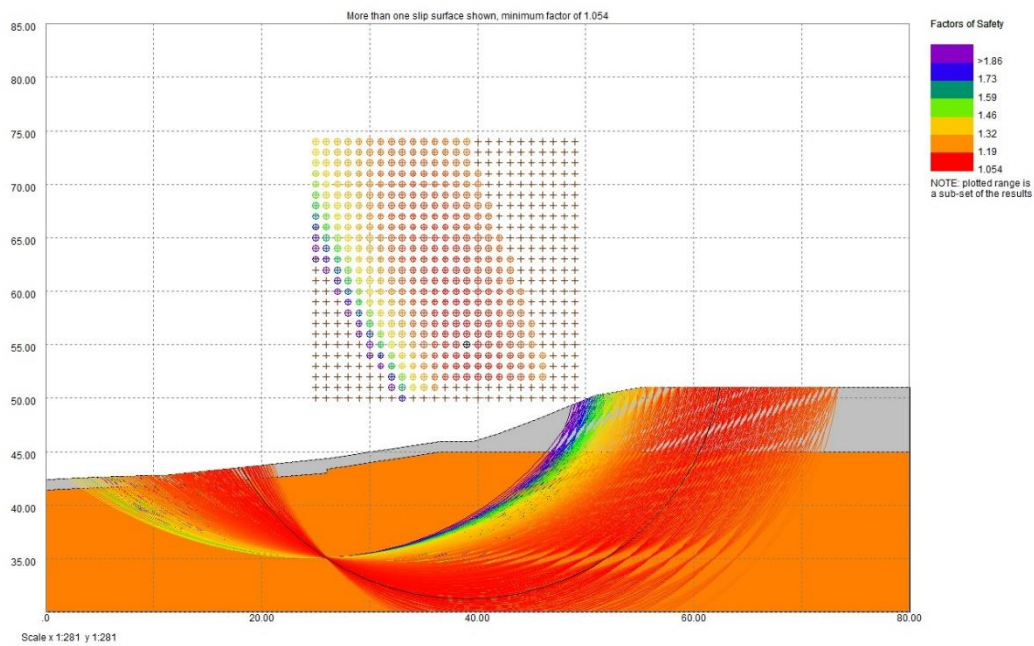
Figure B: No basement, Common Point at 35m AOD, below rear basement floor

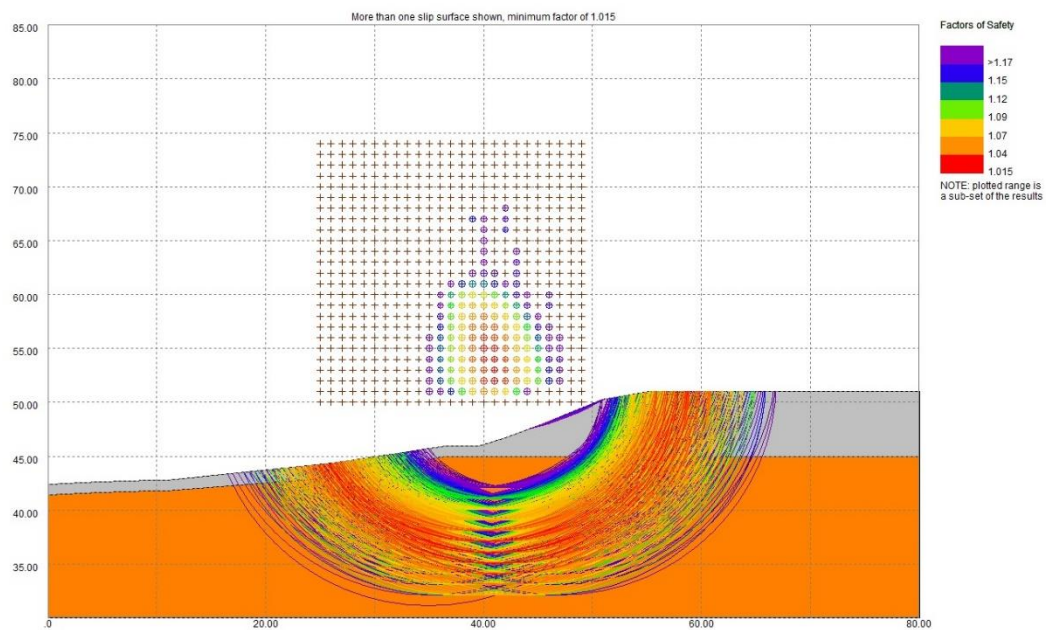
Figure C: No basement, Variable slip circle radii

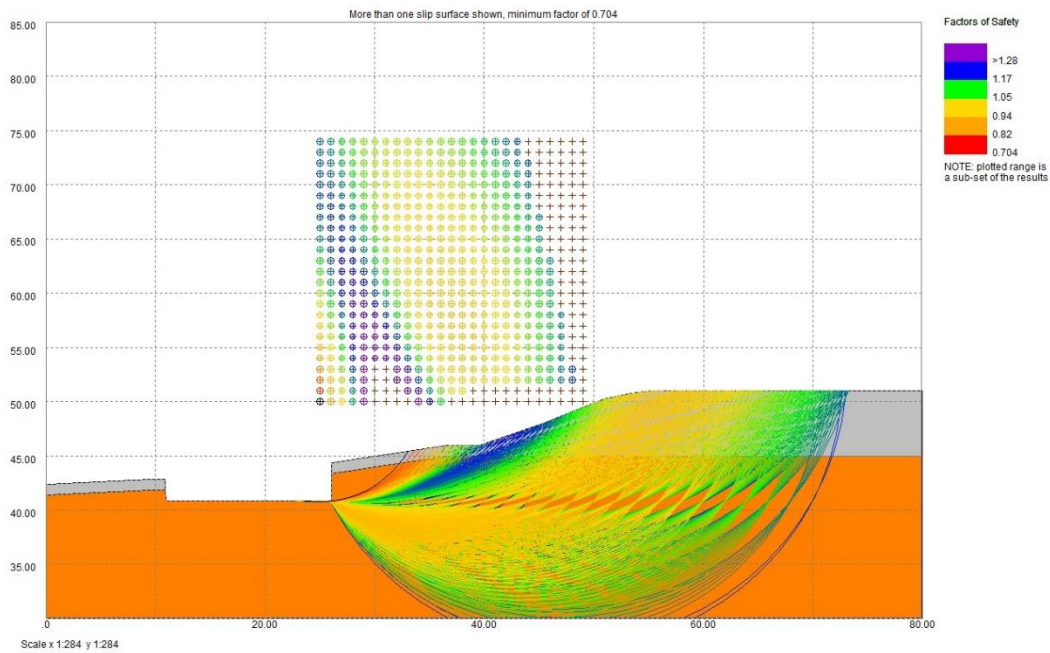
Figure D: With basement, Common Point at rear basement floor

The analysis shows that there is a significant reduction in the factor of safety of the slope arising from the introduction of the basement.

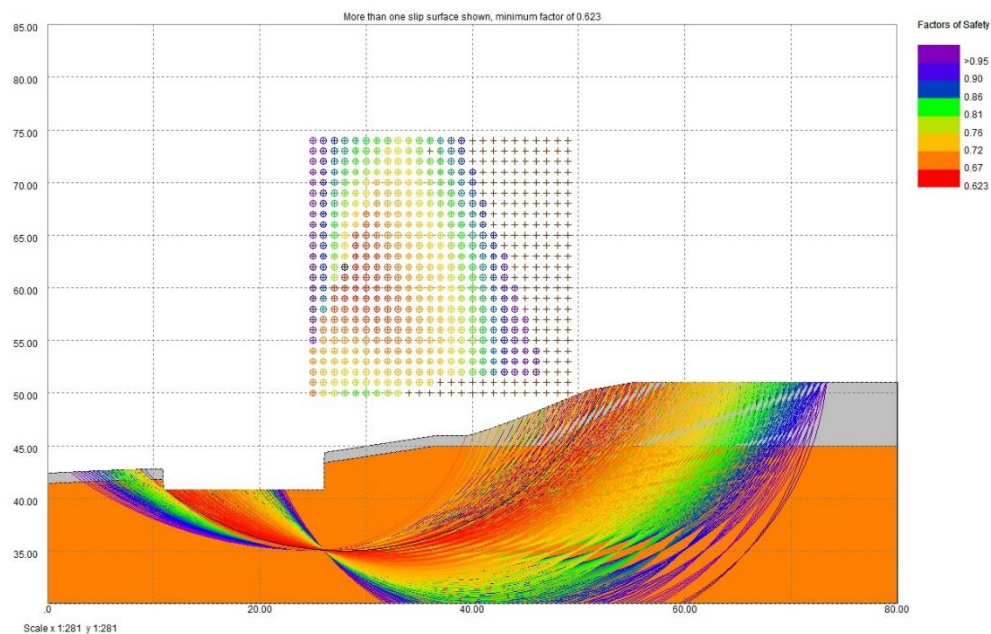
Figure E: With basement, Common Point at 35m AOD, below rear basement floor

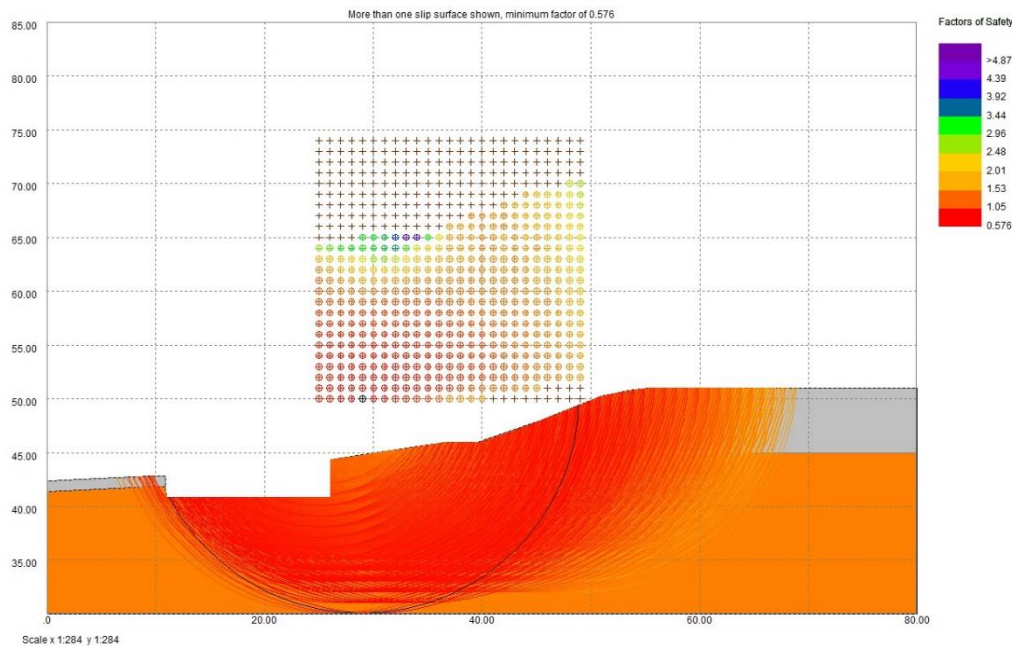
Figure F: With basement, Variable slip circle radii

It is therefore recommended that some intrusive works are carried out at the top of the slope and within the rear garden of no. 43. The college should be approached to see if there is useful borehole and other related data available.

The borehole in the garden could be drilled using a terrier rig and should take undisturbed and disturbed samples of the soils for appropriate laboratory testing. The borehole at the top of the slope would best be drilled using a cable tool percussive rig. Groundwater monitoring standpipe piezometers should be installed. This will then enable more rigorous analysis to be carried out.
