## Arboricultural Impact Assessment

- Tree Survey
- Tree Protection Plan
- Arboricultural Method Statement

1 East Heath Road  
Hampstead  
London  
NW3 1BN

Survey Date: 20<sup>th</sup> May 2016  
Report Date: 24<sup>th</sup> May 2016  
Project no: 895

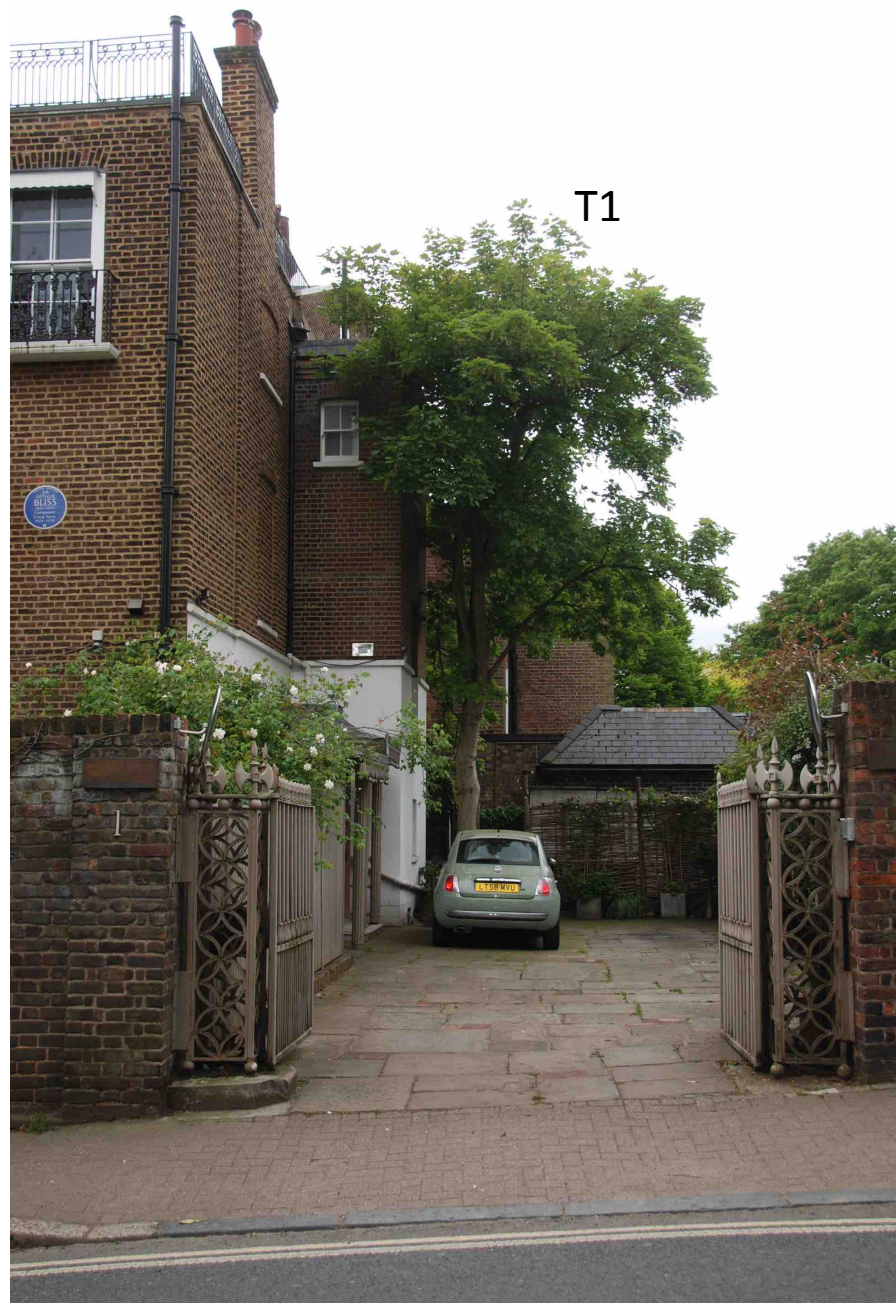
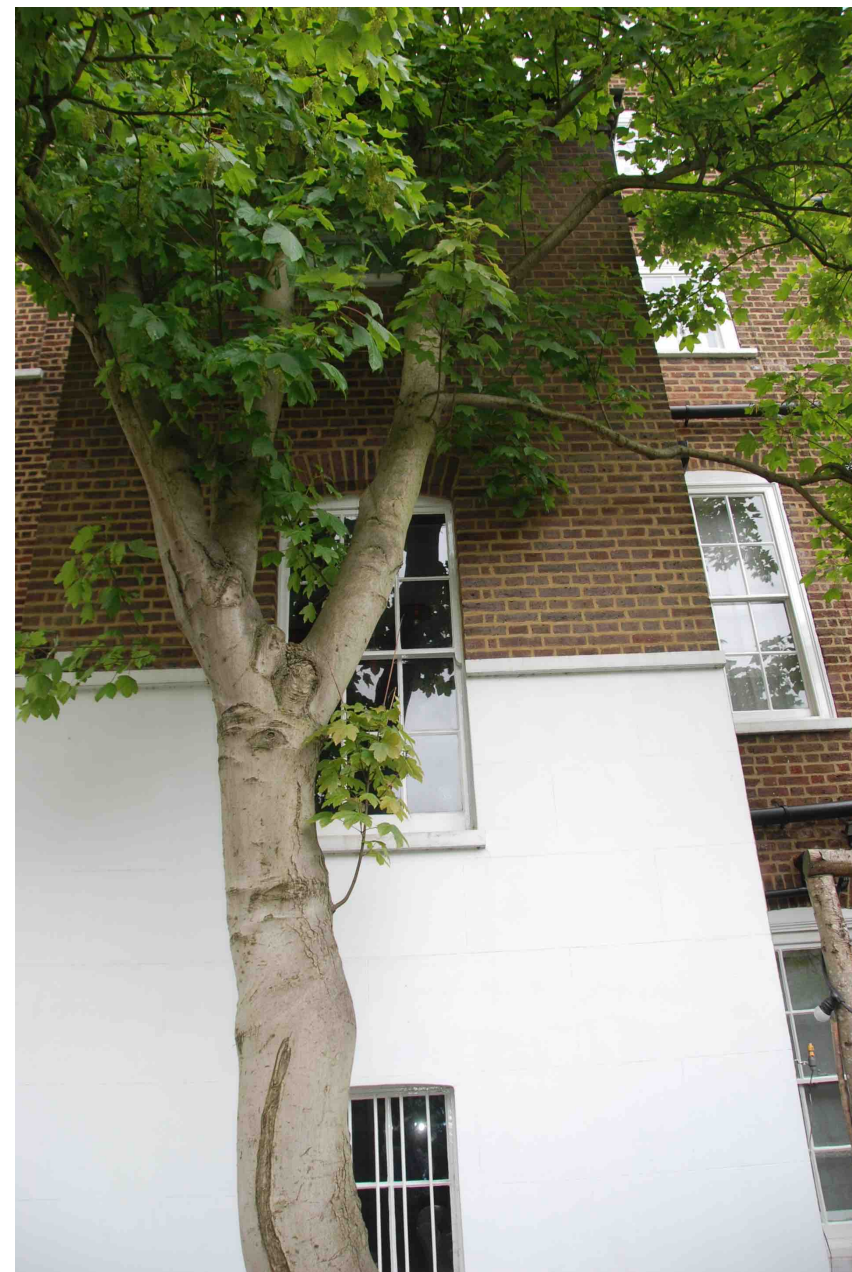
- 4.1.1 The proposal is to construct an extension to the house, where shown on the Tree Protection Plan attached as Appendix A.
- 4.1.2 The new extension will be close to the sycamore (T1), shown in the photos in Appendix Ei). Branches from the tree are hitting the listed building and the trunk is growing immediately adjacent to the basement wall to the house and very close to the brick retaining wall at the edge of the adjacent window recess. This wall has been damaged by the tree, having been pushed out of alignment and cracked, as shown on the photo in Appendix Eii).

- 4.1.3 The tree is not sustainable in this position. Structural damage to the light well has already occurred. Although damage to the upper storeys of the house could be avoided by annual pruning, as the base of the tree expands, structural damage to the basement wall is highly likely.
- 4.1.4 Although the tree does not need to be removed to allow construction of the extension, this project provides an opportunity for removing the tree and planting a new, large growing specimen tree further from the house, where it can grow to maturity and provide greater amenity value in the future.

- 4.3.1 Details of proposed tree works are included in the Tree Schedule included as Appendix B.
- 4.3.2 The sycamore, T1, is proposed for removal.
- 4.3.3 All tree work should be undertaken to the standards set out in BS 3998:2010 Tree work – Recommendations.
