## ARBORICULTURAL IMPACT ASSESSMENT REPORT FOR:

28 Maresfield Gardens  
London  
NW3 5SX

**Ref:** GWA/28MFG/AIA/01a

**Date:** 12<sup>th</sup> September 2016

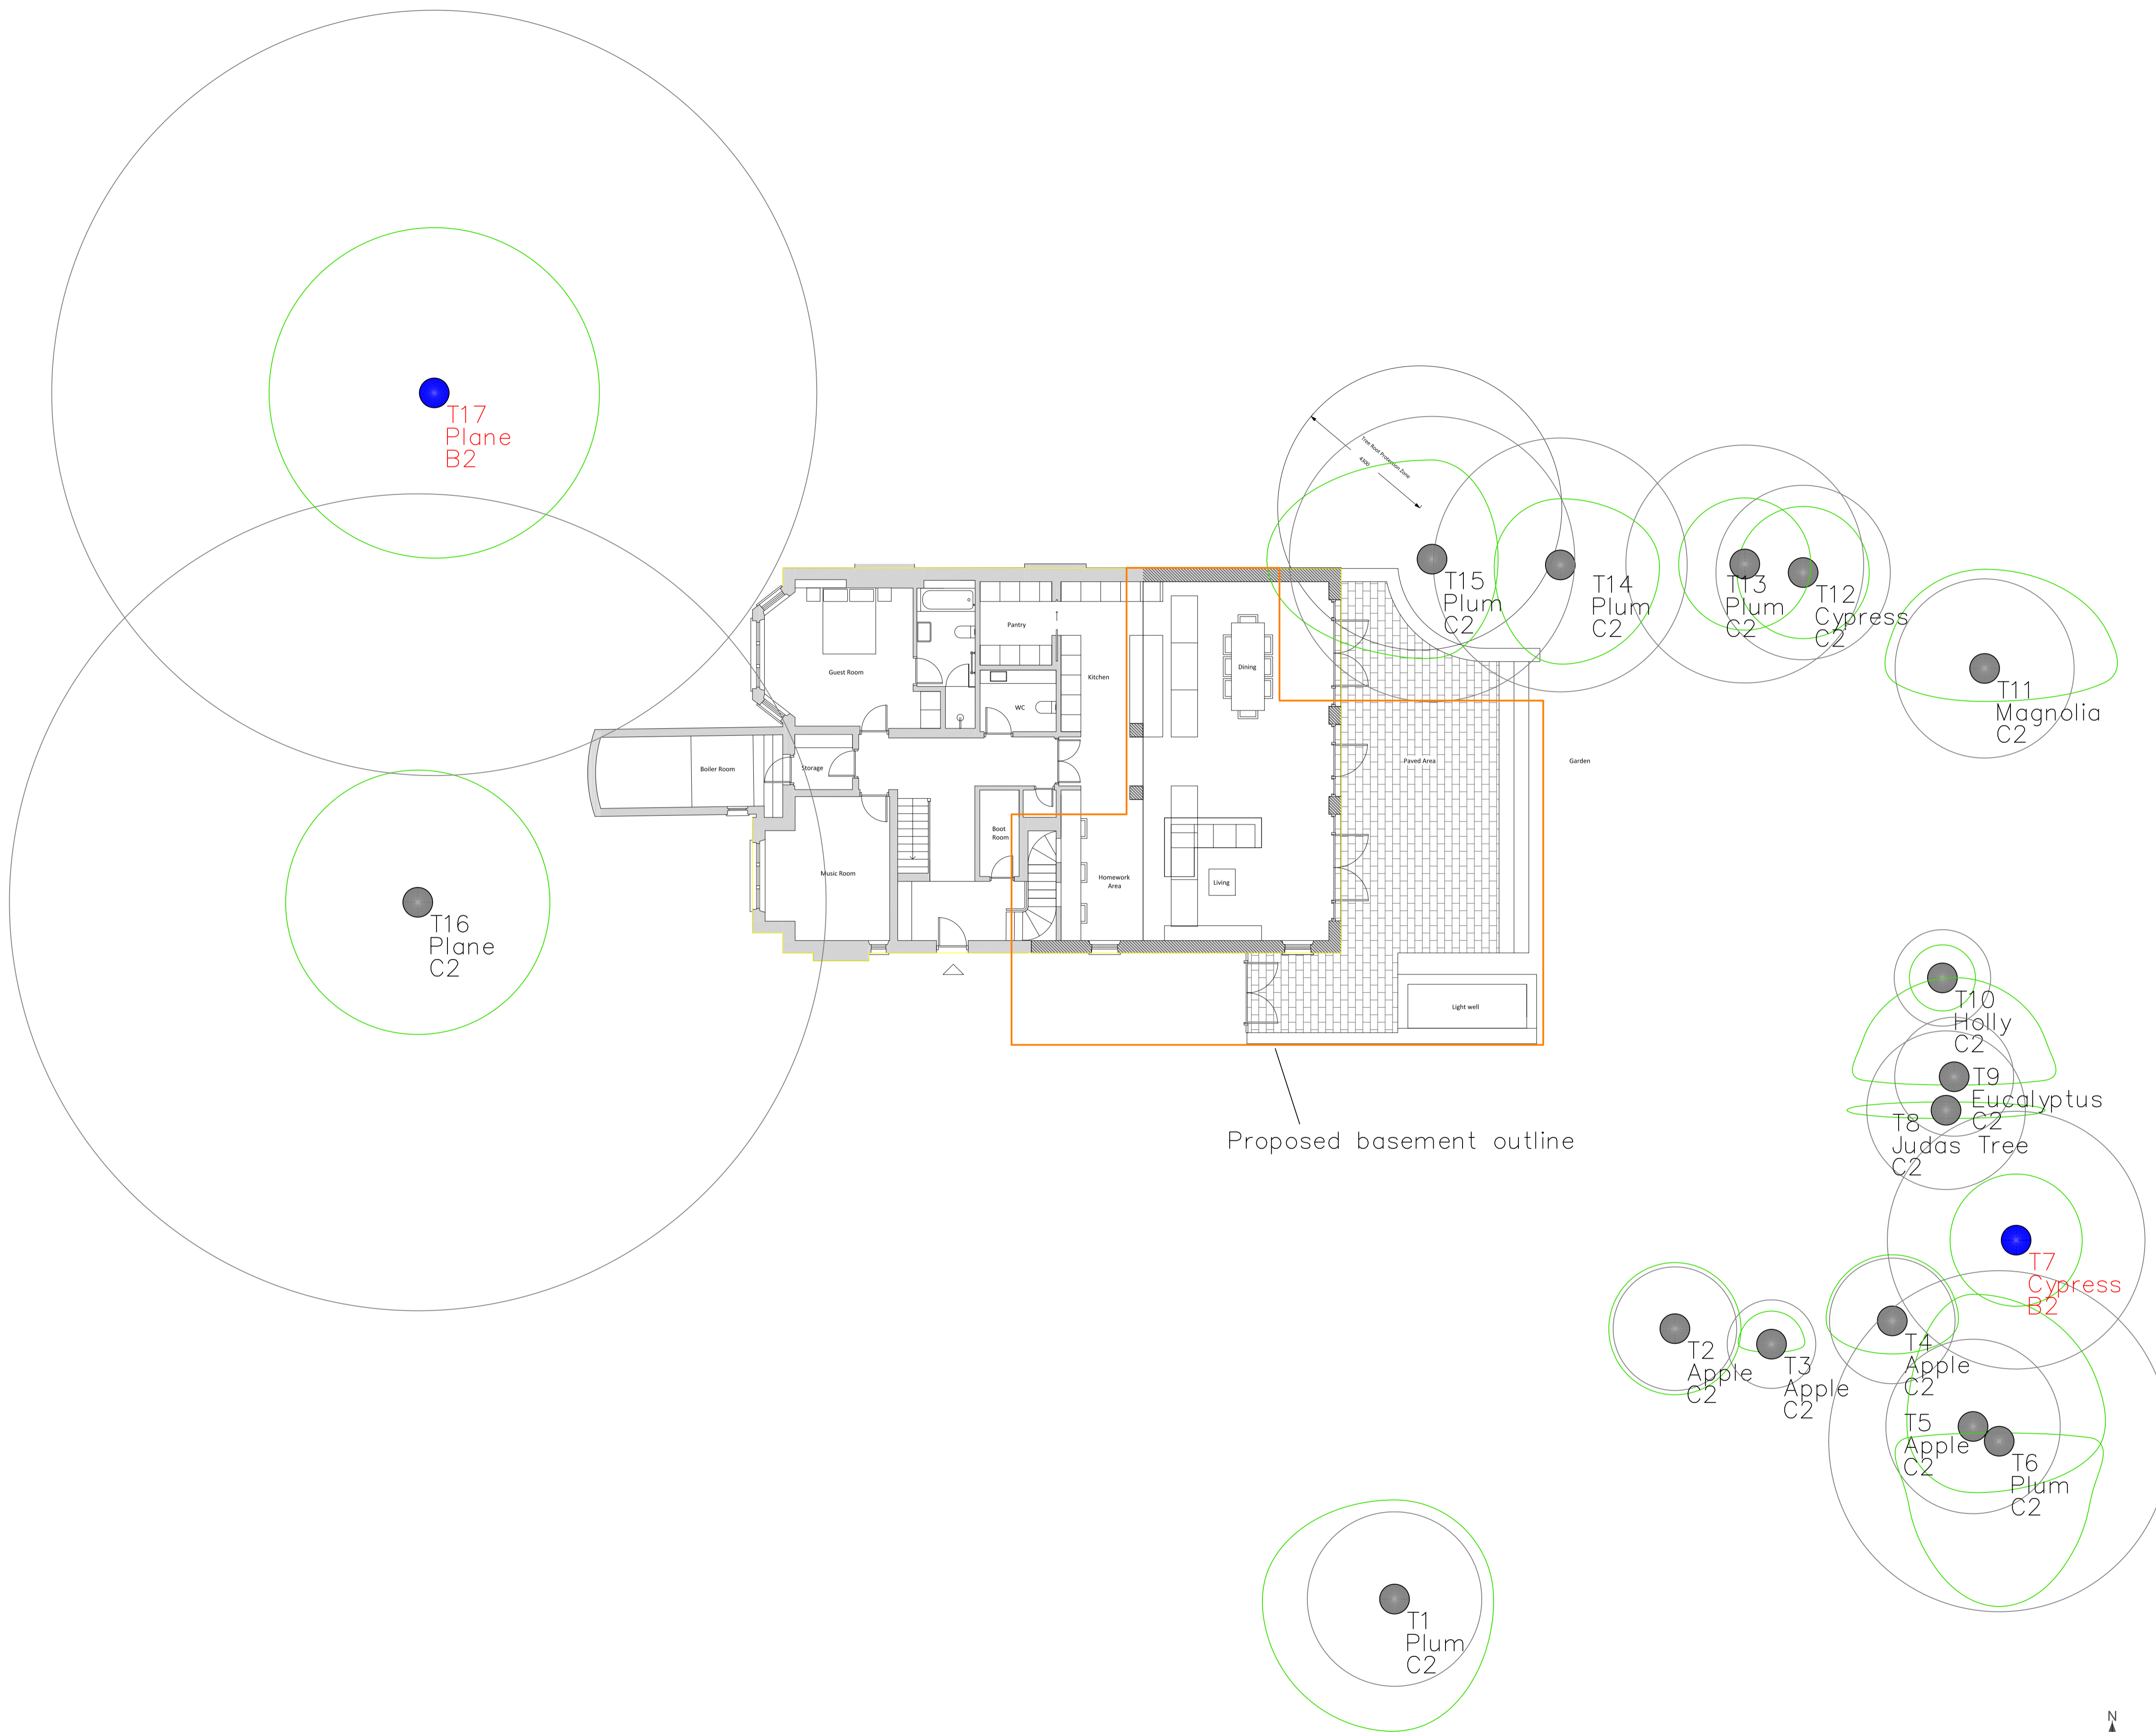
Proposed Lower Ground Floor Plan

- 6.1.2 Further impacts to retained trees comprise the encroachments of the theoretical RPA of T14 by the extension of the patio area and bounding half-wall and steps to the garden level. As the patio extension is at the LGF level, manual excavation of the encroachment in conjunction with pre-emptive root pruning is proposed as mitigation. Subject to the adoption of these measures, the impact to the tree is likely to be very low.
