ARBORICULTURAL METHOD STATEMENT

BS 5837: 2012

Site: 28 Lyndhurst Road, London, NW3 5PB

31/10/2016 Our Ref: 69039

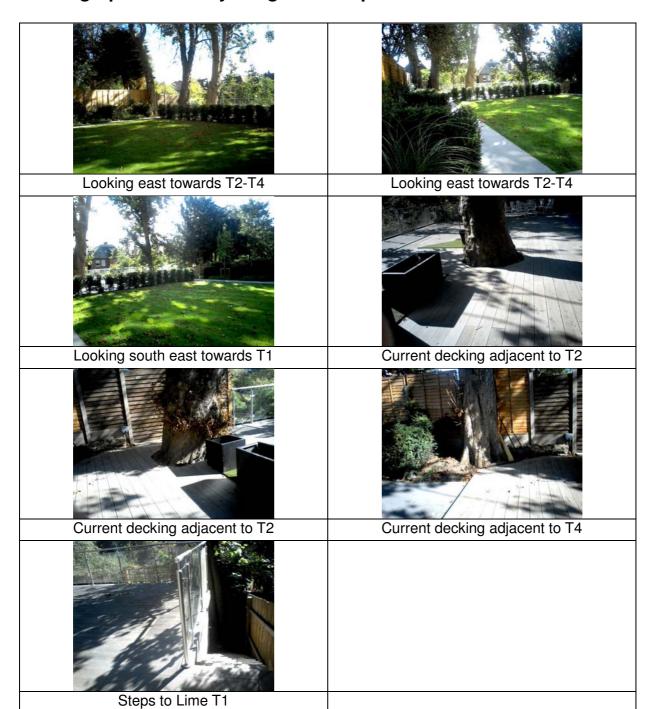
Photographs Supplied by Architect on Construction of Decking

- 5.4 The baton structure as can be seen in the series of photographs at Appendix 4 was effectively installed suspended above ground level so no new compaction was caused.

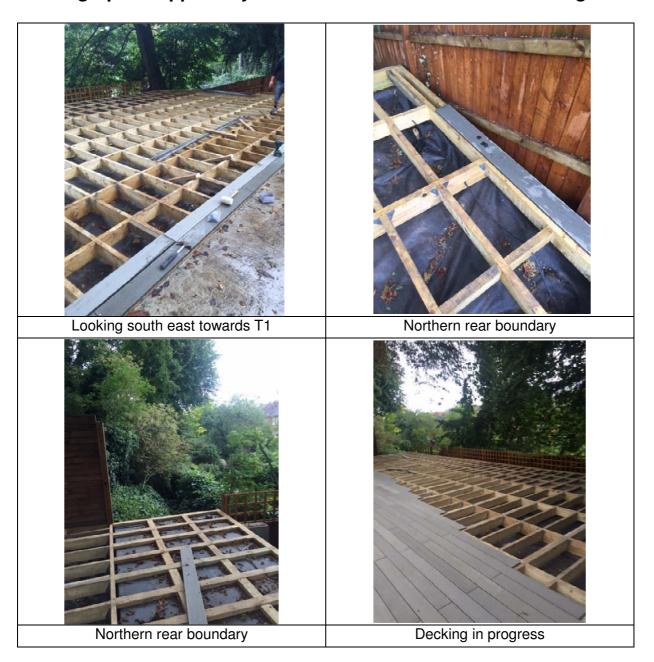
Photographs of Rear Garden Prior to Decking Installation

- 5.1 The site prior to the installation of the decking can be seen in the series of photographs at Appendix 4.
- 5.2 No existing understorey shrubbery was removed in order that the decking could be installed. The same views into rear gardens could be seen before the decking was installed.

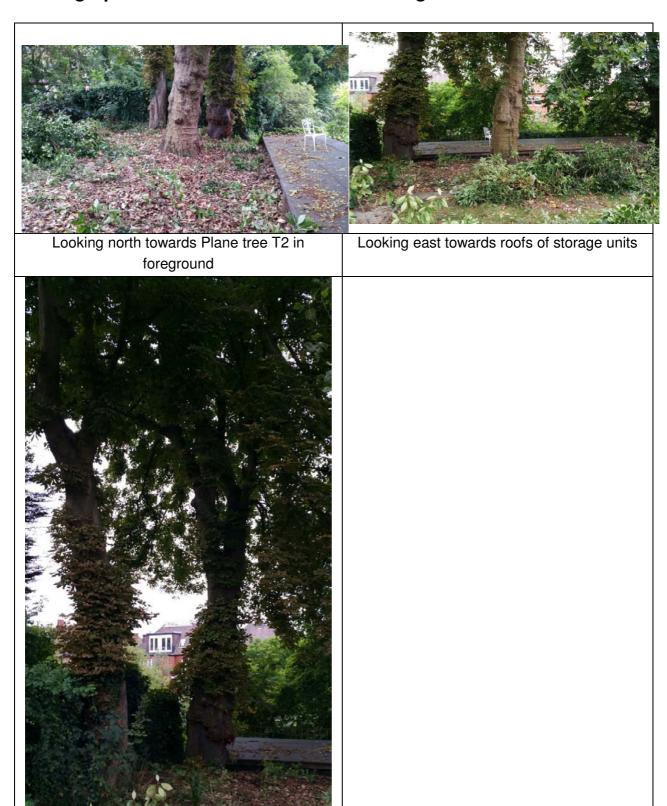
Looking towards T1 and T2
