TITLE:  
**Bay House  
Level 01 Proposed Floor Plan**

PROJECT:  
**Project No. 11581  
Kilderpore Avenue**

DRG NO.    REV.  
**9100-DRG-03BH-0101    B**

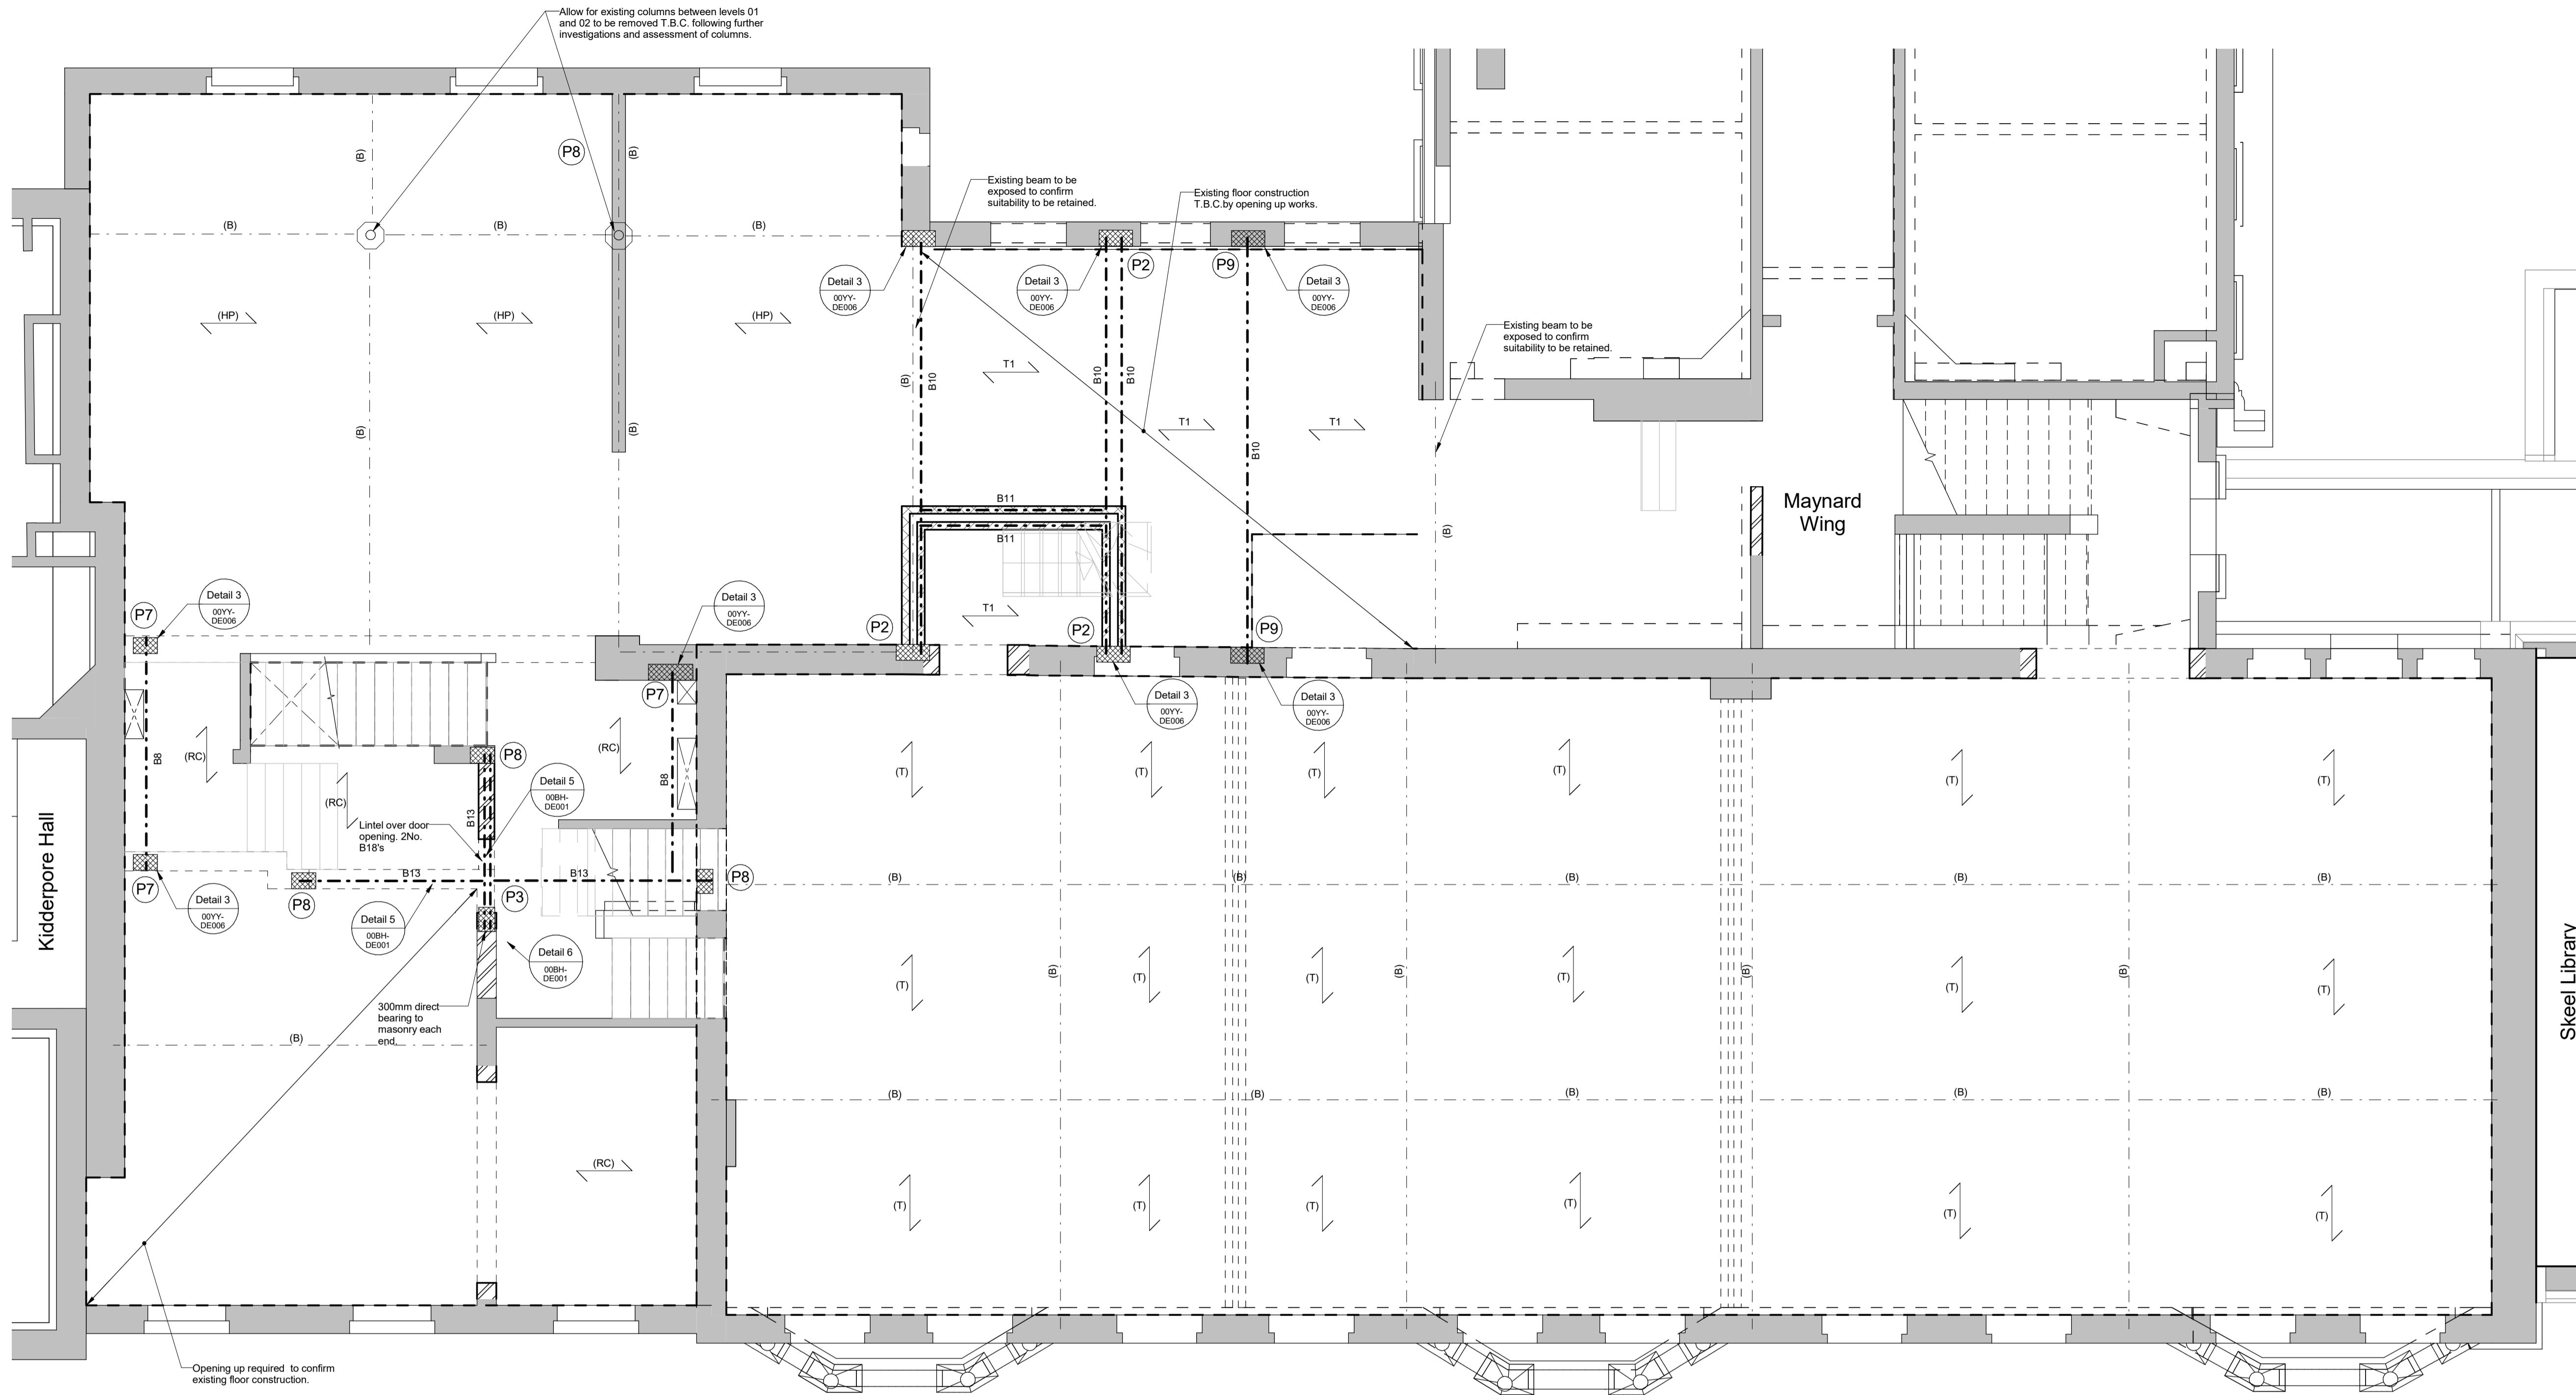
**NOTE**  
PROVISIONAL REPAIR ALLOWANCE FOR DECAYED TIMBER JOISTS: Allow for splice repair to end of timber joists, re-supported off joist hanger. Timber to be isolated from external wall with dpm. Allow for 15No. joist repairs at this floor level.

**NOTE**  
PROVISIONAL REPAIR ALLOWANCE FOR HEAVILY NOTCHED JOISTS: All for doubling up of 40No. joists which have been heavily notched in the past with new 47 X 245 S/W C24 timber joist bolted to side of existing joist. Refer to Detail 6 on Drawing No. 9100-DRG-00YY-DE004.

**NOTE**  
PROVISIONAL REPAIR ALLOWANCE FOR DECAYED WALL PLATE: Allow for removal of existing timber wall plate and make good with new brick. Allow for 4.5m length of repair at this floor level. Refer to Detail 3 on Drawing No. 9100-DRG-00YY-DE004.

**NOTE**  
PROVISIONAL REPAIR ALLOWANCES SHOWN ON THIS DRAWING WILL BE CONFIRMED FOLLOWING LIFTING OF FLOORBOARDS IN EACH AREA. ENGINEER TO INSPECT EACH FLOOR IN TURN AND CONFIRM EXTENT OF REPAIRS REQUIRED.

**NOTE**  
PROVISIONAL ALLOWANCE FOR STIFFENING EXISTING FLOORS: All floor areas to have solid S/W C24 blocking pieces, 47 x 195mm deep, installed at supports and at half-span locations to improve load share between joists. Refer to Detail 7 on Drawing No. 9100-DRG-00YY-DE004.

**NOTE**  
PROVISIONAL ALLOWANCE FOR STIFFENING EXISTING FLOORS: Allow for doubling up joists below lines of new partitions using new 47x195 S/W C24 timber joists bolted to side of existing joist. Refer to Detail 6 on Drawing No. 9100-DRG-00YY-DE004.
