Arboricultural Impact Assessment

Gloucester Lodge, Gloucester Gate, Regents Park,
London, NW1 4HA

Iconic Properties Limited

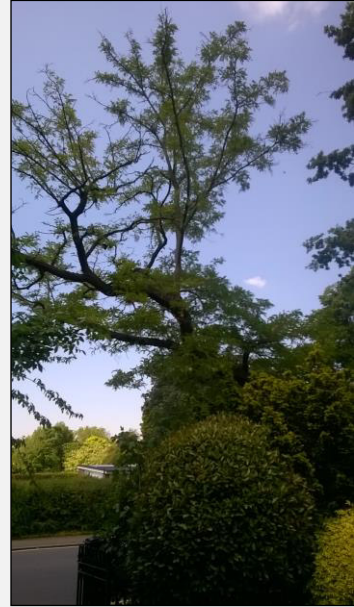
T5 False acacia

T5	False Acacia.	0.37	1	10.4	3	3	4	5	B1	Early-Mature	10_19	3	Average form, shape and condition. Dense crown, moderate crown deadwood.	No Works.	62

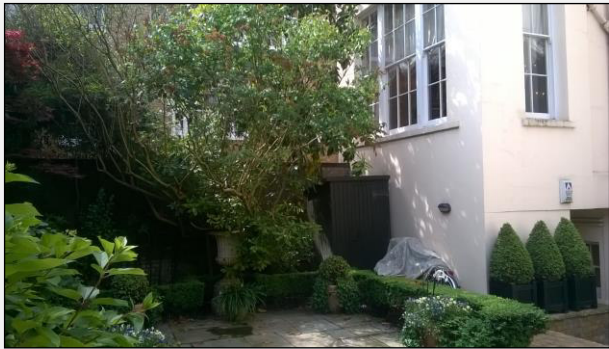
T12 Lilac

Tree No.	Species	DBH	No of Stems	Ht (m)	N	E	S	W	BS Cat	Age Class	Life Expect	Cr Ht (m)	Observation	Recommendations	RPA (m2)
T12	Lilac.	0.09	M/s	3.6	1	3	3	1	C1	Early-Mature	10_19	1	Poor form (Asymmetric canopy), shape and condition.	Fell to ground level.	3
T13	Japanese Maple.	0.04	1	3.4	0	1	1	0	C1	Young	10_19	0	Poor form (Asymmetric canopy), shape and condition. Young newly established tree.	Fell to ground level.	1
H1	Yew.	0.08	M/s	3.5	1	1	1	1	C2	Early-Mature	20_39	1	Average form, shape and condition. Maintained Hedgerow.	No Works.	2
