Addendum To Arboricultural Impact Assessment

Gloucester Lodge, Gloucester Gate, Regents Park,
London, NW1 4HA

Iconic Properties Limited

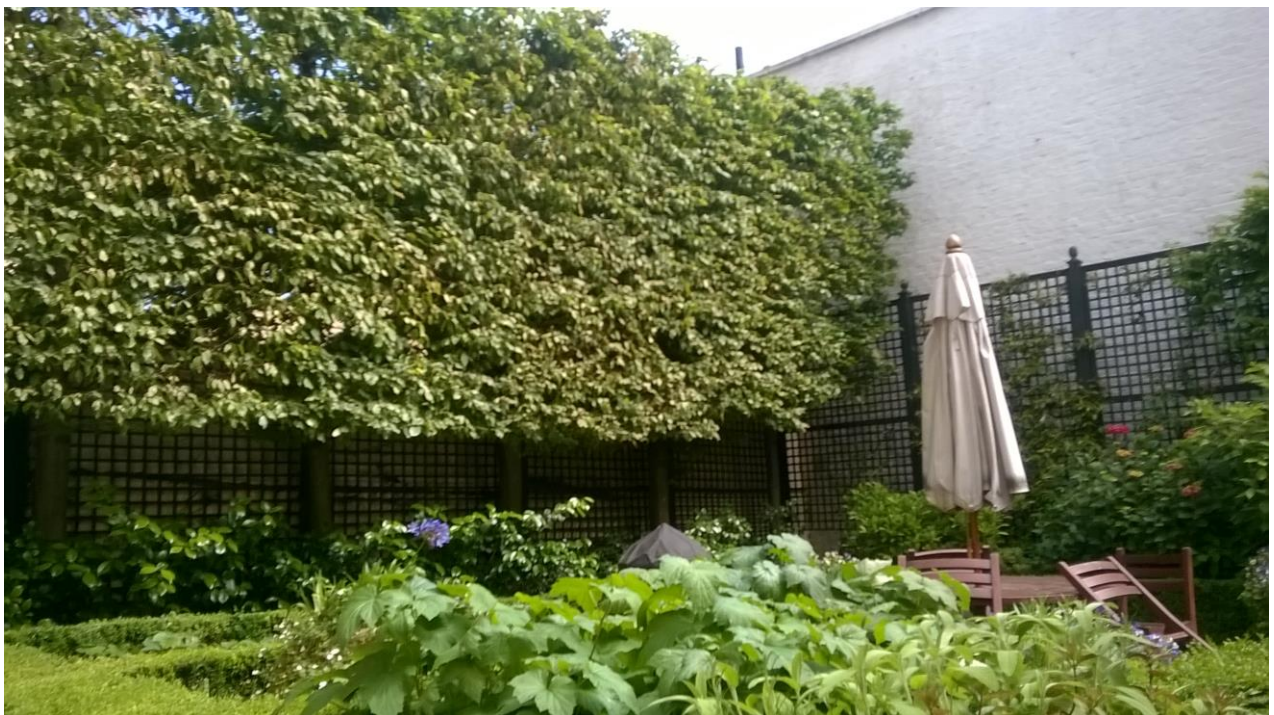
- 2.1 Following correspondence between the client and the LPA, a comment has been received about the impact of the rear basement and the removal of the pleached Hornbeam hedge (see below)

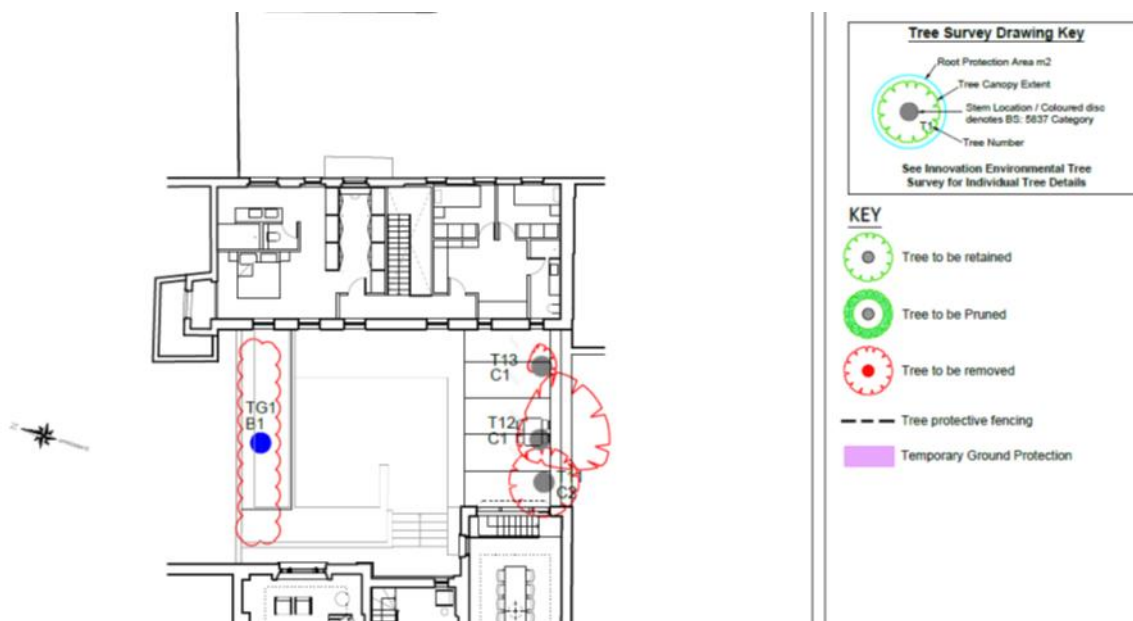
- 2.2 The removal of this hedge is shown on the extract below from the Tree Protection Plan as TG1 (shown in red for removal)

- 2.4 TG1 is a recently planted feature, with little visual amenity (as it can only be viewed from the rear of a small number of properties). Its removal would have no impact upon the streetscene, and would be unnoticed by the majority of people.

- 2.5 The rear basement does provide for boundary landscape treatments, and it would be very easy to replace the pleached trees once the basement was completed. These are commonly available as 'extra heavy' standards or even semi-mature trees, and once planted would immediately replace the screen.

- 3.1 The removal and direct replacement of the pleached Hornbeam hedge is achievable and sensible, considering the proposed development.
- 3.2 The Weeping Ash should be replaced with a suitable specimen
- 3.3 The Local Planning Authority is invited to secure the replacement of both the Hornbeam hedge and the Weeping Ash by way of a Condition of Planning.

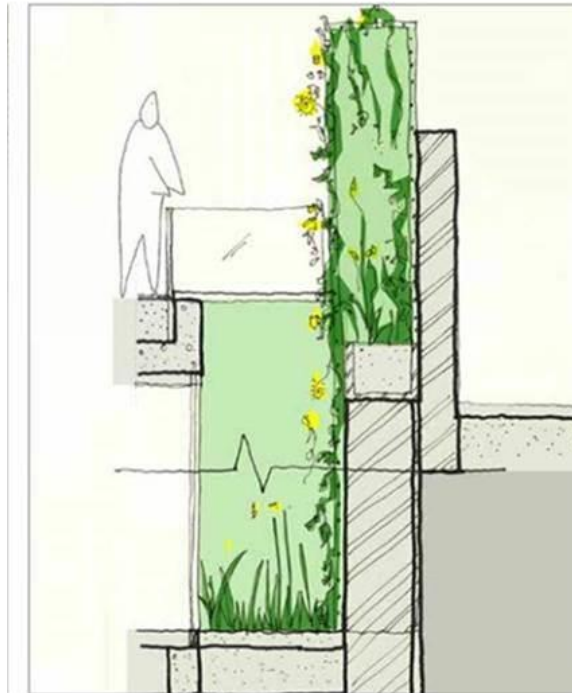
Sketch: Planted trellis
A new boundary wall is built against the existing garden wall. A trellis allows planting to grow up and over to provide a similar level of privacy as currently enjoyed. Suitable planting will encourage biodiversity to the site.

- 2.6 The soil depth of up to 1.0m would be sufficient to allow any replacement trees into a mature specimen, resulting in no loss of bio-diversity. The image below provides an extract from the landscape proposal for the rear basement.

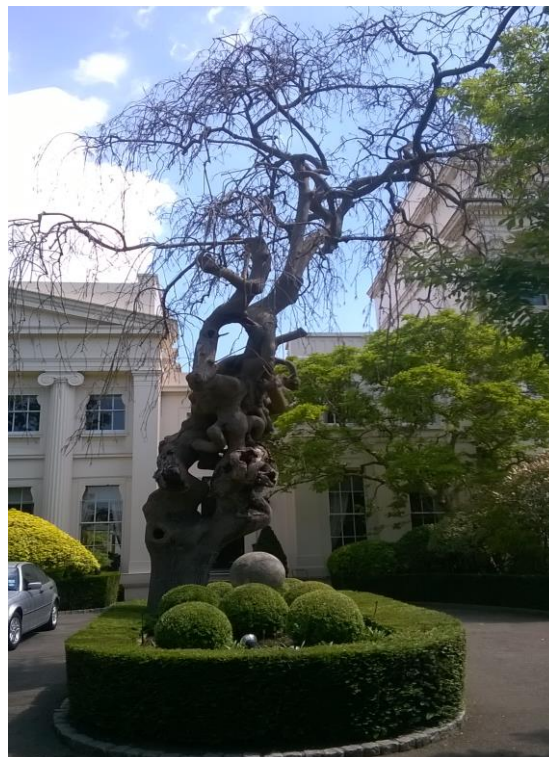
- 2.7 The proposed development provides an opportunity to replace the Weeping Ash located in the front garden (see image below)

This tree is a 'U' category tree and should be removed regardless of any development. The development provides an opportunity to replace this tree with a semi-mature, suitable specimen (exact species (to be agreed in advance with the LPA).
