Arboricultural Assessment & Method Statement
The Hall School, 23 Crossfield Road, London

Mark Wadey NDArb CUEW MArborA MICFor

11 November 2016
15204-AA-MW

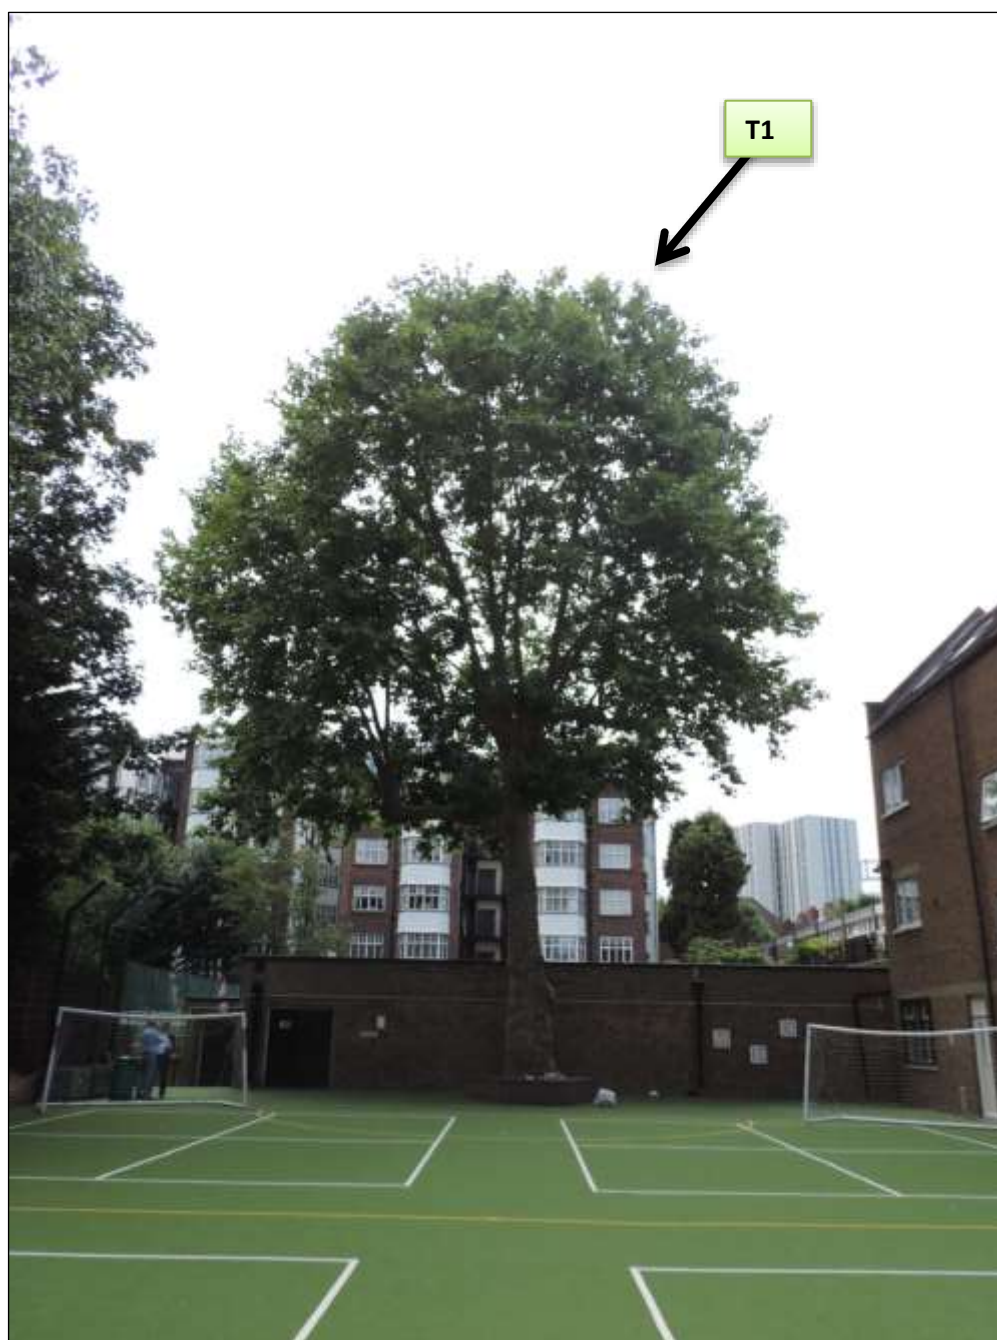
- 7.1 Rooting requirements of T1:** From the provided layout, one London Plane tree (T1 in Image 2) is close enough to be affected by the proposed basement development. Based on its measured stem diameter of 105cm it requires an RPA radius of 12.6m or an area of soil 499m². Whilst it is very difficult to establish exactly where tree roots grow, in many cases in London, we have found them growing vigorously at depth below hard surfaces or structures. Plane trees especially, have capacity to root deeply and often it is possible to find tree roots exploiting suitable areas of soil 2-3m below ground level. In that context, I would expect this tree to be rooting deeply in the surrounding area underneath the playground surface and up to the existing building walls.

Image 2: The London plane (T1) viewed from the northern end of the playground

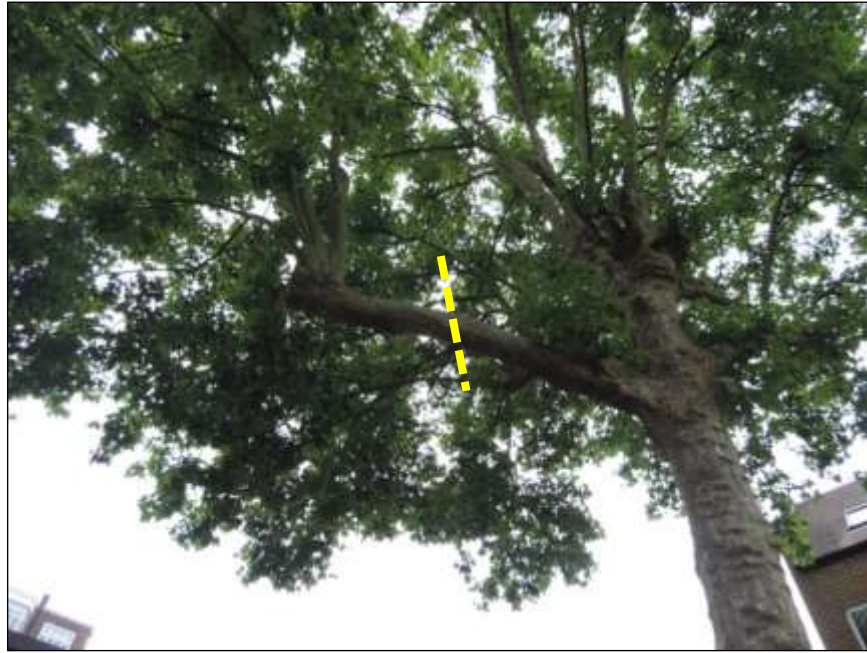
Image 3: The yellow dotted line indicates the approximate line agreed for pruning to accommodate the new building and staircase.

- 7.4 Impact from pruning to accommodate the proposal:** The proposed classrooms are close to the canopy of the tree so the crown will need to be contained on this side in the future. However, this tree has been regularly reduced in the past to leave multi-stemmed regrowth that currently extends 1-2m beyond the old pruning points (Image 5). If this regrowth is left unmanaged there is the potential for parts to fail as they increase in size, causing harm or damage to the property or children and teaching staff below. It is for this reason that approval was given in the past for the regrowth to be reduced back to contain the crown. Further pruning work was considered acceptable in principle by Mr Bell during our site meeting. On this basis, I believe that the crown can be regularly managed in the future and I do not believe the location of the tree or its canopy will adversely affect the normal use of the property.

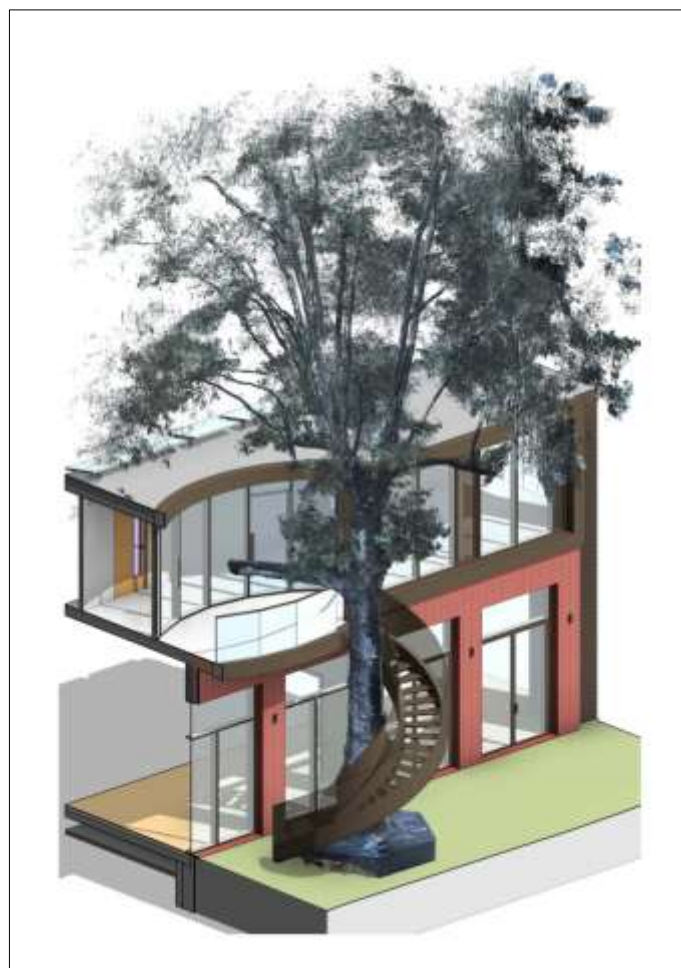
Image 4: Computer 3D model showing that the lowest branch can be cut back to provide space for the classrooms without adversely affecting the shape or health of the tree

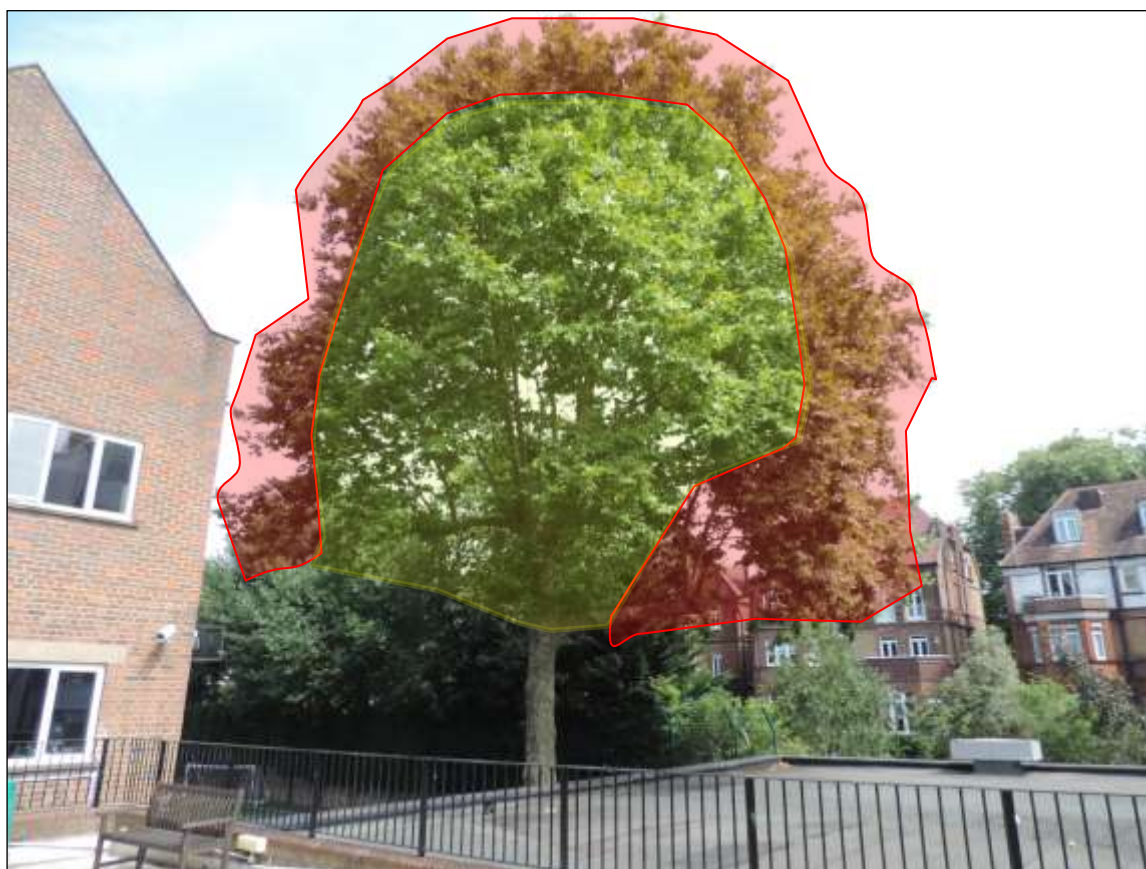
Image 5: The old reduction points are indicated by the yellow fill and this part of the crown will be retained. The red fill indicates the regrowth that will be reduced back to the old pruning points.

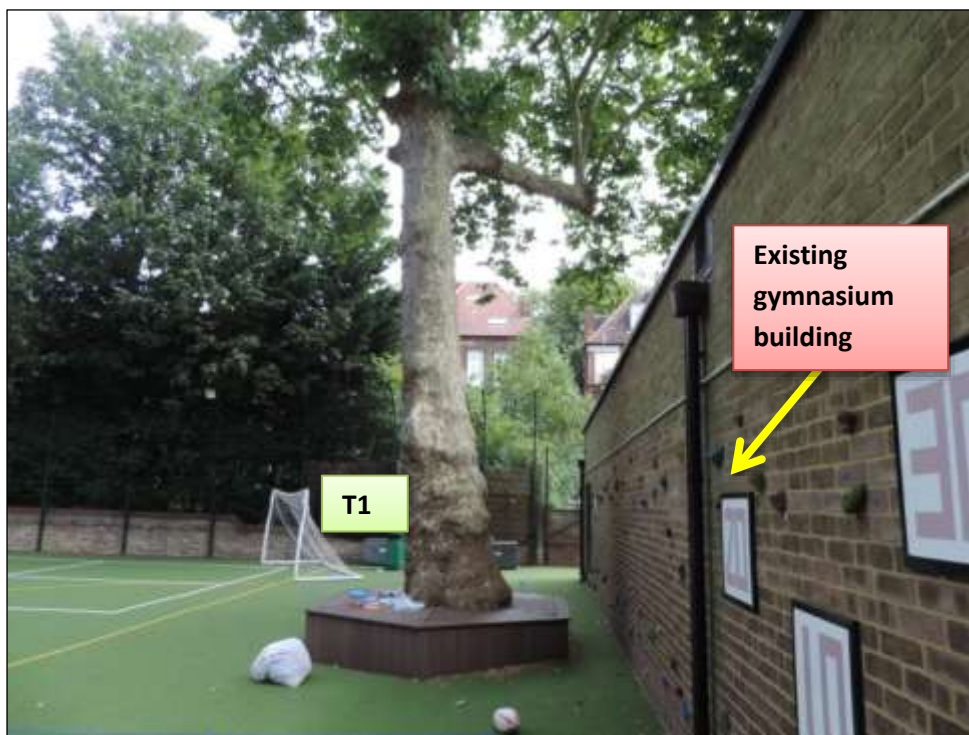
Image 6: The tree and existing building are close to T1.

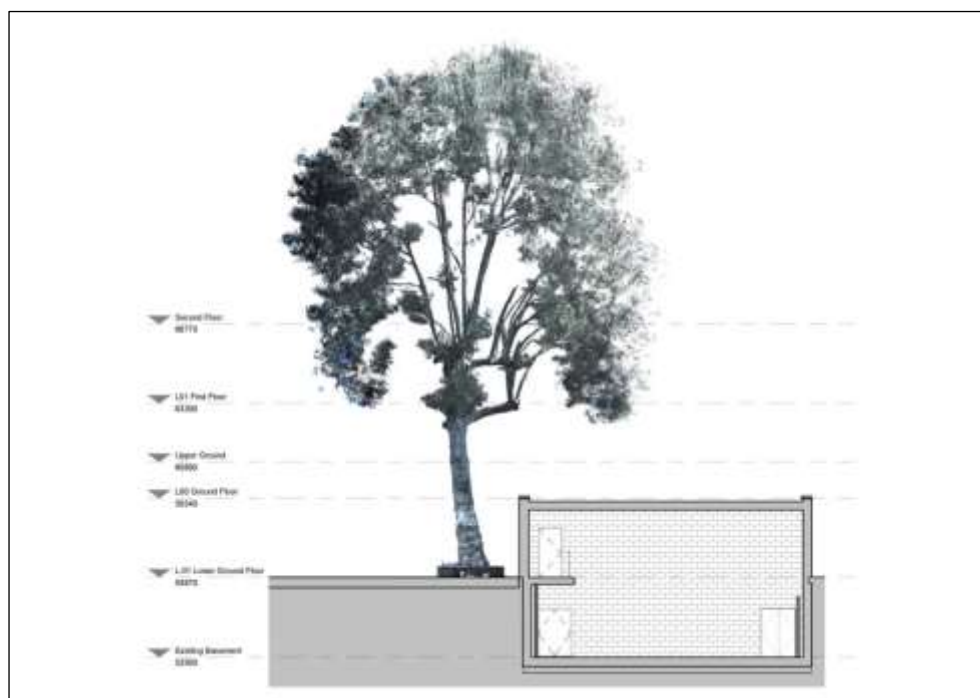
Image 7: Section showing the existing basement in relation to T1

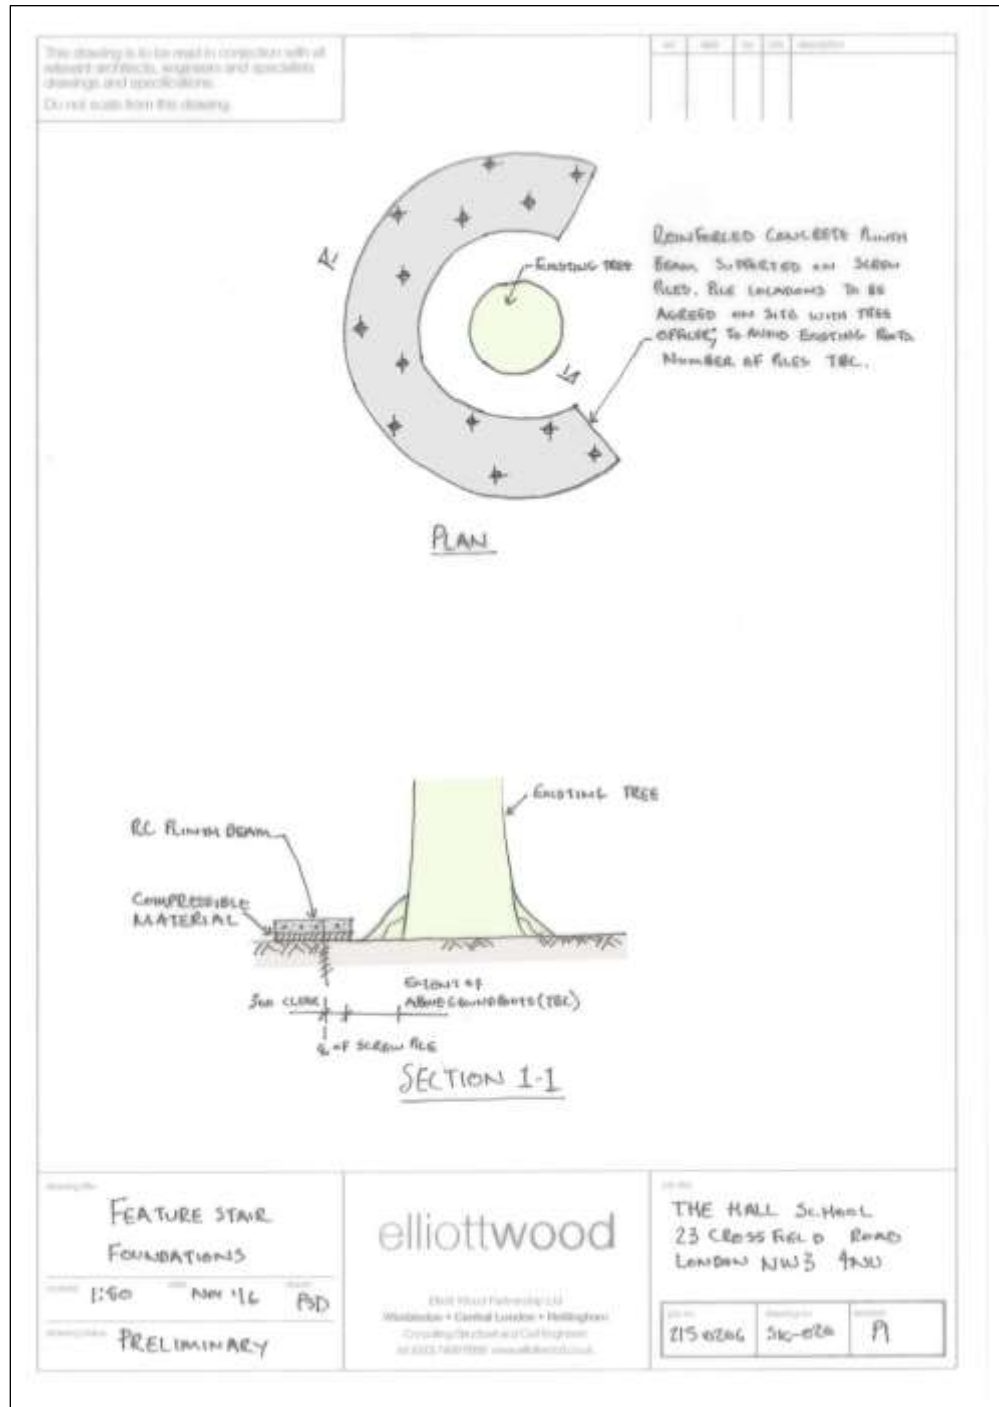
Image 8: Sketch provided by Elliottwood showing the proposed concrete base location and installation method

- 7.6 Impact from the installation of the stairs close to T1:** Based on discussions with the structural engineers, it has been agreed that the staircase will be constructed around the tree in a manner that minimises harm to tree roots. On this basis, it is proposed that the staircase framework will be supported by a concrete base which is installed with screw piles strategically located to avoid the main structural roots (Image 8). These will be installed after the timber seat has been taken down and the surrounding soil carefully removed by hand or with an airspade to reveal the main buttress root area without harm to the tree.
