PRE-DEVELOPMENT ARBORICULTURAL SURVEY

CAMDEN GOODSYARD, CAMDEN

Report No: RT-MME-122107-01 Rev D

Date: April 2016
Revised: November 2016

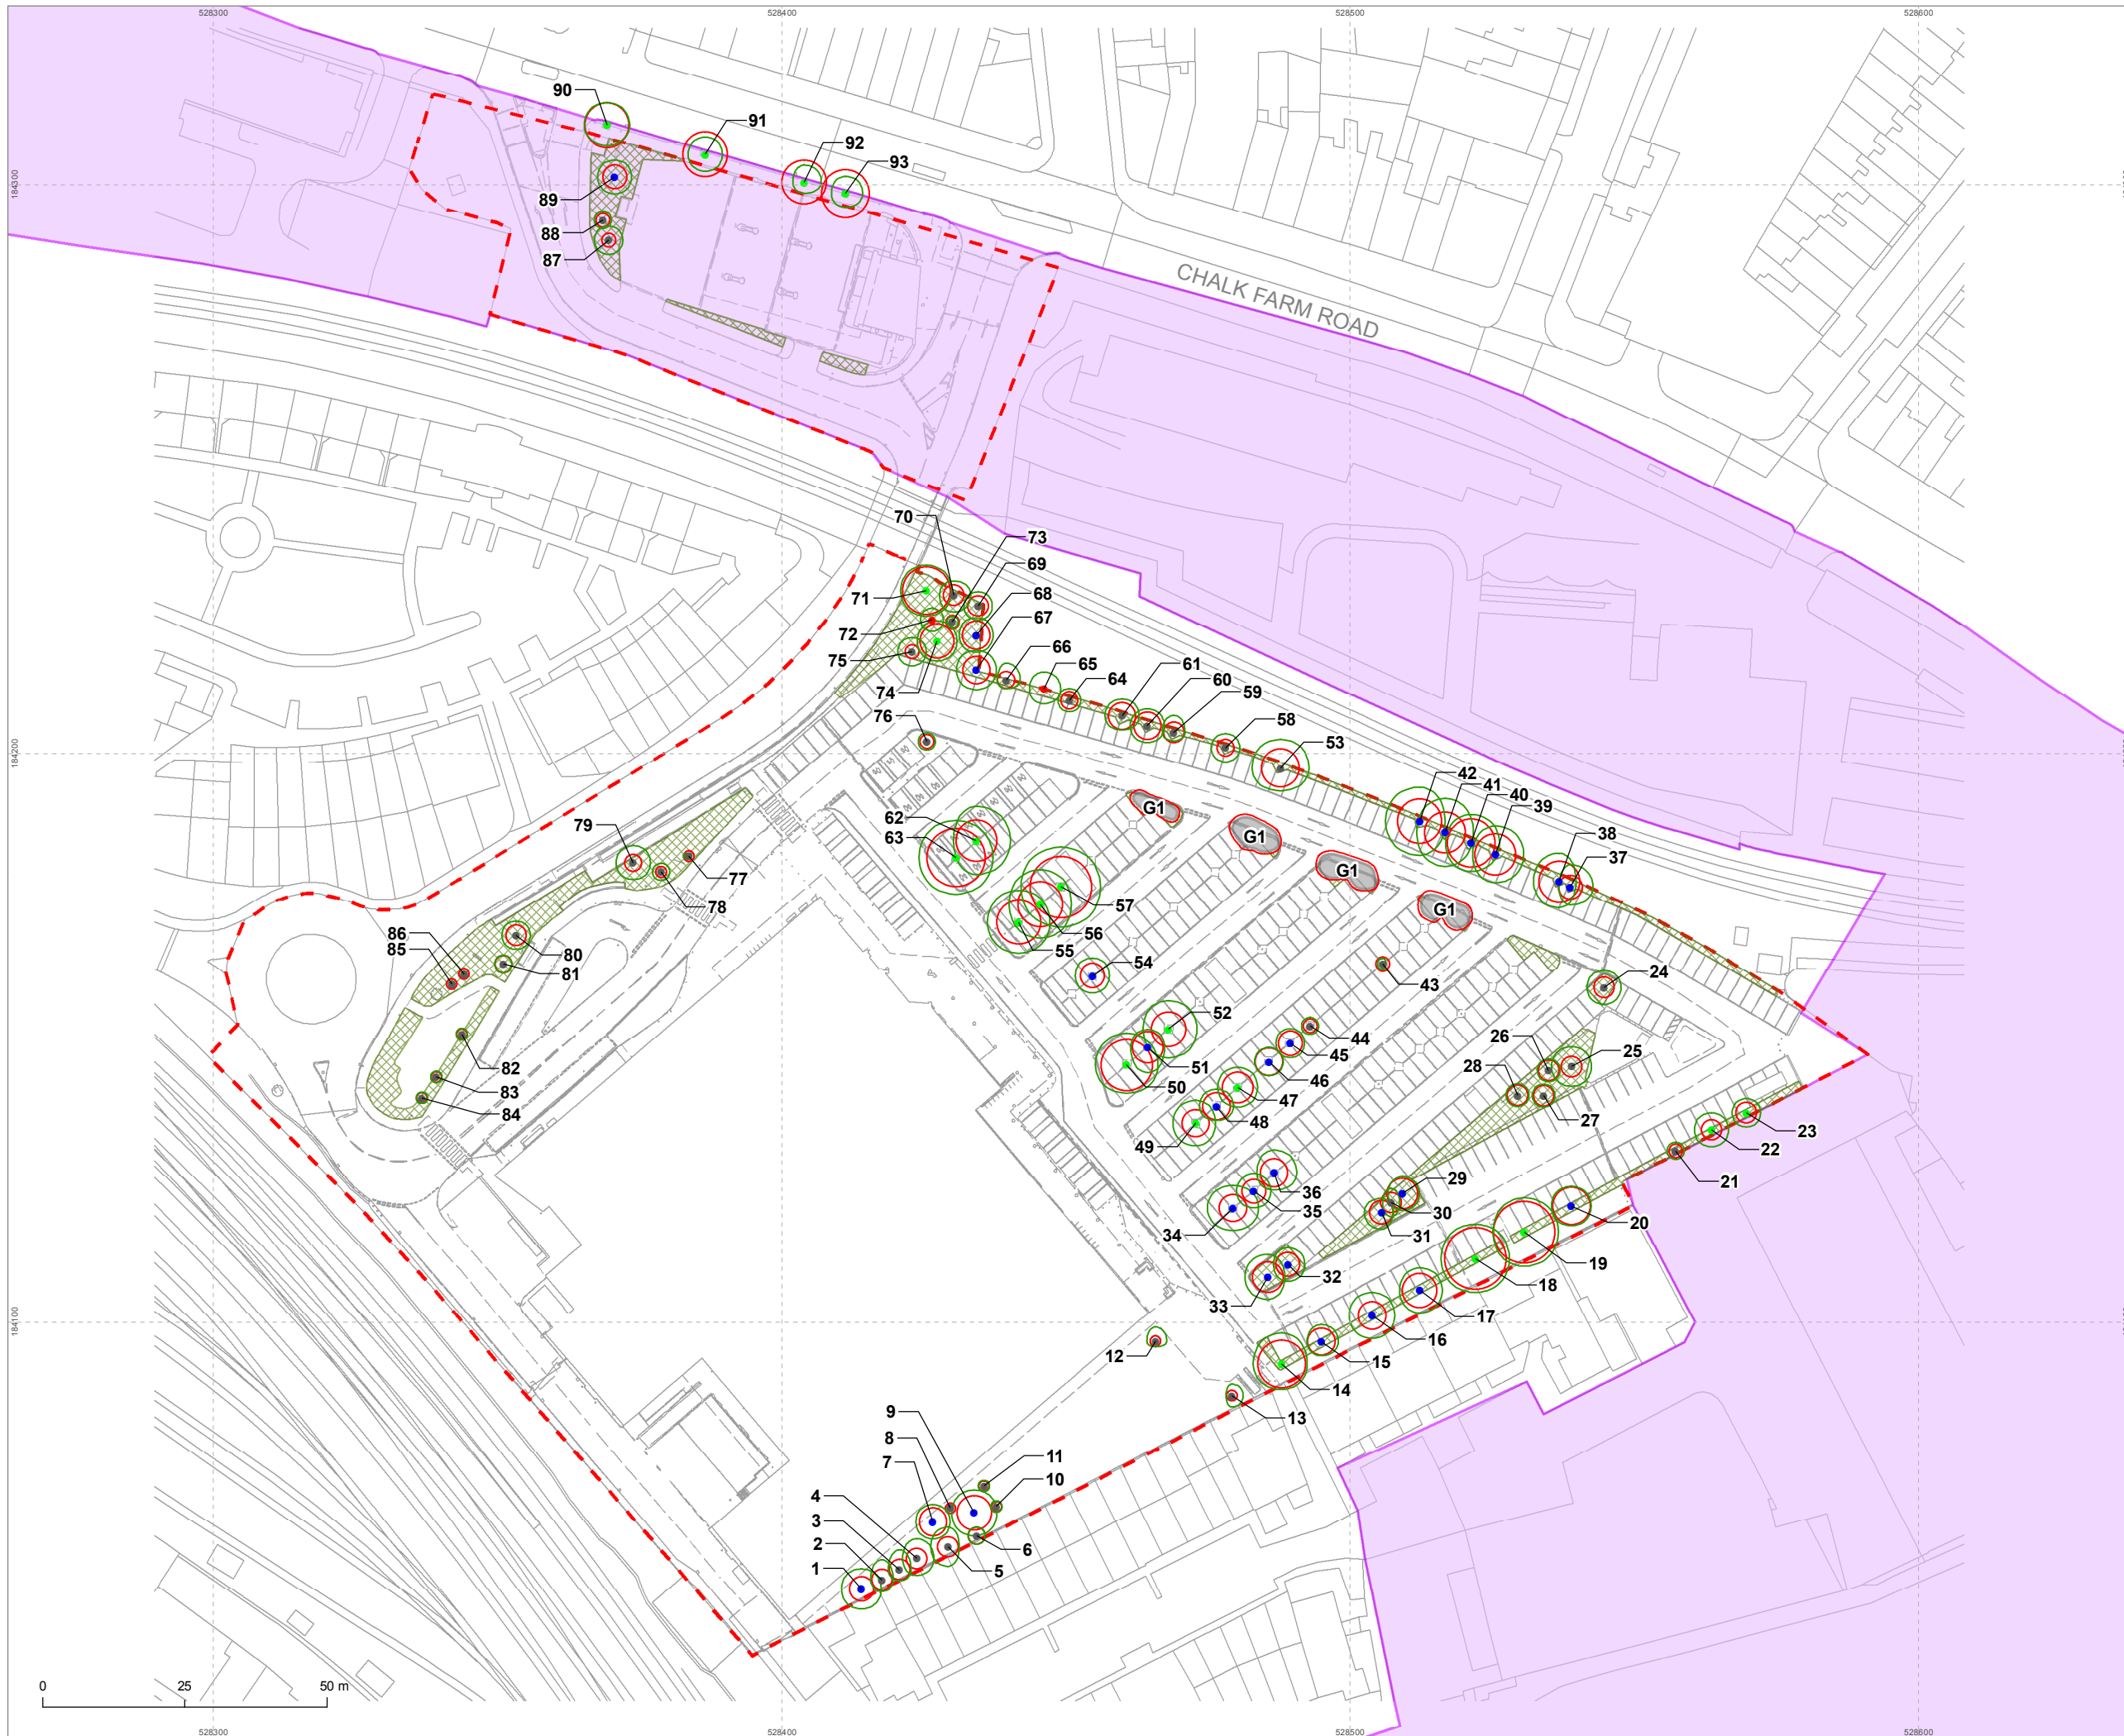
Project		Camden Goodyard, Camden	
Drawing		Tree Constraints Plan	
Client		Safeway Stores Limited and BDW Trading Limited	
Drawing Number	C122107-01-01_RevA	Revision	Rev A
Scale @ A3	1:1100	Date	June 2016
Approved By	BJ	Drawn By	AM

The Tree Constraints Plan (Drawing Number C122107-01-01 Rev B, contained within Section 7 of this report) is designed to show the influence that the trees have upon the site by virtue of their size and position. The plan seeks to act as a design tool that shows both the above and below ground constraints presented by the trees. The plan shows the initial RPA which may be modified dependent on site conditions.
