OMC Associates

BSi 5837 Tree Survey for Development

| SITE: | R/O 27 Leighton Road, London, NW5 |
| OUR REF: | 1073/CJO/2009 - Rev 1 |

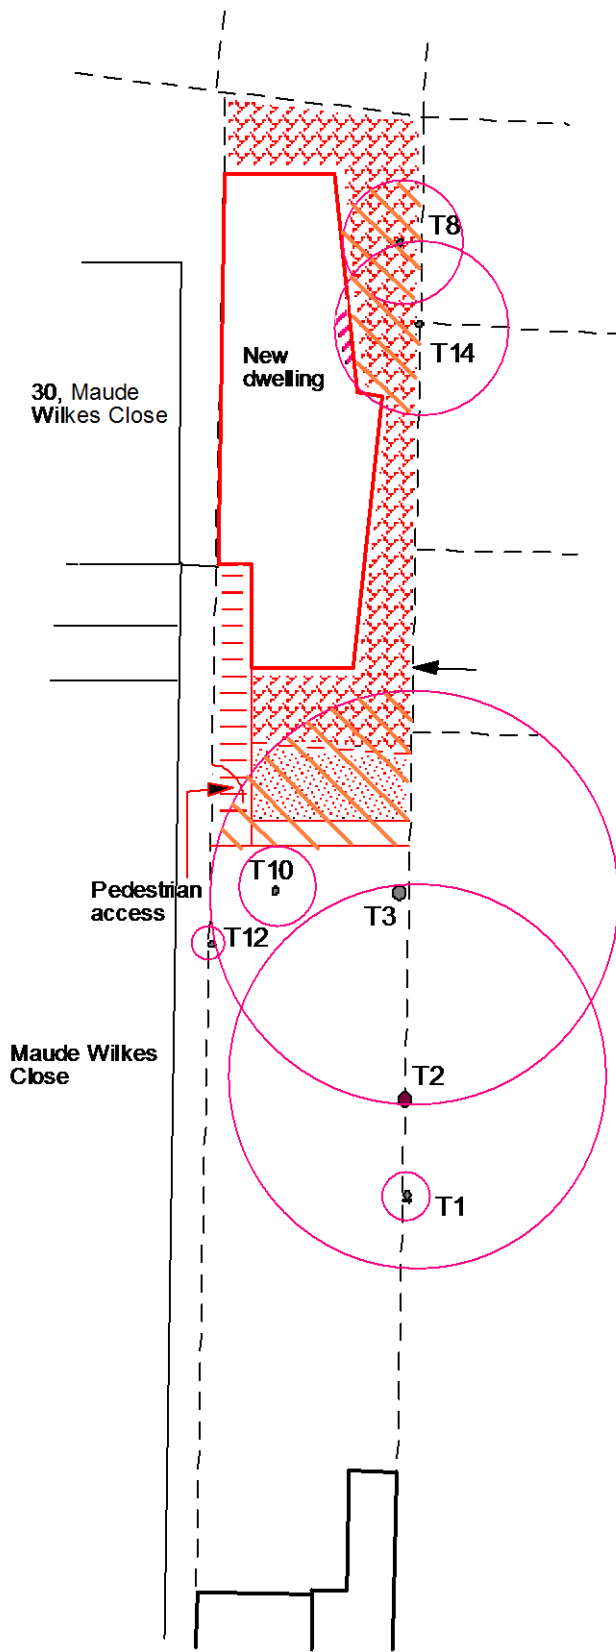
| Tree Constraints Plan | | |

On the basis of T8 & T14 being retained, the only impact of the development would be the incursion of the new hardstanding within their RPAs, which currently comprises open ground. In the case of T8 this represents 65% of the RPA and with T14, 40%. If not constructed appropriately this could give rise to damage types D3 & D6 described in Section 3.1. An encroachment of the proposed dwelling upon a peripheral section of T14's RPA is noted but this, at an estimated 6% of its RPA is deemed negligible, particularly in view of the vitality of the tree. This is illustrated in the TCP in Appendix 2.

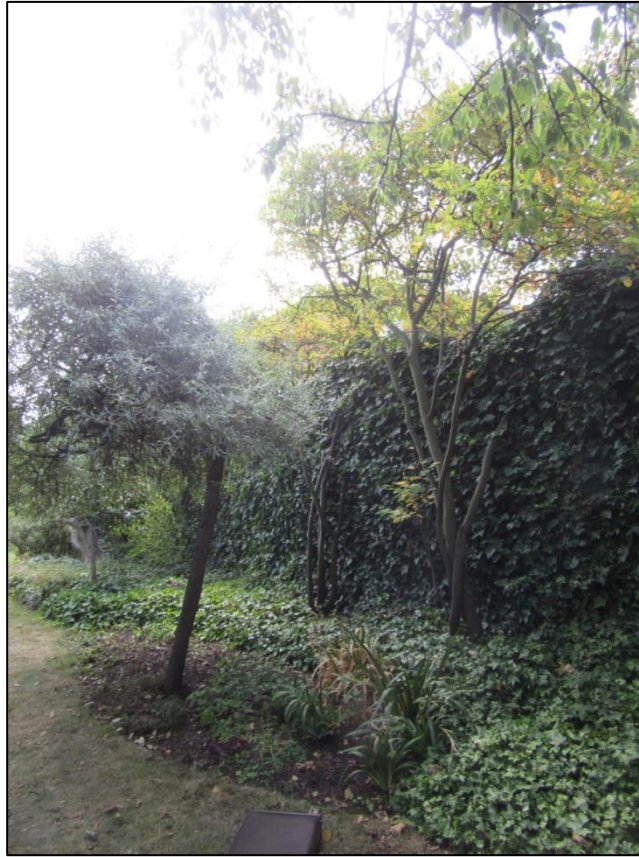
T10-T12

| TREE NO. | SPECIES | HEIGHT (m) | DIA. AT 1.5M (MM) | CROWN RADIUS (m) N S E W | AGE CLASS | SULE | CONDITION STRUCTURAL | CONDITION PHYSIOLOGICAL | QUALITY CATEGORY | TREE-WORK | SPACE BELOW CROWN | RPA RADIUS (M) | COMMENTS |
|---|---|---|---|---|---|---|---|---|---|---|---|---|---|
| T10 | <i>Pyrus salicifolia</i> Pendula Ornamental pear | 3 | 110 | 1 3 1 0.5 | M | 20-40 | Good | Fair | C2 | N | Y | 1.3 | Small, asymmetric specimen |
| T11 | <i>Amelanchier laevis</i> Snowy Mespil | 3.5 | 130 | 2.5 2 1 2.5 | M | 20-40 | Good | Good | C2 | RA | - | 0.7 | Established, small specimen in good health |
| T12 | <i>Amelanchier laevis</i> Snowy Mespil | 3 | 100 | 1 2.5 0 1.5 | M | 20-40 | Good | Good | C2 | N | N/A | 0.5 | Established, small specimen in good health |

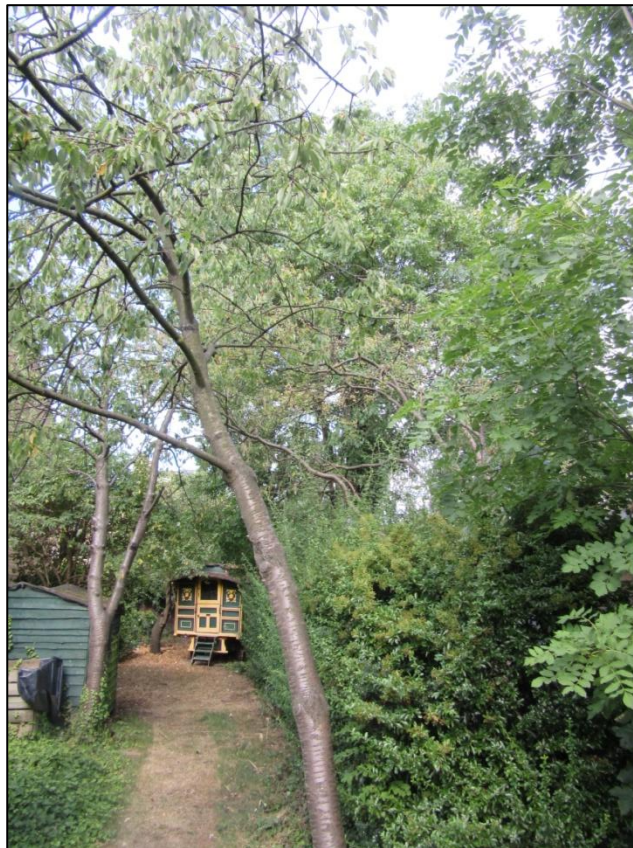
| TREE NO. | SPECIES | HEIGHT (m) | DIA. AT 1.5M (MM) | CROWN RADIUS (m) N S E W | AGE CLASS | SULE | CONDITION STRUCTURAL | CONDITION PHYSIOLOGICAL | QUALITY CATEGORY | TREE-WORK | SPACE BELOW CROWN | RPA RADIUS (M) | COMMENTS |
|---|---|---|---|---|---|---|---|---|---|---|---|---|---|
| T4 | <i>Prunus cerasus</i> Sour Cherry | 5 | 180 | 4 3 1 3 | M | >40 | Good | Fair | C2 | RA | - | 2.1 | Small, established tree |

Eastern boundary looking north, T4 in foreground

The footprint of the proposed dwelling necessitates the removal of trees U grade tree T5 and small C grade trees T6, T7 & T9. The layout requires removal of the small, C grade trees T4 & T11. Though the scheme could accommodate these two trees, the stress they may suffer and constraints posed by retention of such indifferent trees is unjustifiable. In totality, the schemes requires removal of five C grade trees and one U grade tee. None are of any notable landscape value but provision is allowed for replacement planting in the landscape scheme.
