# 125 DOC B5 Heritage Statement & Impact Assessment

39 Great James Street, London, WC1 N Rev B - November 2016

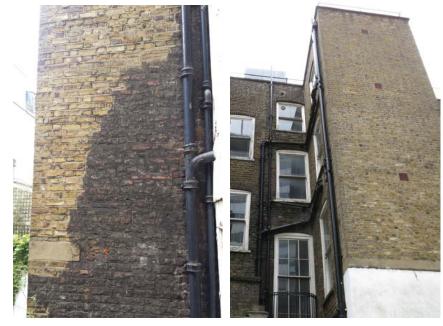
Despite no recorded bomb damage to No.39, it is clear that much of the closet wing to the rear has been re-built in London stock bricks.

Fig.3q No. 39 - Side of closet wing. with lintel above ground floor.

Fig.3r No. 39 - Rear of closet wing, with lintel above ground floor.

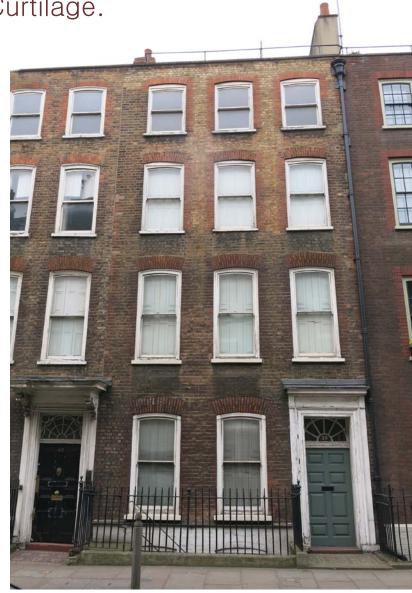
The brickwork is discoloured, but in fair condition. Noted by Historic England as brown brick, No.39 (and no.40) appear in fact to be London stocks. The window heads are finished with arched reds. The mortar joints across the whole facade have been poorly re-pointed with stuck cement. Originally the brickwork would

Fig.4c Front elevation of the property.

- Repair all brickwork, as required. On front elevation, rake out sand cement mortar and re-point with lime mortar and tuck pointing. On rear elevation patch point as required.

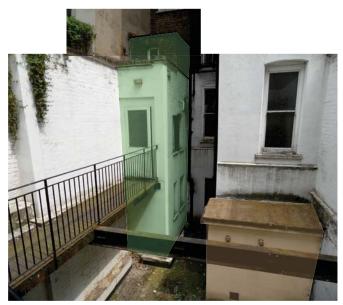
Fig.4h Rear elevation showing WC and plant room extension.

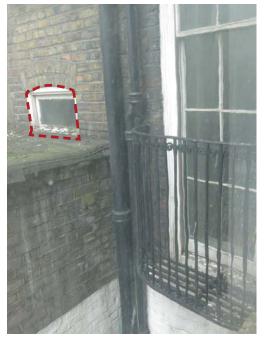
Fig.4g Window shortened to allow WC extension.

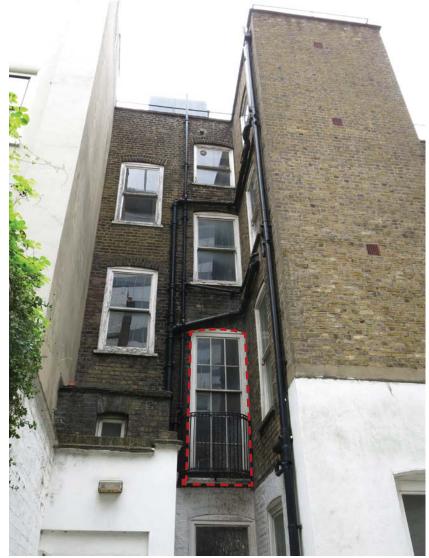
Fig.4h Window lengthened in the Regency period.

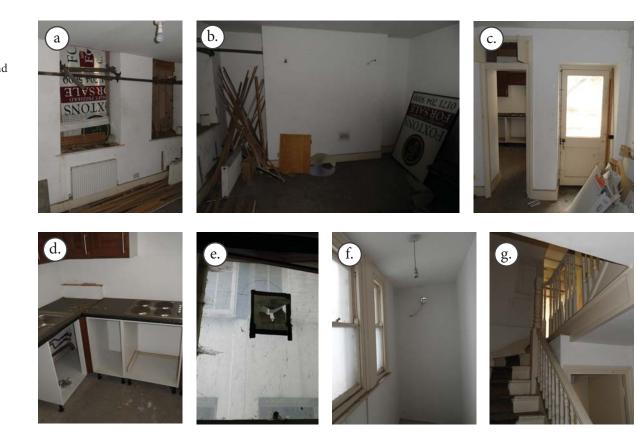
Basement Floor

- a. Boarded window in front room
- b. Bricked over chimney.
- c. Narrow entrance to closet extension and
- modern exit to garden.
- d. Kitchenette
- e. Sash window in poor condition. f. Long narrow WC extension g. Modern stair to ground floor.

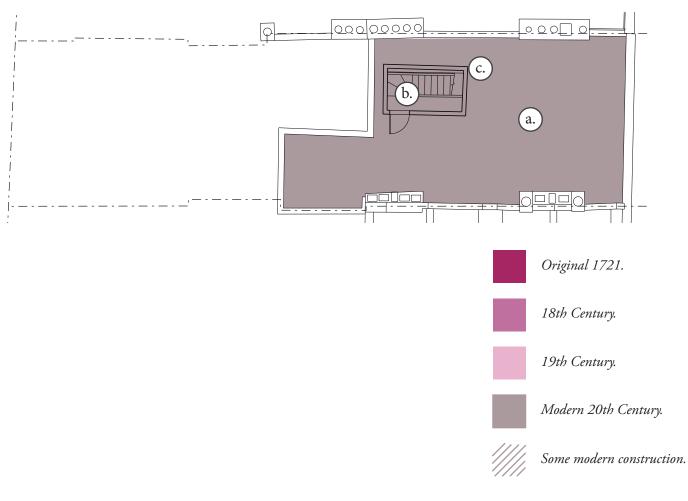
The flat roof is covered in a grey painted bituminous material. This is in poor condition and leaking in through to the ceiling below at the junction with the party walls.

a. New roof to replace original double pitched roof - as found at Number 40 Great James Street - built in 1960s.
b. Modern stair to roof built in 1960s.
c. Access structure built in 1960s.
