# *OMC Associates*

BSi 5837 Arboricultural Report for Development

CLIENT:	Mr Maisel
CONTACT:	Mr Maisel
SITE:	8 Nutley Terrace, London NW3 5SY
OUR REF:	1107
DATE OF REPORT:	6 December 2016

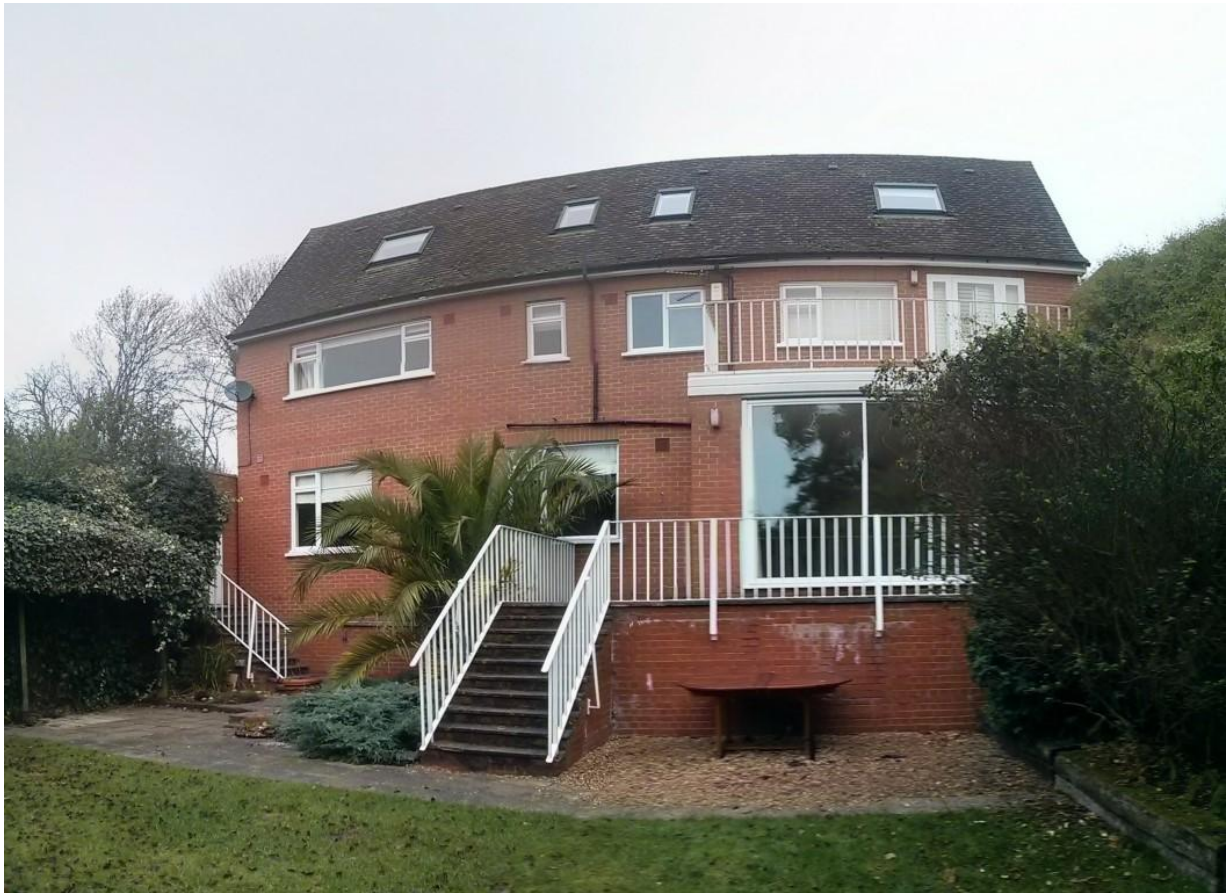
**Above:** Rear of property with date palm proposed for removal

Extension of the southern (rear) extent of the property will require the removal of the date palm and fastigate yew in close proximity to the existing rear wall of the house. Both trees are inconspicuous and could easily be replaced. The palm is also of a species that is somewhat out of keeping with the character of the local area and its removal could provide the opportunity to plant a replacement better suited to the local setting. If the local planning authority is minded to accept the removal of these trees, their replacement with trees of a suitable size for the location and species better suited to the character of the local landscape is strongly encouraged and should form an integral part of any proposal, in the form of a detailed soft landscaping scheme.

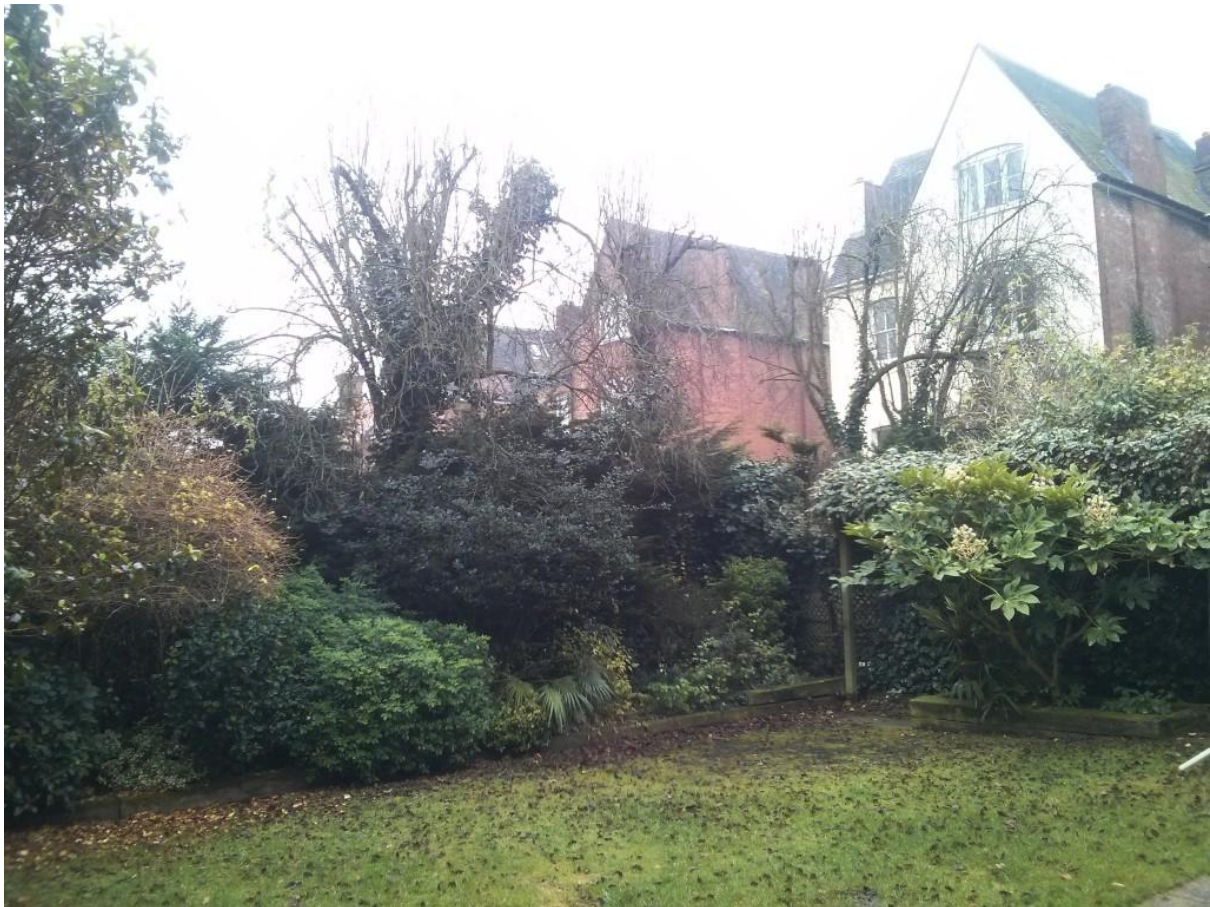
**Below:** Rear garden with T1 – T3 & H1

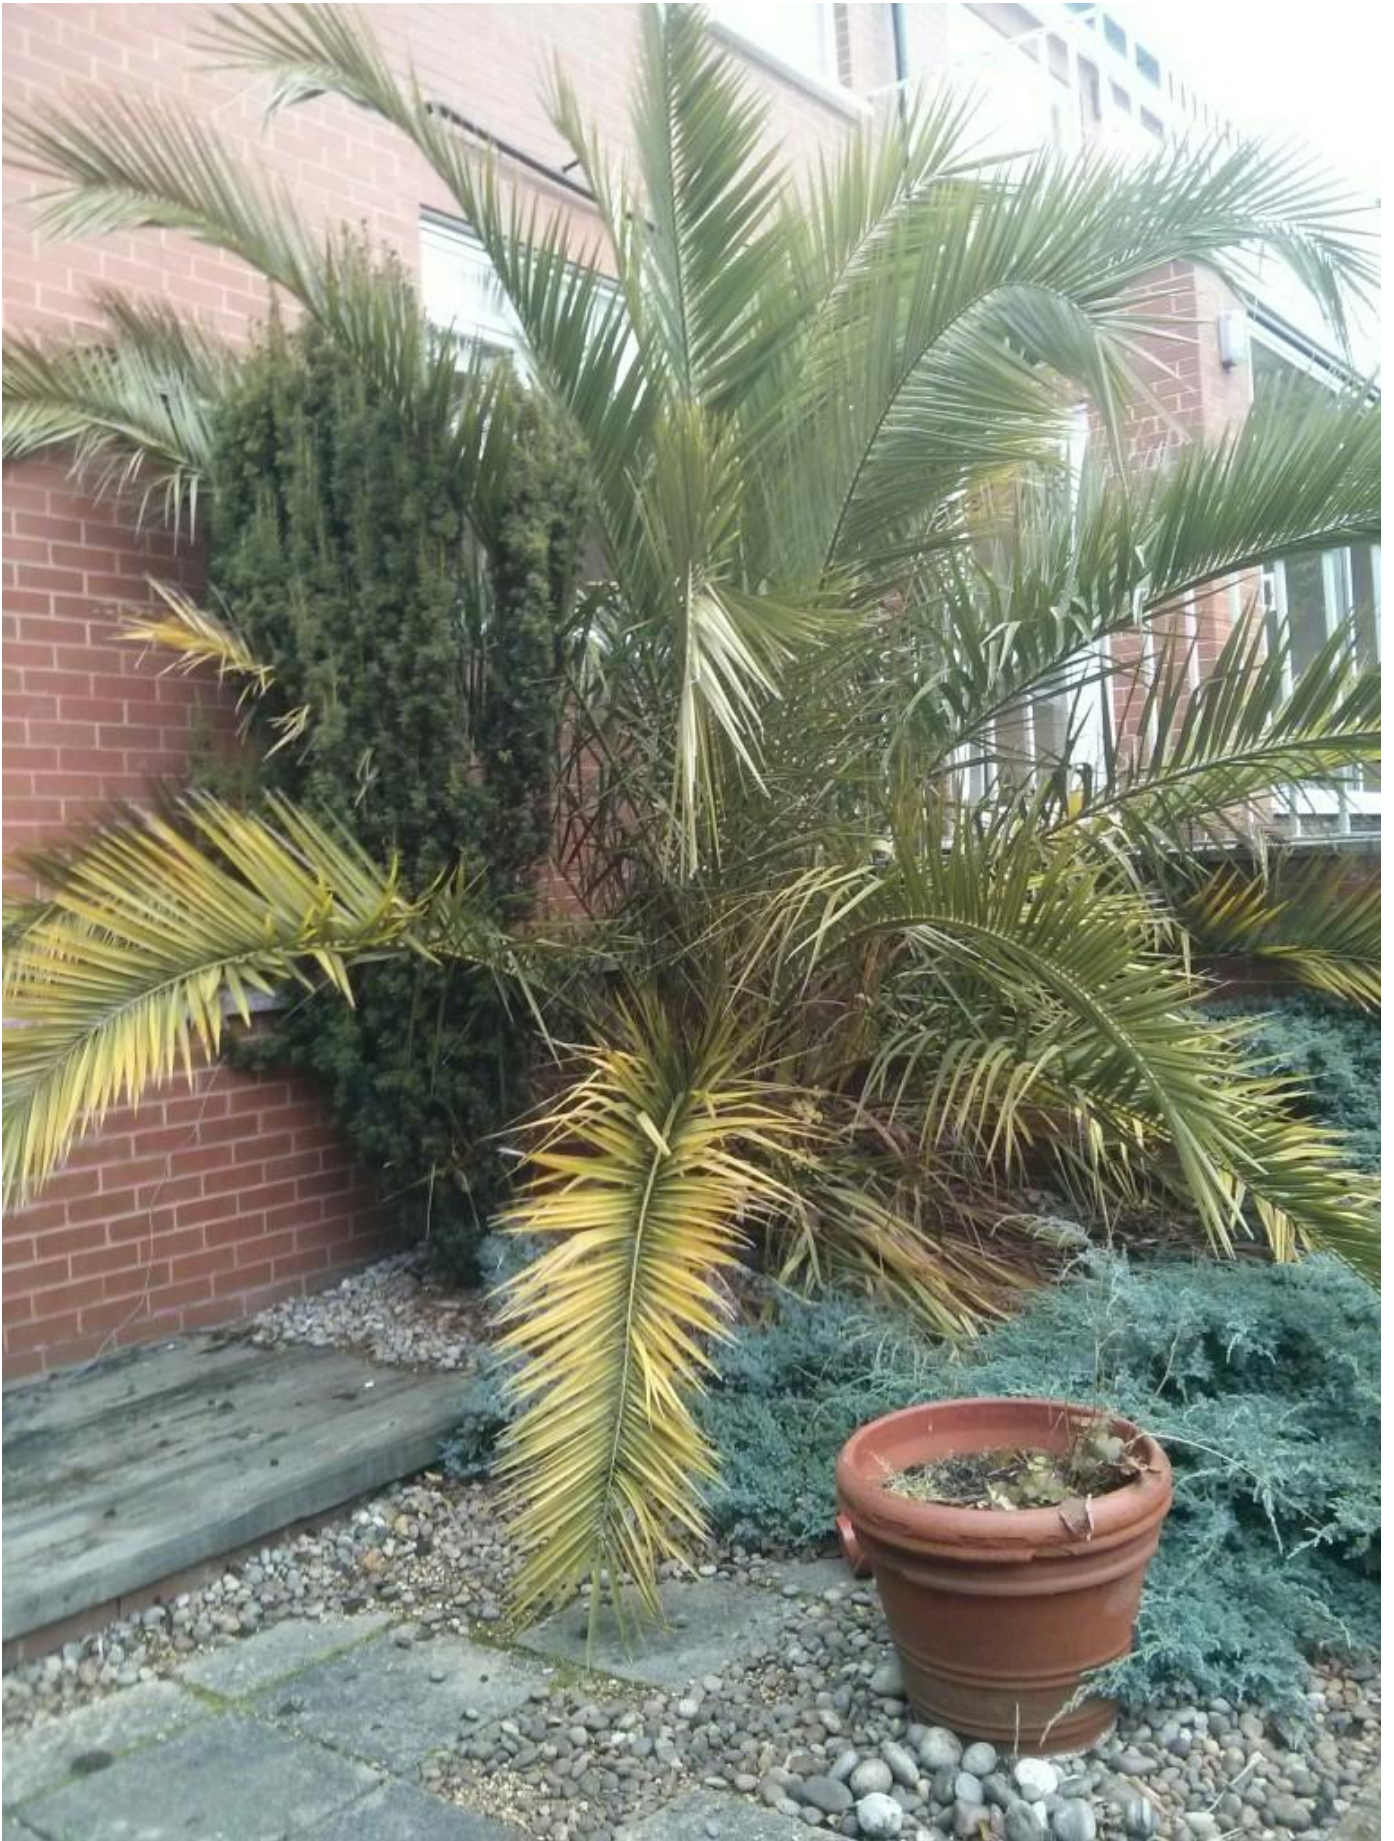
A small date palm and fastigate yew exist in very close proximity to the rear wall of the house. According to British Standard criteria the yew is below the minimum stem diameter to qualify for assessment; the palm is also young and of little amenity value. The southern and eastern borders of the rear garden are densely vegetated with mature woody shrubs and herbaceous plants; a single young holly (T3) exists roughly central within the border on the southern boundary. Two purple-leafed plum trees (T1 and T2) exist in very close proximity to the southern boundary in the neighbouring garden to the rear (28 Maresfield Gardens); both trees are of average general form for their species and have been heavily reduced. A relatively young Leyland cypress hedge comprising 9 trees also exists on the southern boundary in the neighbouring garden; this has also been subject to moderate reduction and appears to be regularly maintained at reduced dimensions. Although unremarkable, the trees have moderate screening value between properties.

**Above:** Date palm and fastigiate yew

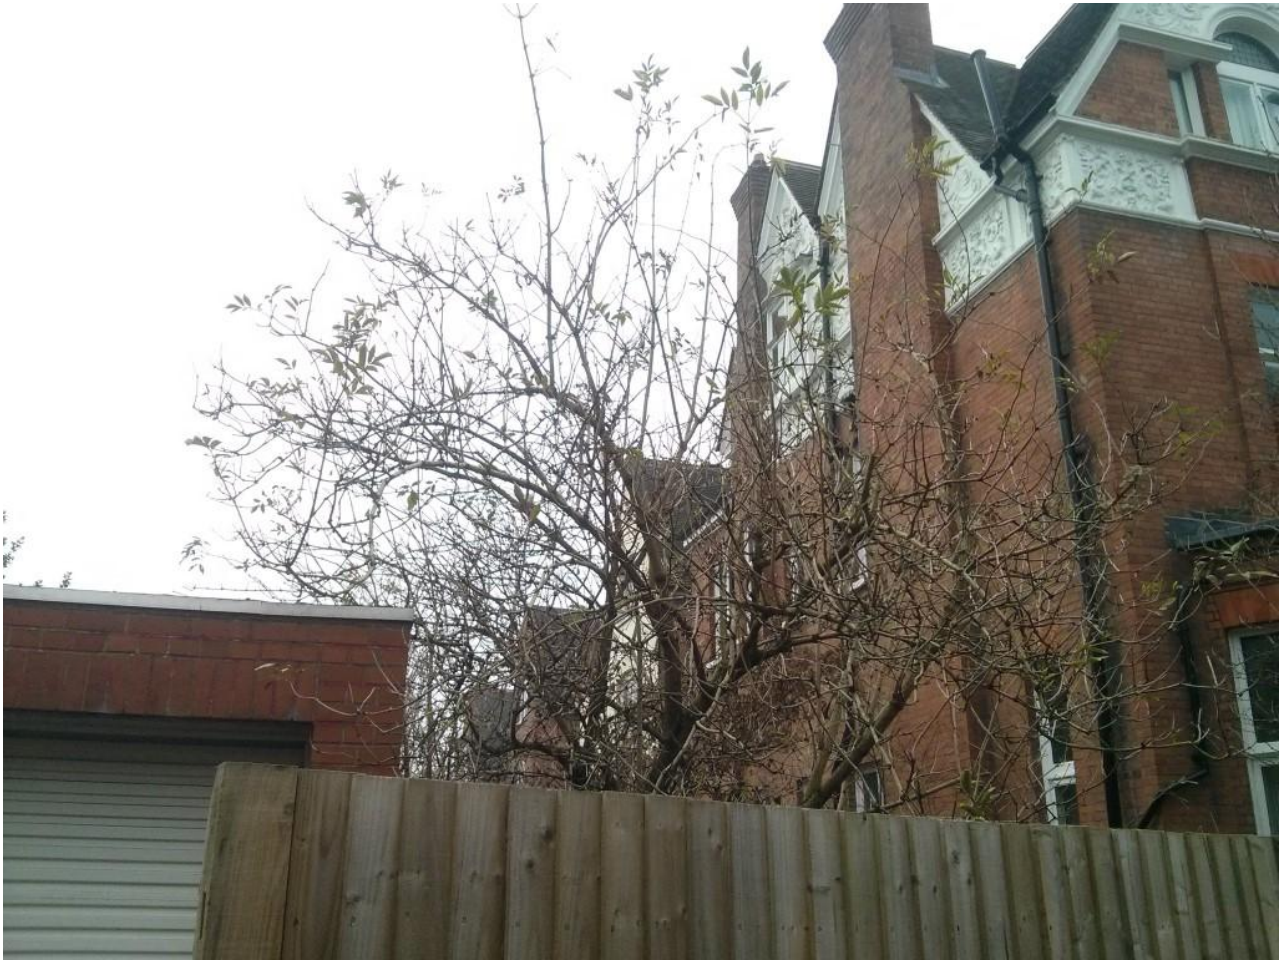
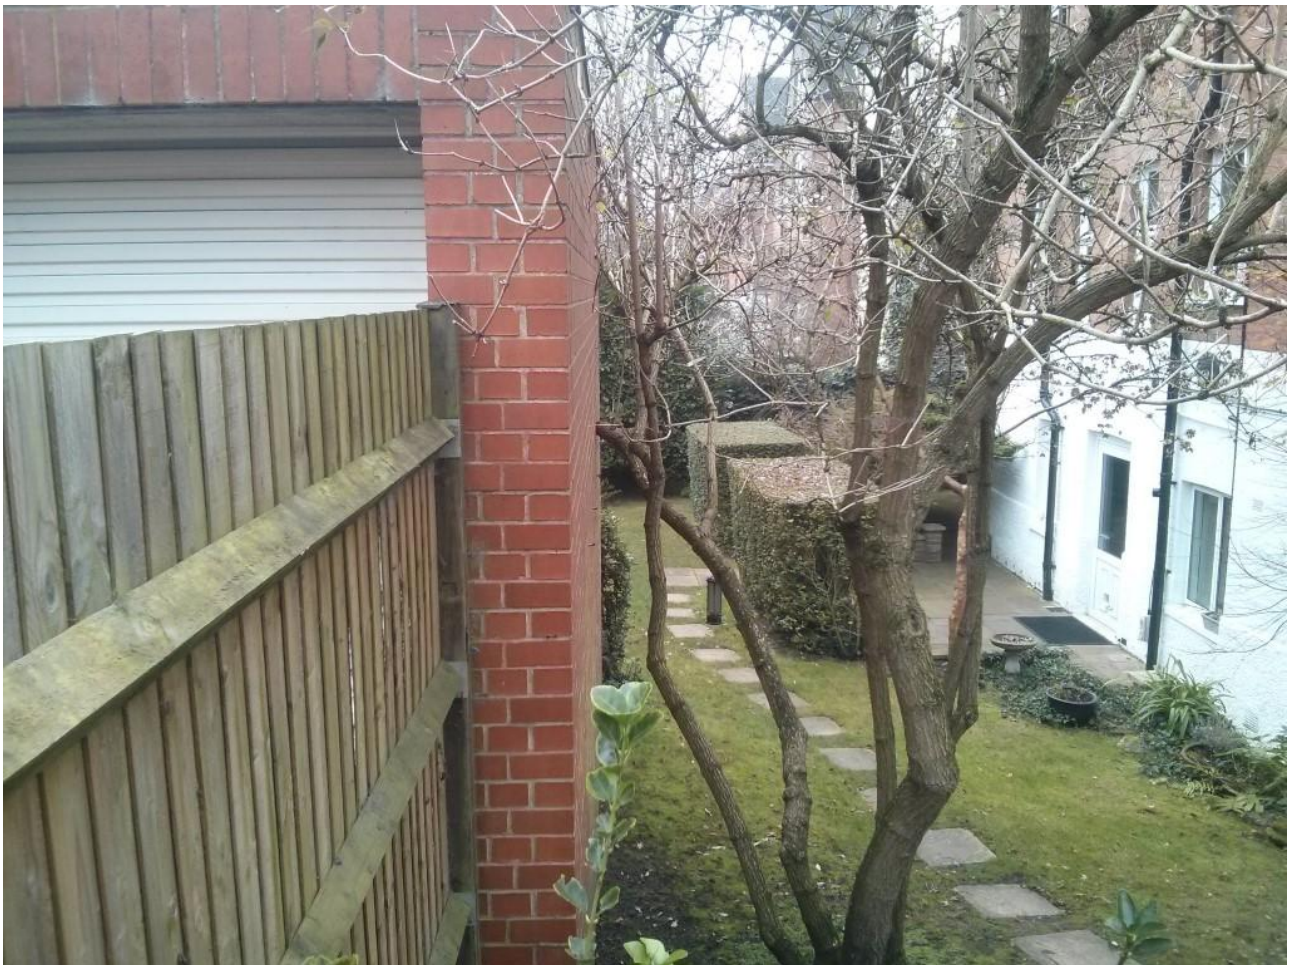
Where the crowns/canopies of trees to be retained overhang a development site, careful assessment of the implications must be made in order to avoid damage to stems and branches. Given the close proximity of T5 to the garage, some minor pruning of its eastern lateral crown (1 metre) will be necessary to create working space.

**Above / below:** T5 in neighbouring rear garden to west of garage

Vertical extension of the existing garage will necessitate some minor pruning of T5 to allow space for construction. Given the tree's location on neighbouring land, its owner should be informed of this work prior to its commencement. The owner's permission will also be necessary if the work necessitates access within the neighbouring garden. Protection of the tree's crown will also be necessary during construction to prevent damage from falling debris or spattering with wet materials e.g. render, cement or paint.

Given the close proximity of T5 to the flank wall of the garage, protection in the form of heavy gauge netting e.g. polyethylene scaffold debris netting will be suspended on scaffold poles over the tree to protect it from falling debris or being spattered with wet products such as cement / render / paint etc. If scaffold is to be erected over the tree it will be constructed in such a way to accommodate the tree's structure – boards supported by the scaffold framework will also constitute adequate protection.
