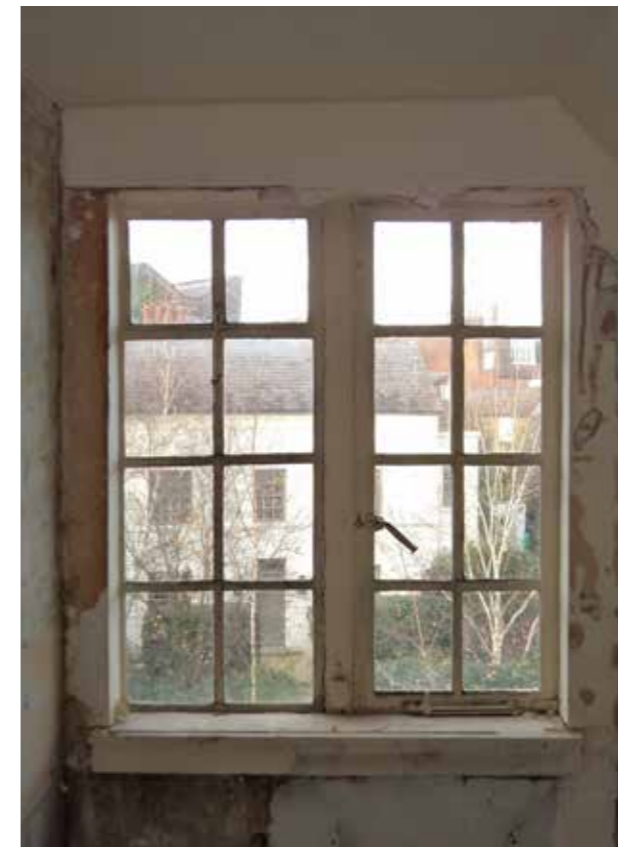
Existing casement window WSF-12

- WSF-12. This window is to be replaced with a sash window to match existing profiles and the other windows on the facade. (The previous consent is for it to be blocked in).

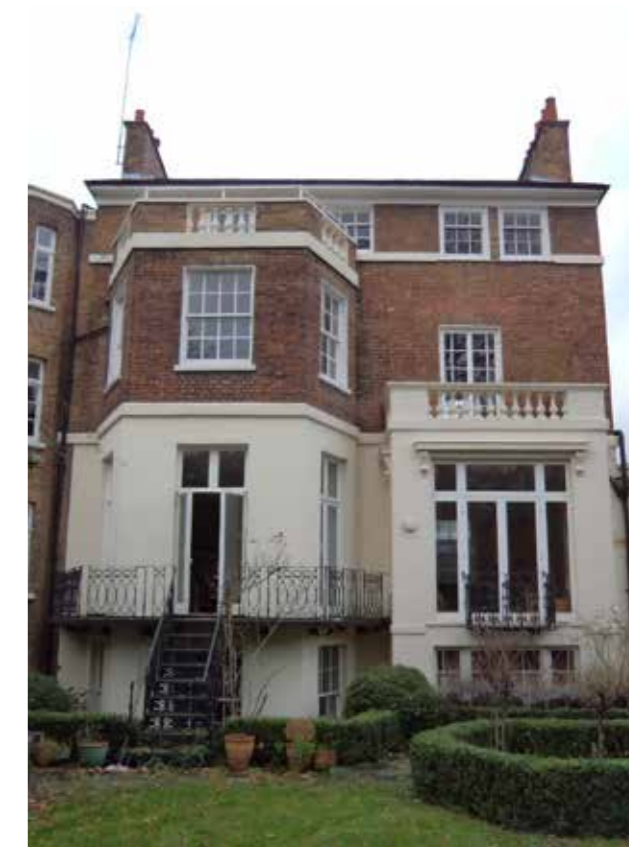
Existing window WSF-05, just visible at top right corner of bay, proposed to be realigned

- WSF-04 & WSF-05. Reconfigured to balance with each other, and be centred around the terrace door. Both will match the existing WSF-06 & WSF-07 in size and detailing.

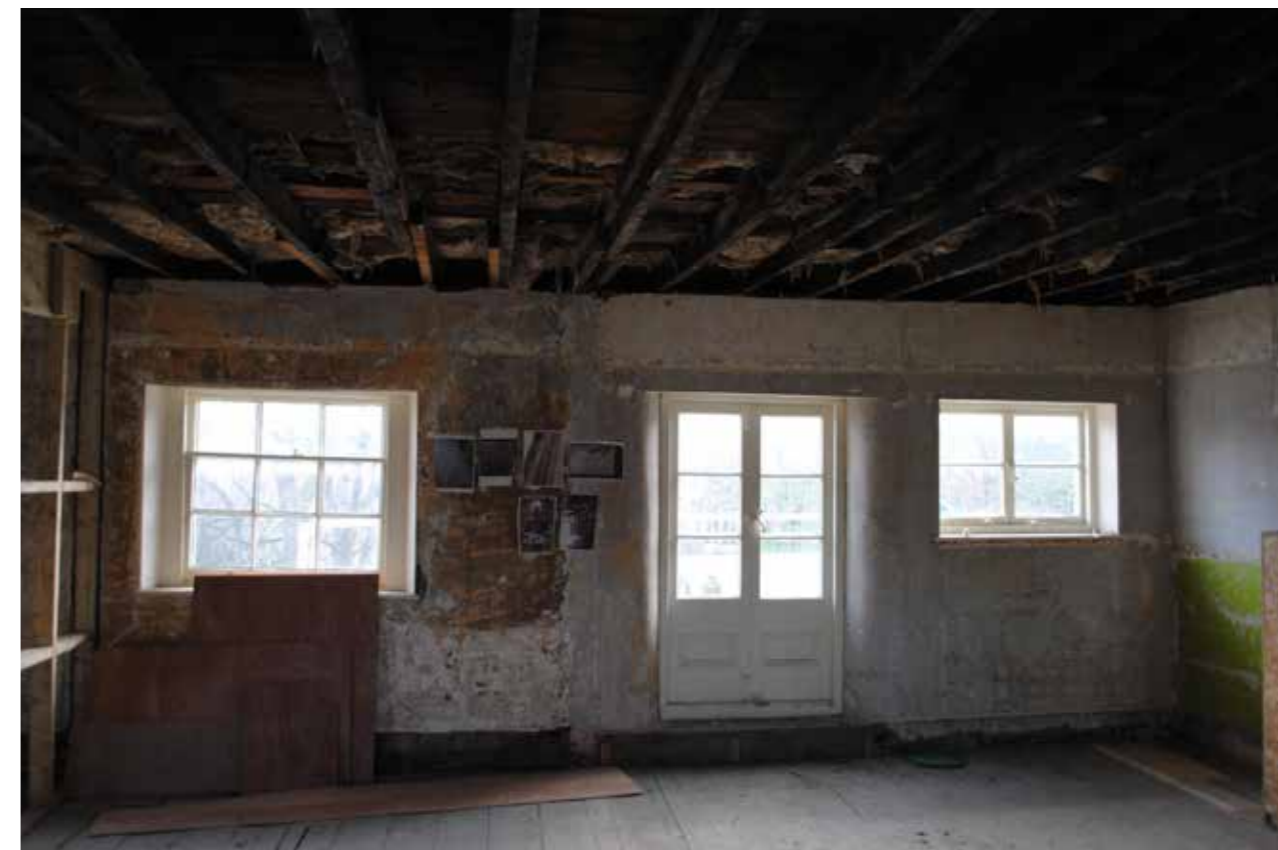
Existing window WSF-05 (left) & WSF-04 (right), proposed to be realigned to balance with each other, and be centred around the terrace door

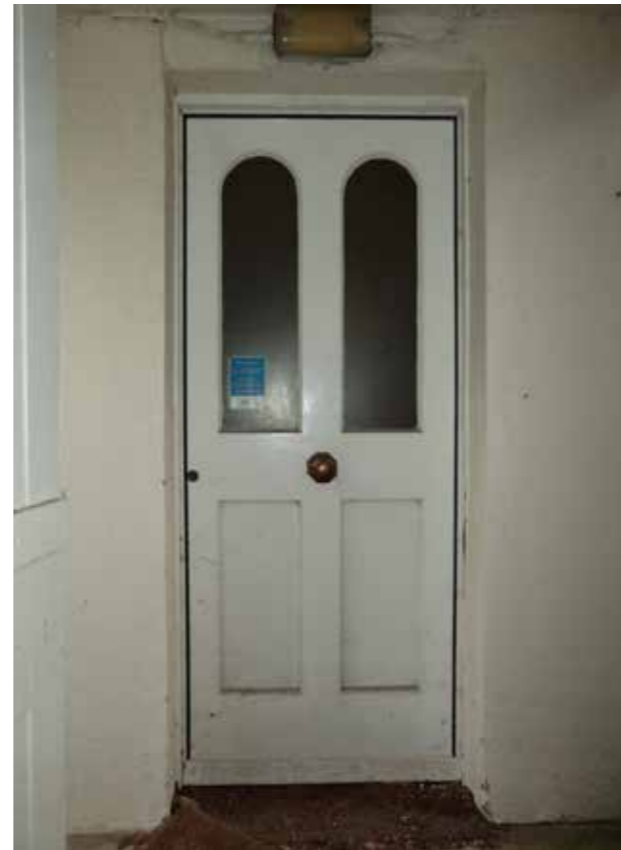
Existing door DLGF-07

- DLGF-01, 07 and 10 will be replaced with 4-panel doors traditional to the period of the building, with an increase in height where necessary, to suit the new lower ground floor level.

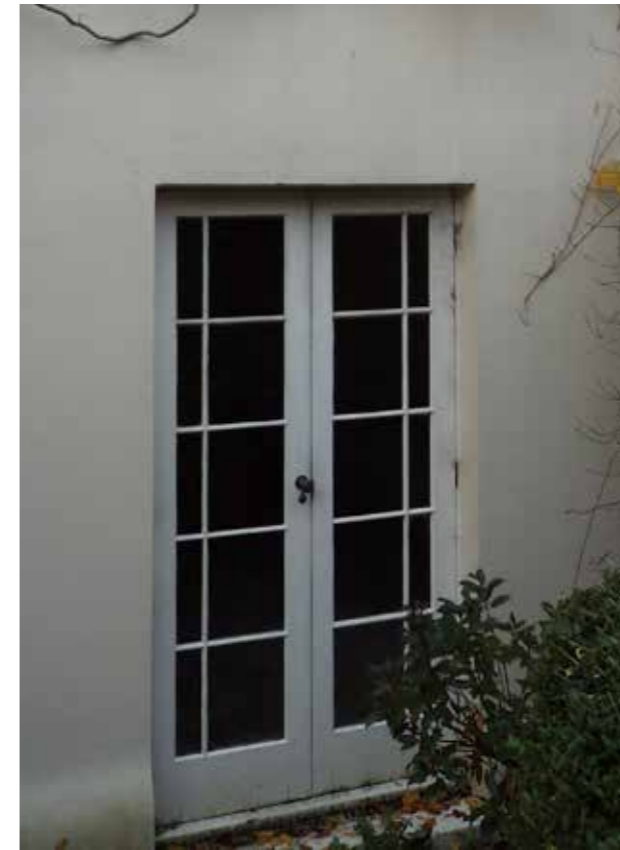
Existing door DLGF-09

- DLGF-09 will be replaced like for like, but increased in height to suit the new LGF level and with laminated glass.
- DLGF-21 & 22 are still to be replaced, as previously consented, but the doors approved are the wrong proportion for these openings. This application proposes to replace them with smaller panelled double doors, that are more in keeping with the building, and existing doors seen to the balcony on the GF above.

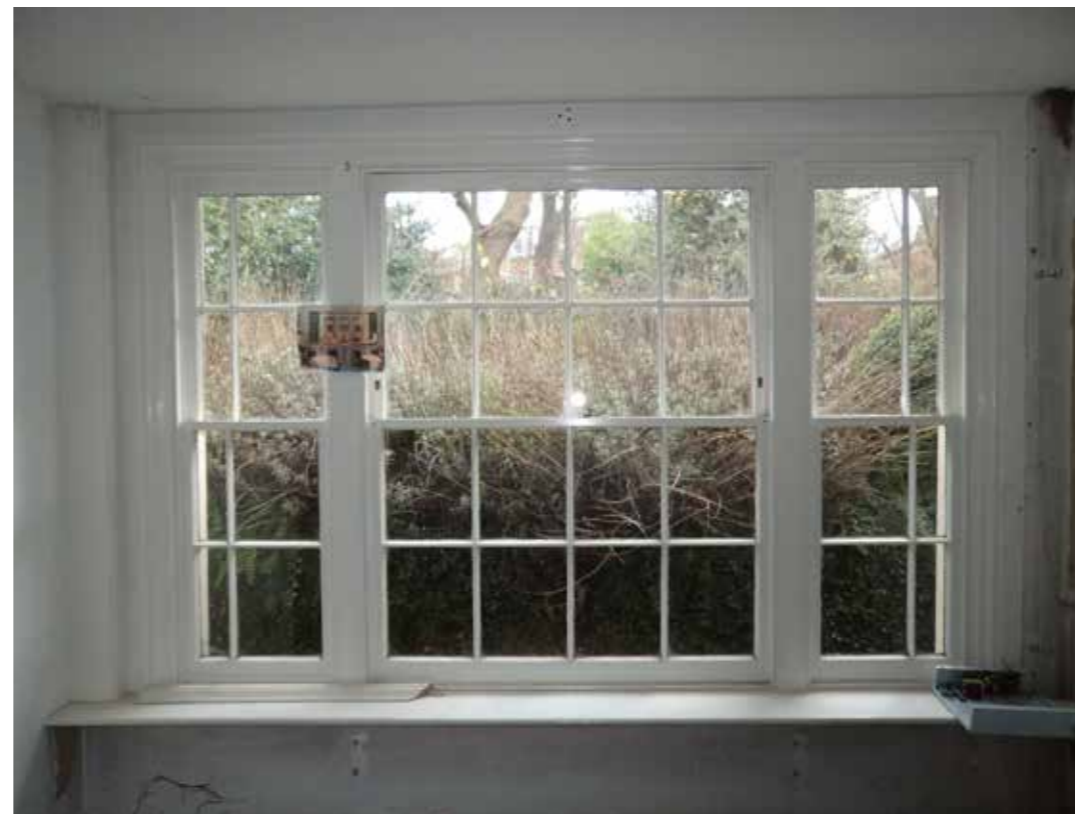
Existing window WLGF-06 proposed to be replaced with door DLGF-25

- DLGF-24. New door and side panels proposed to replace WLGF-06, and to match the detailing of DLGF-09. The existing window was added in 1997 when the LGF Living room/Lounge was extended into the bay. The building fabric, glazing and window frames are all modern and have no historical significance. The Living/Lounge would benefit from being opened up to the rear garden and having direct access to the LGF newly extended terrace.

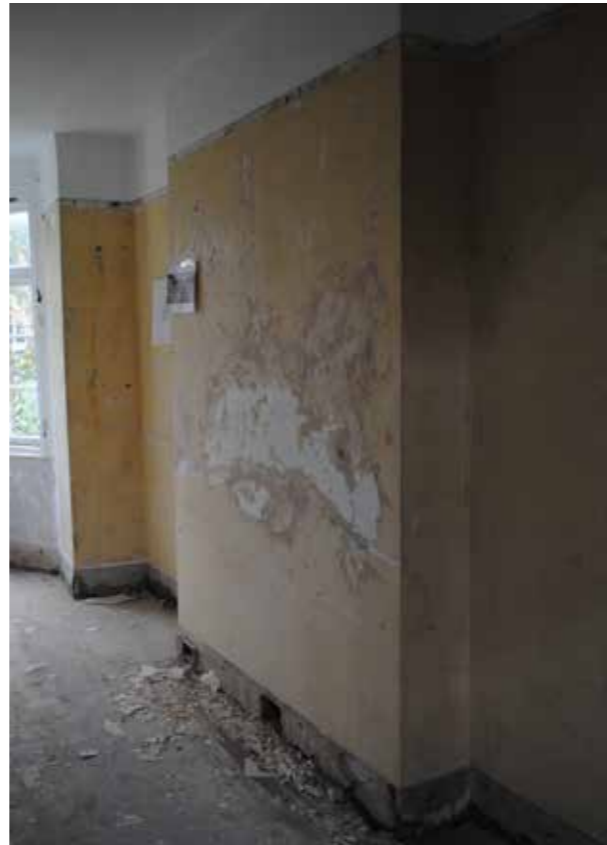
4 storey extension - Chimney to be removed, currently blocked up

The removal of the chimney to the 4 storey extension is only partially visible within the parapet, therefore its removal will not impact the streetscape. This part of the building was added in the late 19th century, and the stack is likely to have been taller originally, to draw the smoke from the fireplaces below more efficiently. Today it appears mutilated and truncated, and out of proportion with the rest of the 4-storey extension. Internally all of the fireplaces have been removed or blocked up. The chimney breast imposes into the rooms to varying extents at each level, and the rooms could be put into more effective reuse if the space could be maximised to the full.

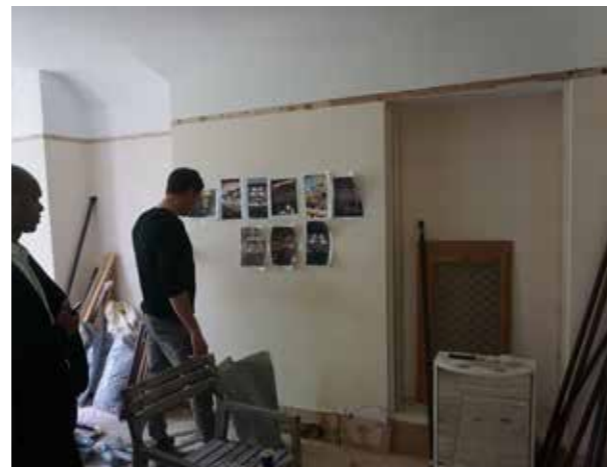
4 storey extension - Chimney to be removed, minimal depth and no longer readable as a chimney breast

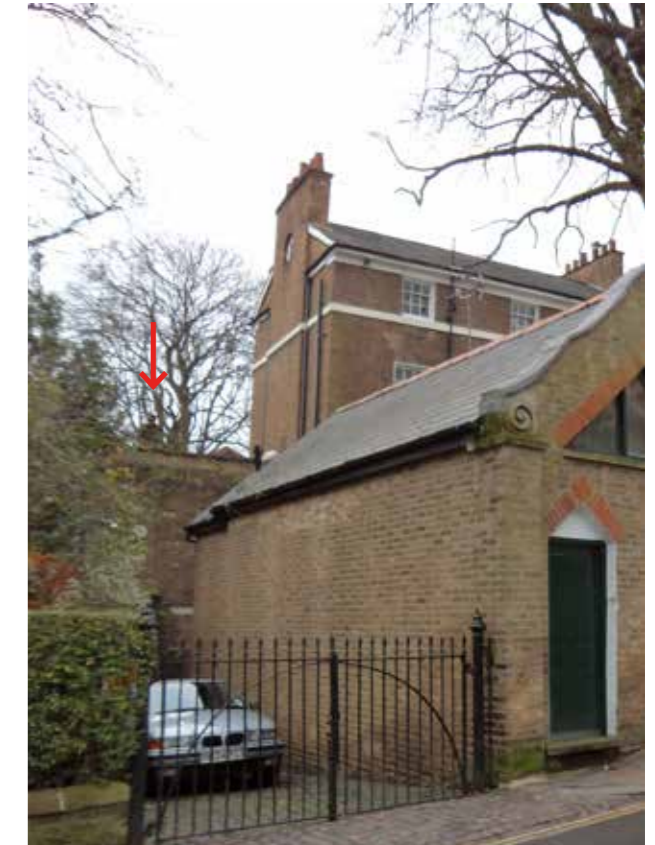
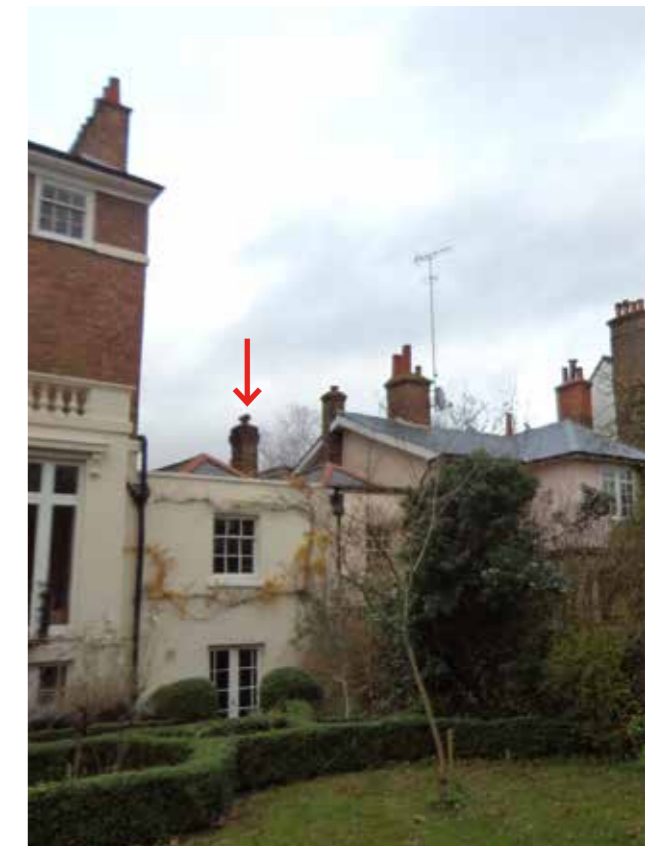
Stables - Chimney to be relocated centrally in plan

The realigning of the chimney to the stables is of a minimal distance, therefore will not impact the streetscape. The roof is of modern construction and the chimney has also been rebuild more recently, so there will be no loss of historic fabric.

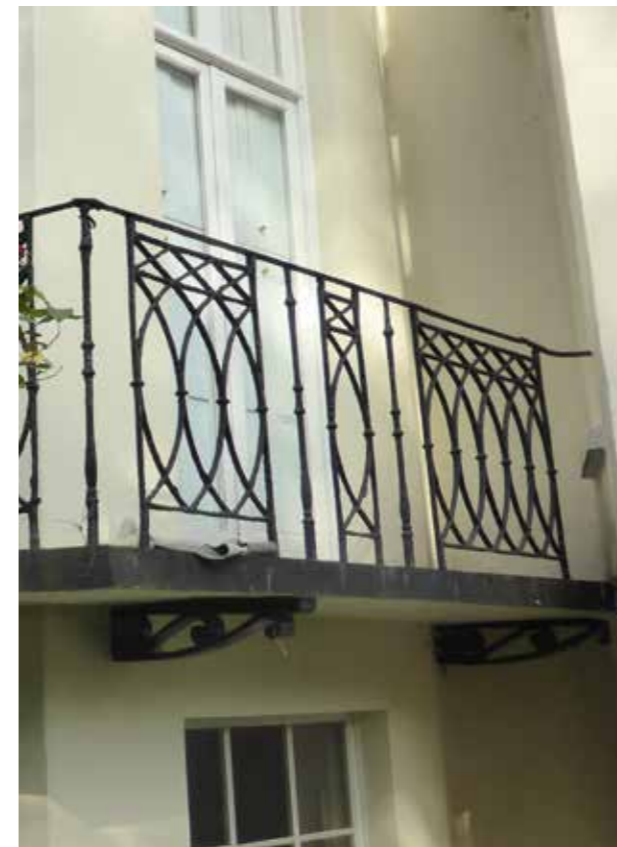
Existing cast iron support to stone plinth, detail to be retained and repaired

- Repairs to wrought iron balustrades
- Repairs to stone plinth and cast iron support.
- Replacement of cast iron balusters to stair with wrought iron detail to match the existing balcony baluster design.

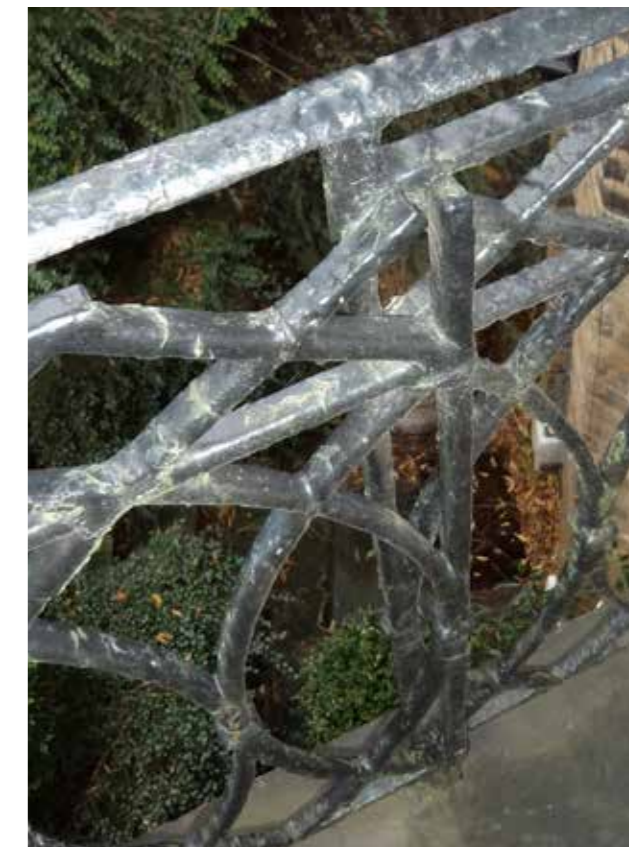
Existing wrought iron detail to canted bay, detail to be retained and repaired

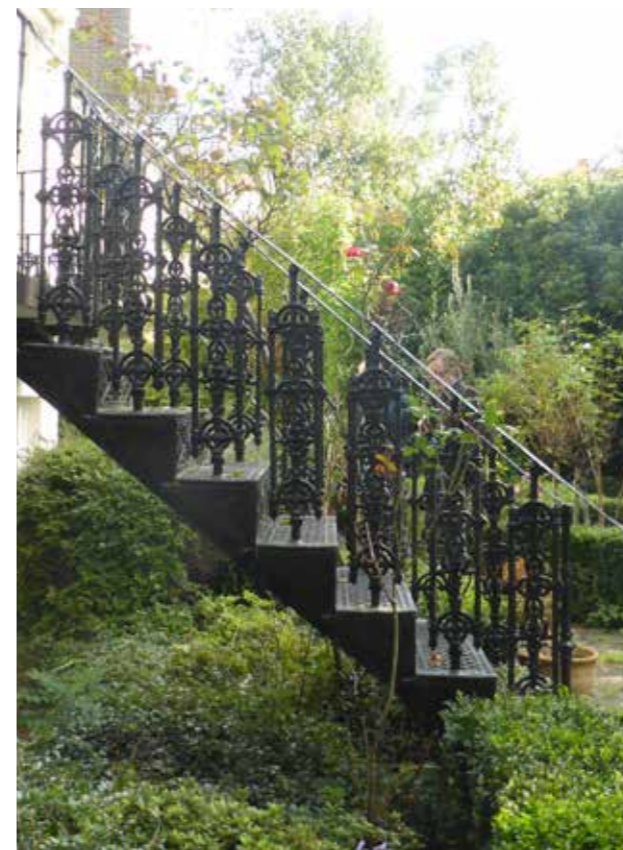
Existing stair with cast iron balustrades

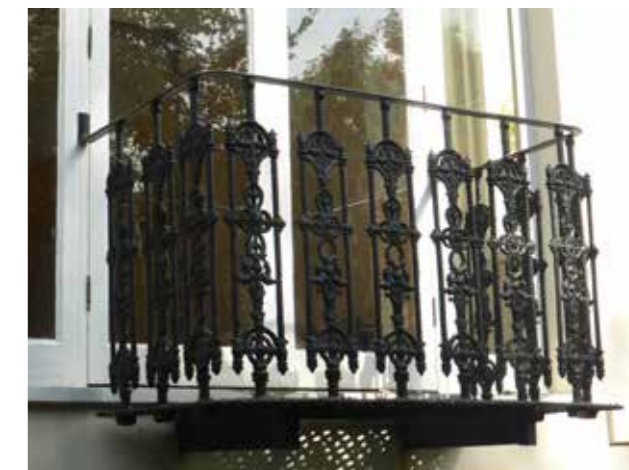
Rear balcony to Ground Floor Lounge; cast iron base and balustrade

- Removal of cast iron balcony.
- Replacement with a wider balcony as previously evident in this location in 1997, to match the detailing of the existing main balcony; stone plinth with cast iron support and wrought iron balustrades.

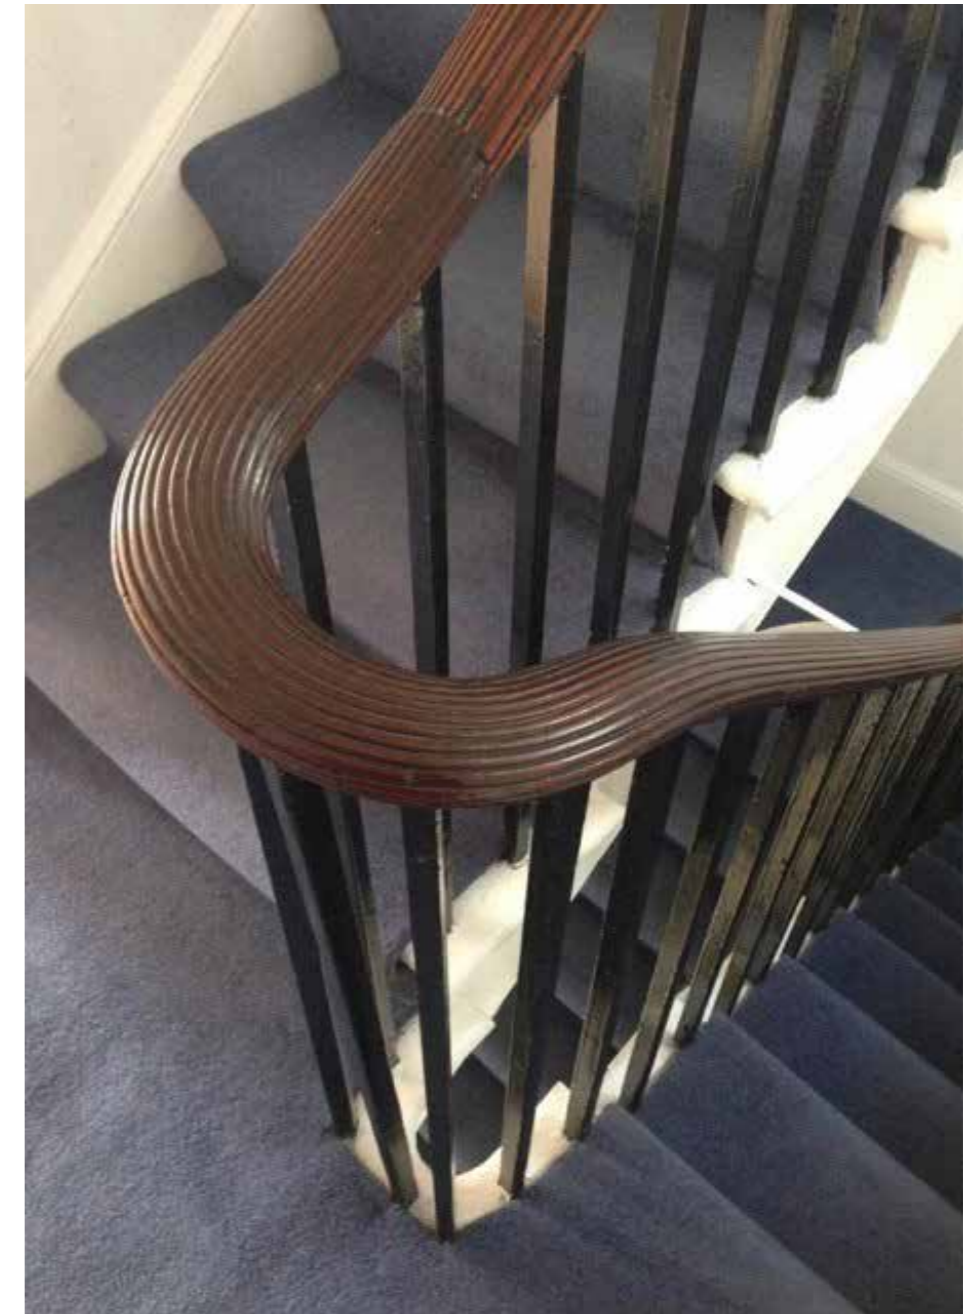
Existing wooden reeded handrail, to be retained, with straight spindles to be replaced by Soane pattern

- Repairs to wooden and stone steps.
- Clean and redecorate steps, and add a new runner.
- Retain and redecorate reeded handrail.
- Reinststate reeded handrail, to match the existing, to the 2F and the new GF stair.
- Replace the straight spindles with a curved Sir John Soane pattern, using traditional materials and methods.

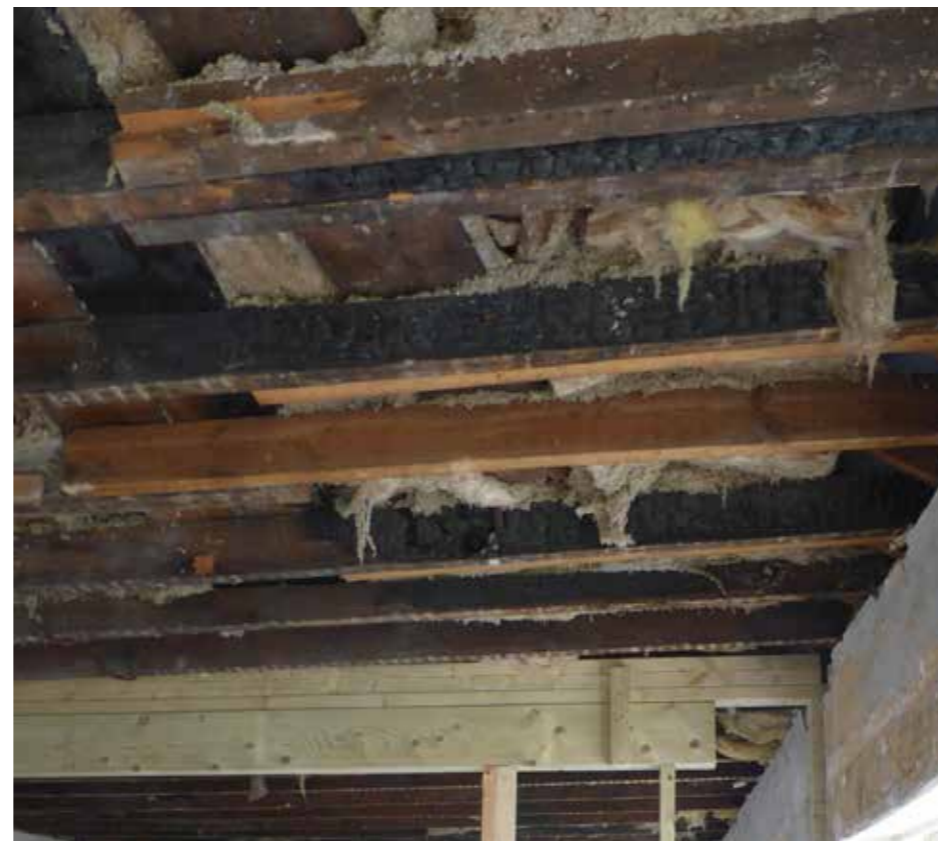
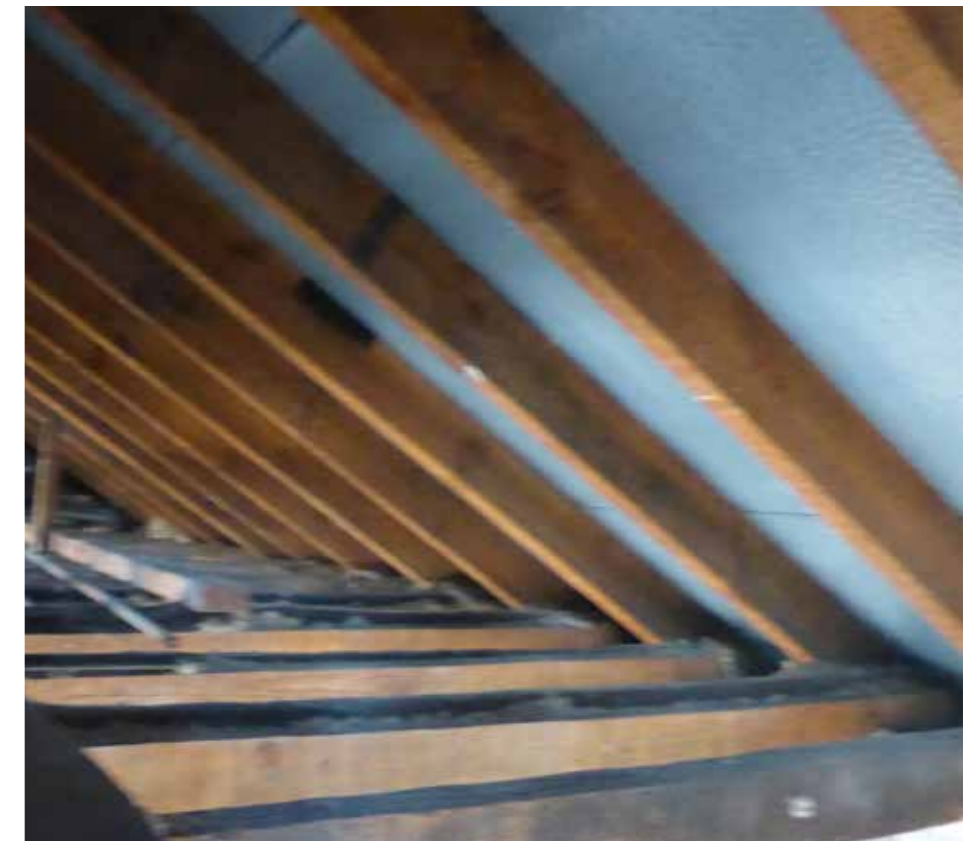
2nd floor soffit: *The ceiling to the Second Floor is not original. There was a fire in the 1970s destroying the original fabric and the roof had to be rebuilt. The roof is slate. The whole Second Floor is believed to be a later addition to the main building. The ceiling structure is exposed and is in poor condition with fire damage evident.*

Existing ceiling

Existing ceiling insulation, joists, rafters and membranes

- Remove existing ceiling joists as they have incurred fire damage and are in a poor condition.
- Retain existing rafters and introduce 5no. trusses with purlins to add extra stability to the roof. The trusses are proposed to be fitch trusses sitting on padstones, contained within the existing external masonry wall, in line with where the existing ceiling joists are.
- Introduce insulation to the roof build up.
- Reinstate wall partitions in previous locations with 2-panel doors.

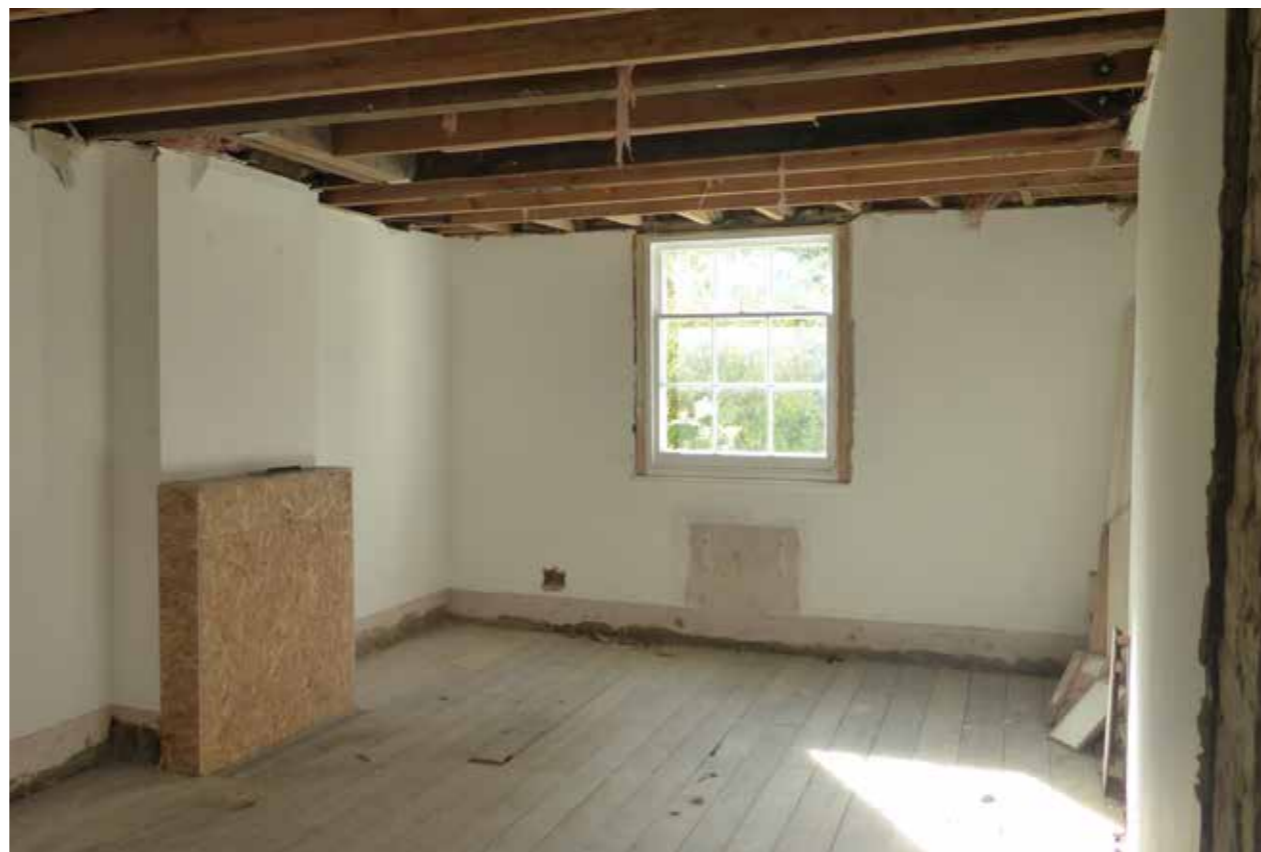
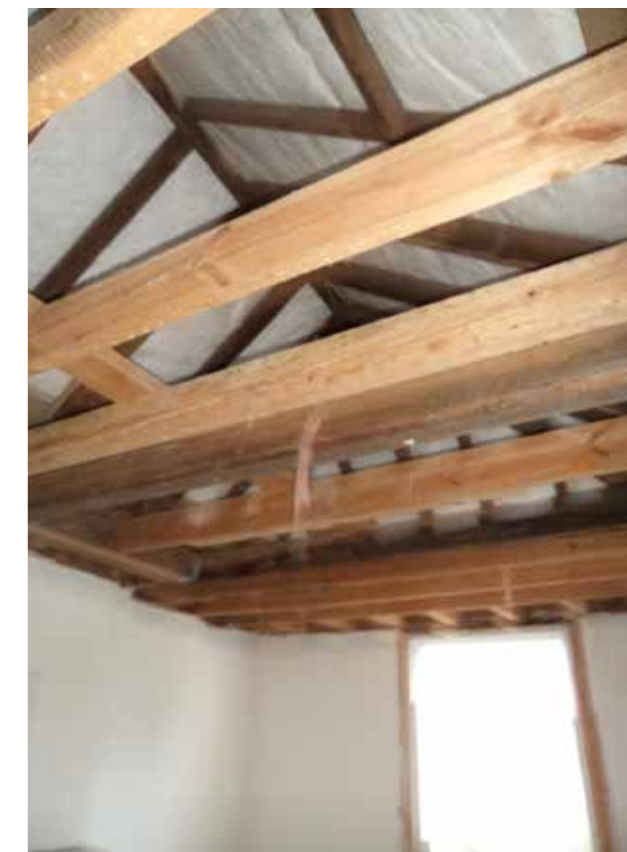
Existing ceiling to stables

- New structural supports to the roof and stable walls.
- The introduction of an arched ceiling.
- New architectural features in keeping with the proposed hierarchy throughout the house.

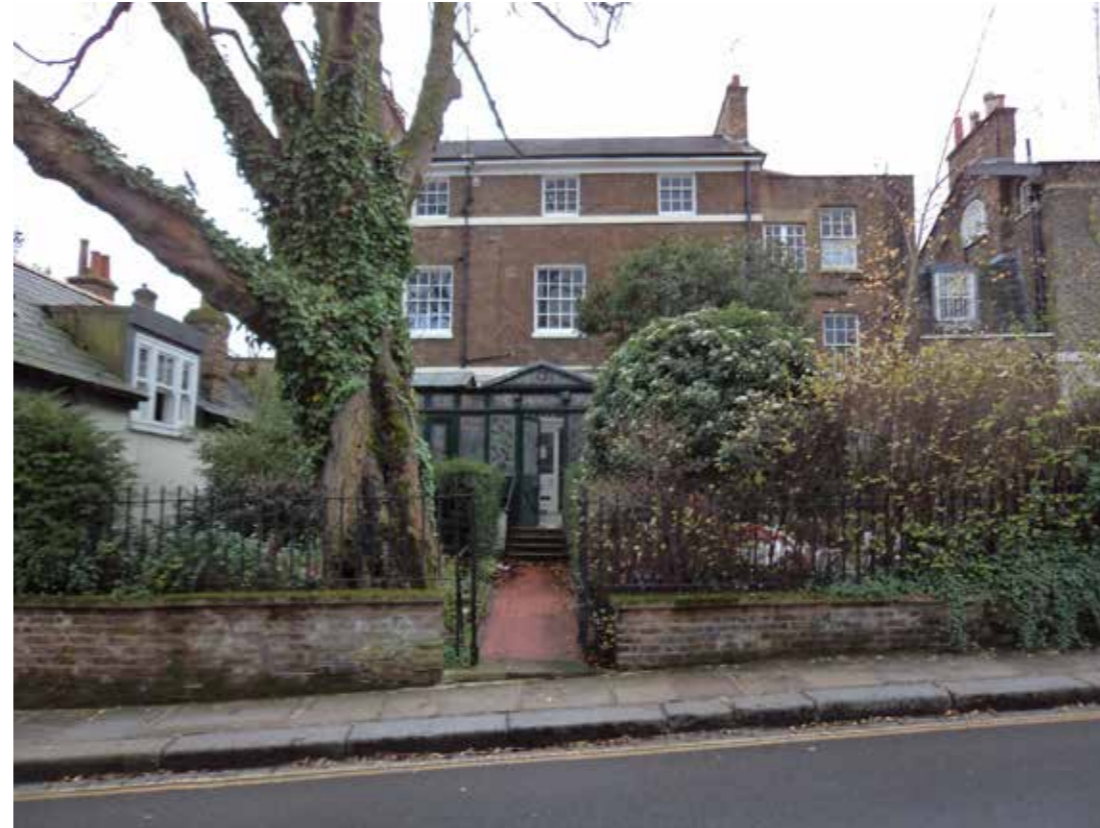
Main gate & Front wall: *The main gate is in poor condition and will be replaced to match the existing, with the addition of a lantern, which can be seen elsewhere in the Conservation Area. The front wall will be repaired.*

No.4 Existing railings and low wall

- Railings to be repaired and redecorated as existing
- Cleaning to copings and wall generally
- Repairs to areas of missing and damaged brick
- Repointing to the missing lime mortar
- Existing railings to incorporate a new post box and entry phone system, as visible at No.3.
- Replacement of the main gate in like for like profiles, but with a new lantern incorporated to signify the hierarchy of this main gate to that of the existing side gate.

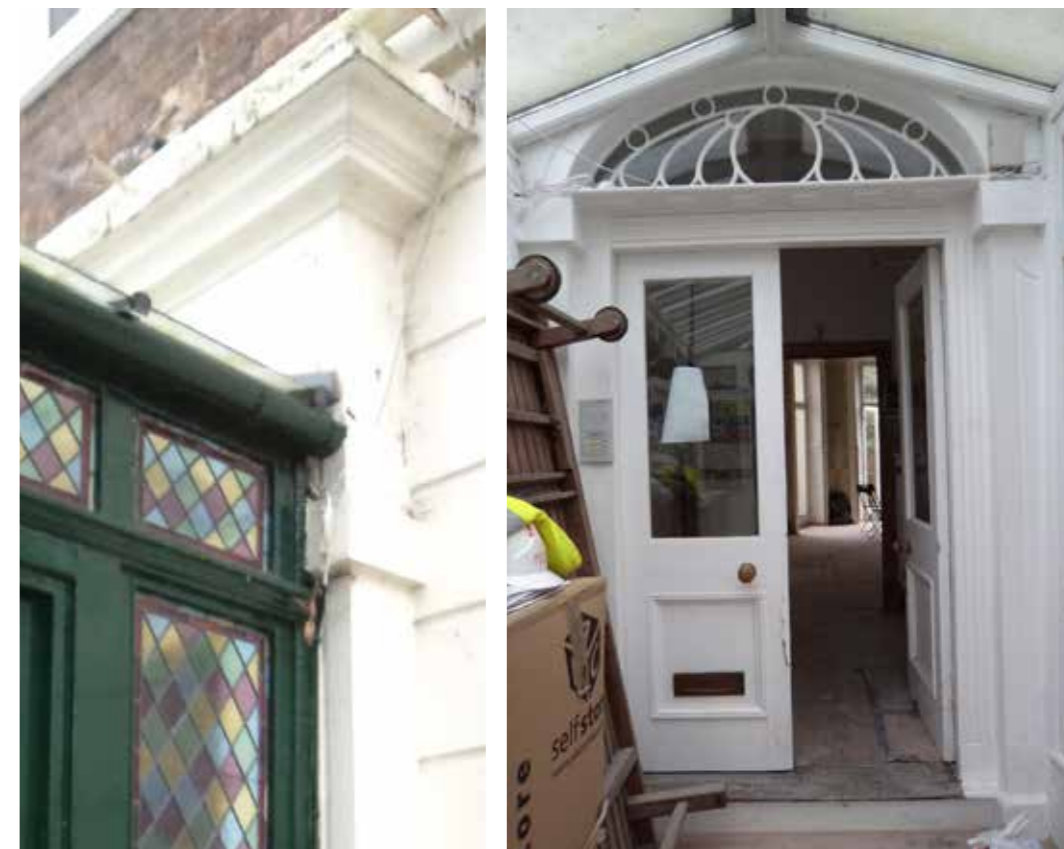
The existing Porch does not respect the existing front door fanlight and moulding surrounds. From the photographs it can be seen that it cuts the mouldings in half. The refurbished roof will retain the same pitch externally, but will enhance the existing doorway by ensuring the roof shape internally reflects the fanlight and more of the moulding is revealed. This refurbishment will also replace the modern PVC glazed roof that was added after 2004, and detracts from the character of the Porch.

Existing Porch does not respectfully meet existing door surround and fanlight

- Refurbishment of the Porch internally and externally, whilst retaining its existing configuration, plan form and street elevation.
- Replacement of the modern PVC glazed roof with a traditional lead roof
- New internal structure not visible from the exterior, that follows the shape of the existing fanlight.
- Reinvention of the glazing to the side elevations to bring more light into the space.
- Removal of the later doorways and replacement with reinstated wooden panelling & glazing to match the existing.

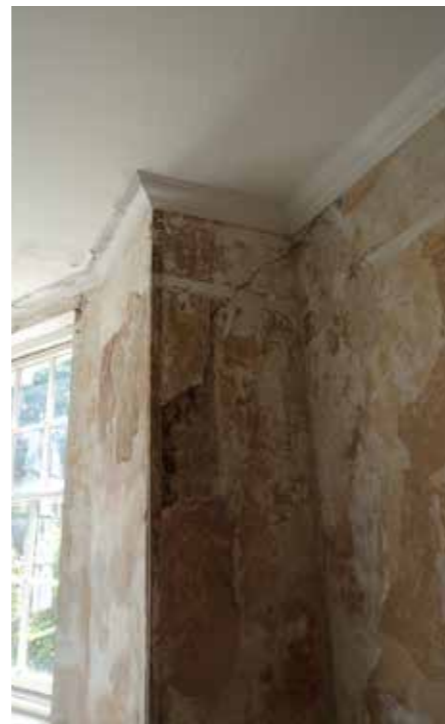
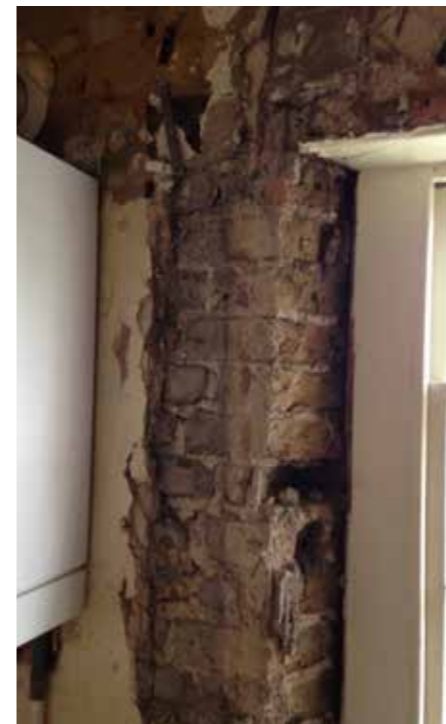
Examples of areas in need of repair

Localised repairs to the existing lime plaster will be carried out using hydraulic lime plaster.

Existing gypsum plaster will be repaired to match the existing wall fabric, and where plasterboard is already present it will be retained or repaired.

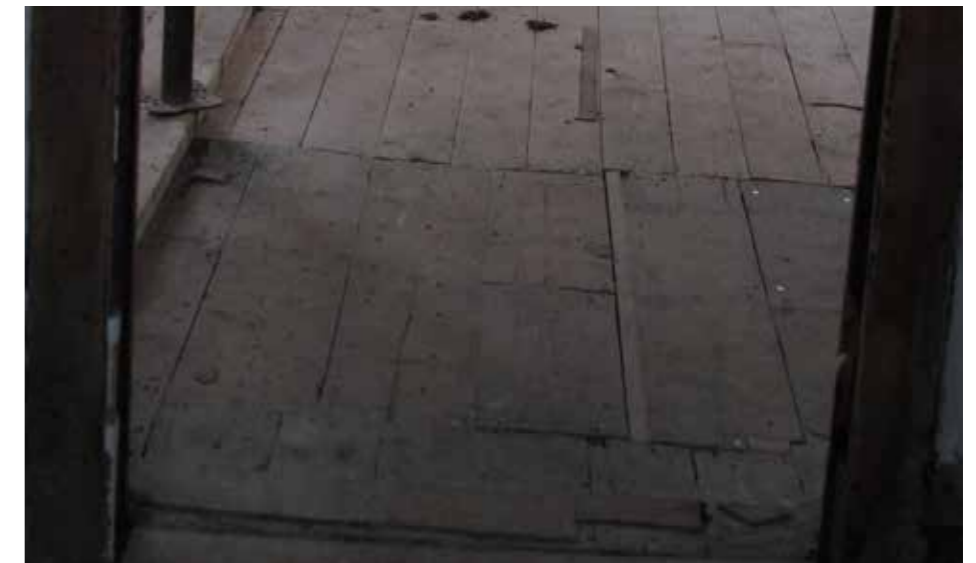
Ground Floor timber floor boards - showing lines of previous partitions

Reception & Lounge - New timber flooring is proposed to the significant ground floor rooms. The existing timbers have suffered damage due to previous alterations and whole areas have been replaced. However, there is hope to reuse these boards elsewhere in the house, whilst restoring the hierarchy of the Ground Floor rooms with new flooring.

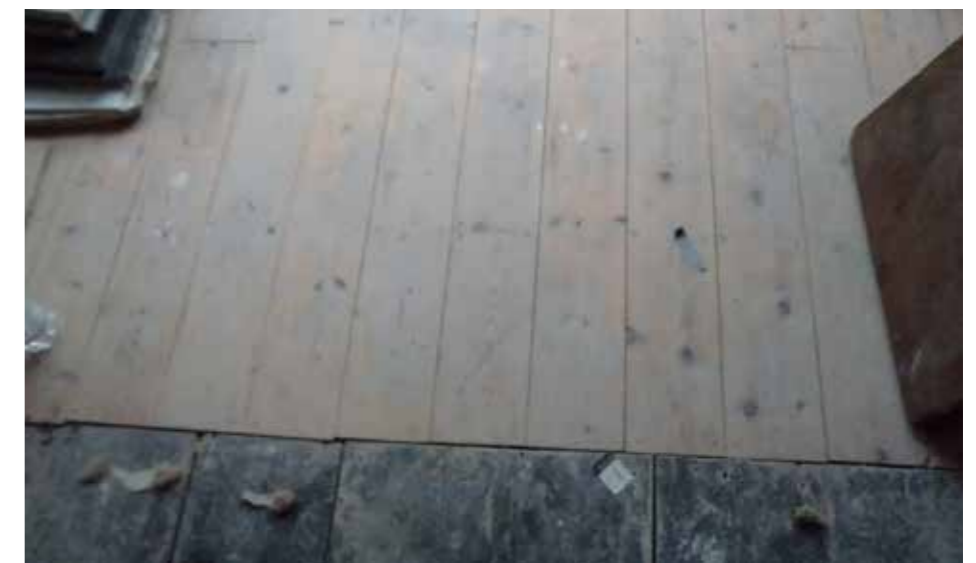
Ground Floor timber floor boards - showing lines of previous extensions

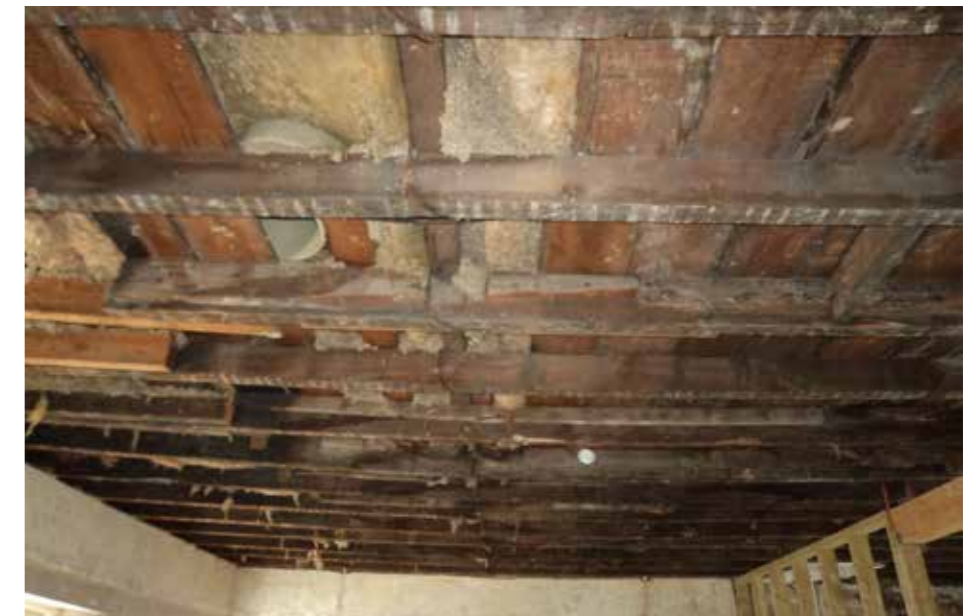
First Floor missing ceiling

Where possible the existing plaster / plasterboard ceilings will be repaired and retained. New ceilings are proposed in 10-07, 11-02 and 12-04/12-05 where the room use will change or the ceiling is missing.

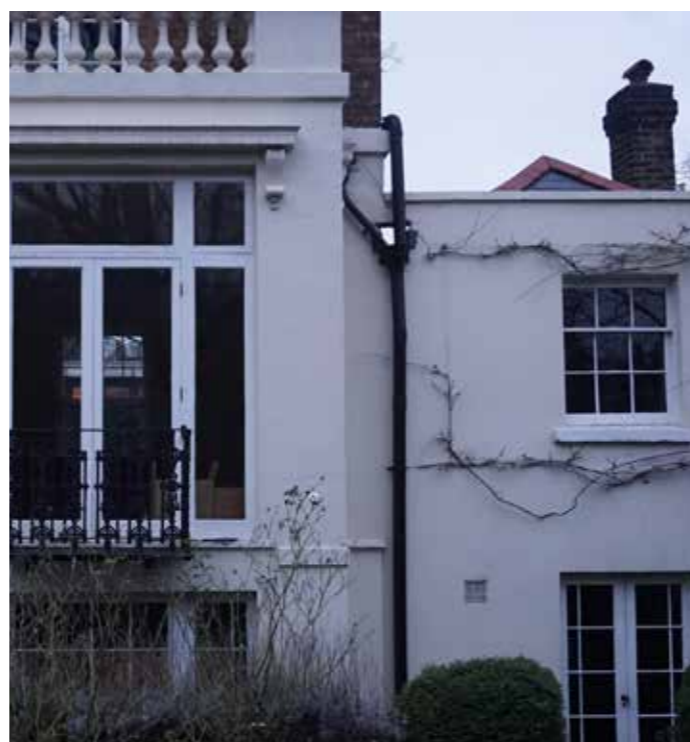
Repairs/rationalising rainwater goods

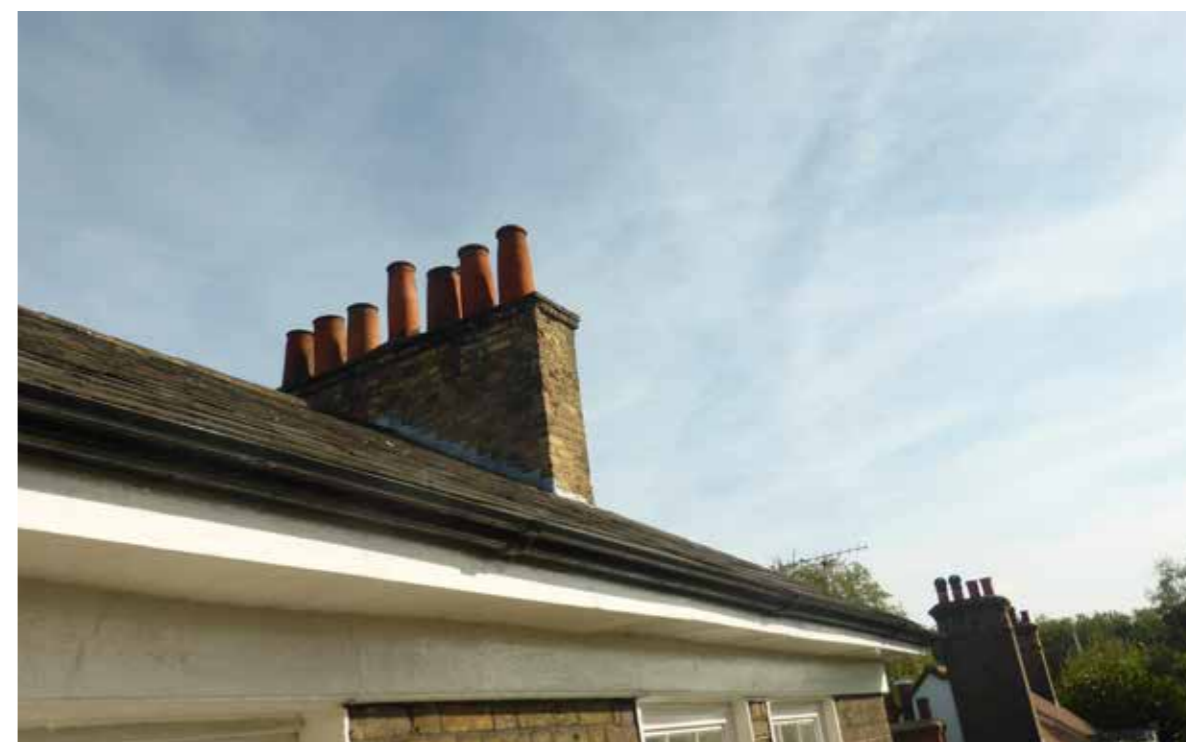
Repairs to gutters

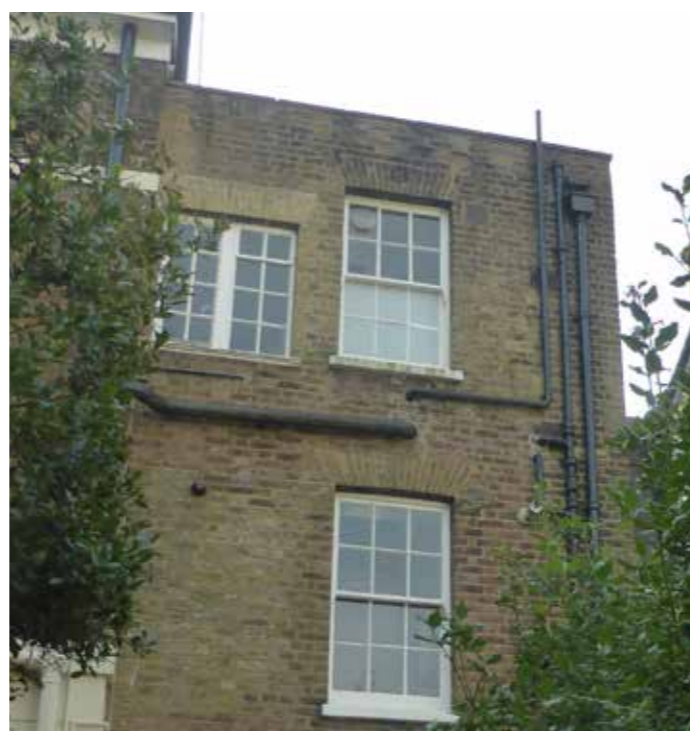
Repairs/rationalising rainwater goods

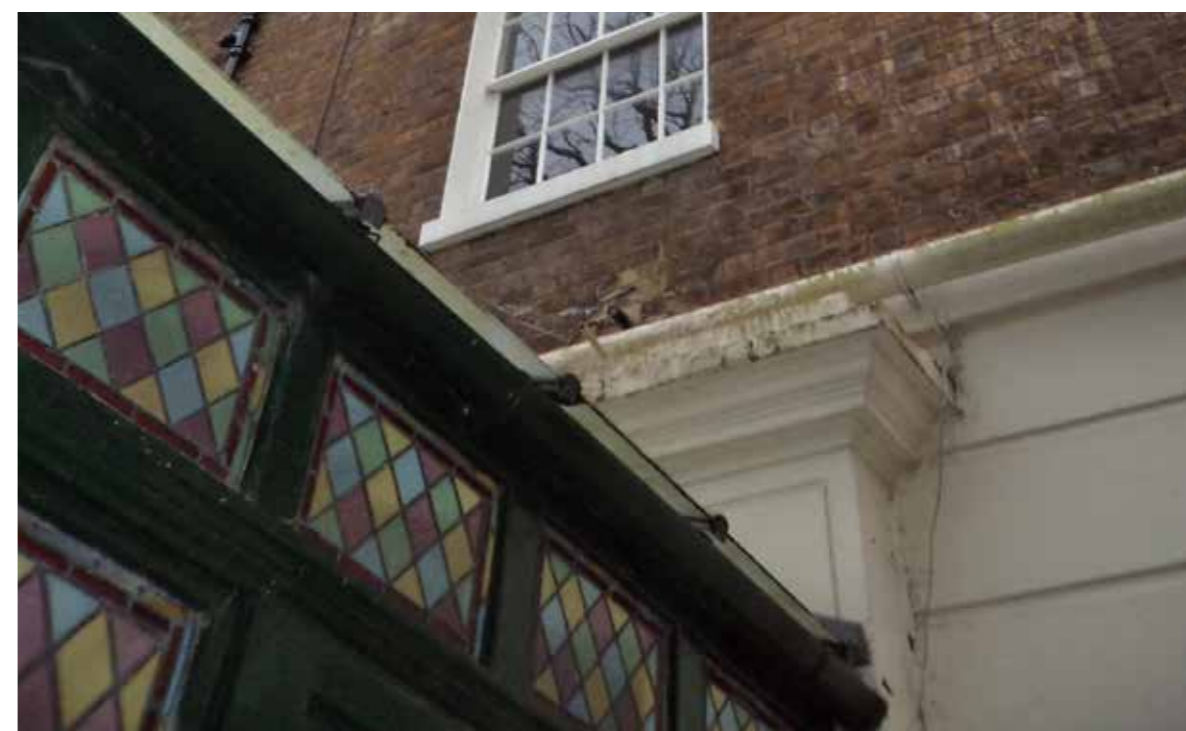
Repairs to brickwork
