Manhattan Loft Corporation St Pancras Booking Hall

Ticket Office Mezzanine – Phase 2 of Structural Feasibility Study

Final | 24 June 2016

Appendix A: Intrusive Column Survey Report

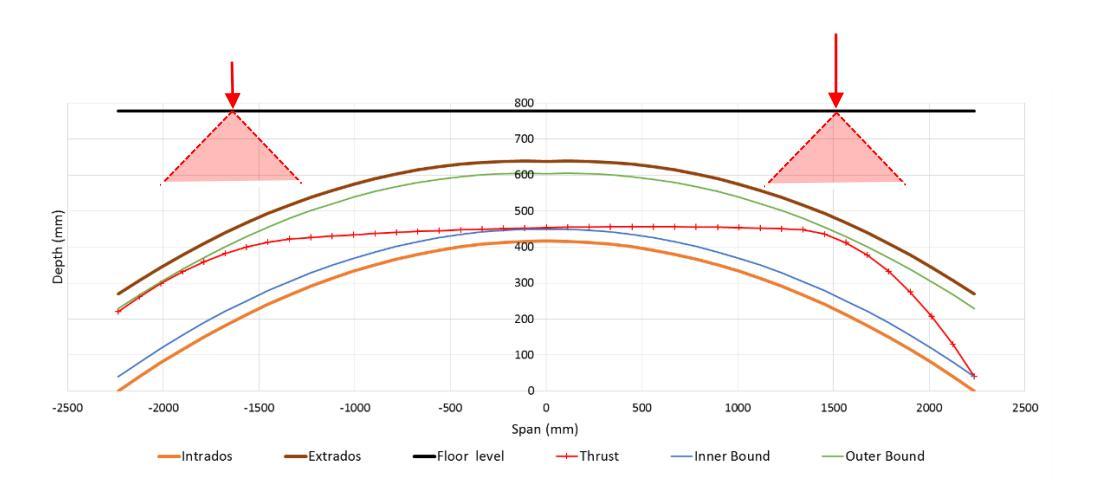
Figure 3: Line of thrust analysis with eccentric point loading

An analysis using the dimensions in Figs. 1 and 2 and unfactored loadings in Sect. 3 was conducted. Various loading cases were considered to give the worst case. A large point load with little uniformly distributed load gave the most critical condition. Fig 3 illustrates the analysis for the case where there is point loading at each end of the beam with a 500mm eccentricity from the support of the arch. It shows that the compression thrust line is within the voussoir, hence is stable, but only has a geometric factor of safety of 1.4 (within the middle 70%). Since this line of thrust goes outside the middle third of the voussoir depth, cracking will occur in the arch. Furthermore, to achieve this line of thrust requires a large horizontal thrust which may make the neighbouring arch unstable if that arch has little vertical load acting on it. Thus our study indicates that the existing masonry arch is not suitable to carry the large eccentric point loads from the new mezzanine columns.

Due to the existing masonry arch flooring being unable to carry eccentric, concentrated loading, we have devised a detail to avoid loading this floor arch. A schematic of this detail is shown in Fig. 7. The detail involves excavating locally into the fill of the floor (see Fig. 8), beneath the existing wooden walls and floor finishes, and having the new steel structure (which supports the new mezzanine) bear directly above the columns. Fig. 7 is drawn approximately to scale and indicates that there is sufficient space to install the new structure. Although this proposed structure will involve complicated detailing and tight tolerances, we believe it is a workable solution.

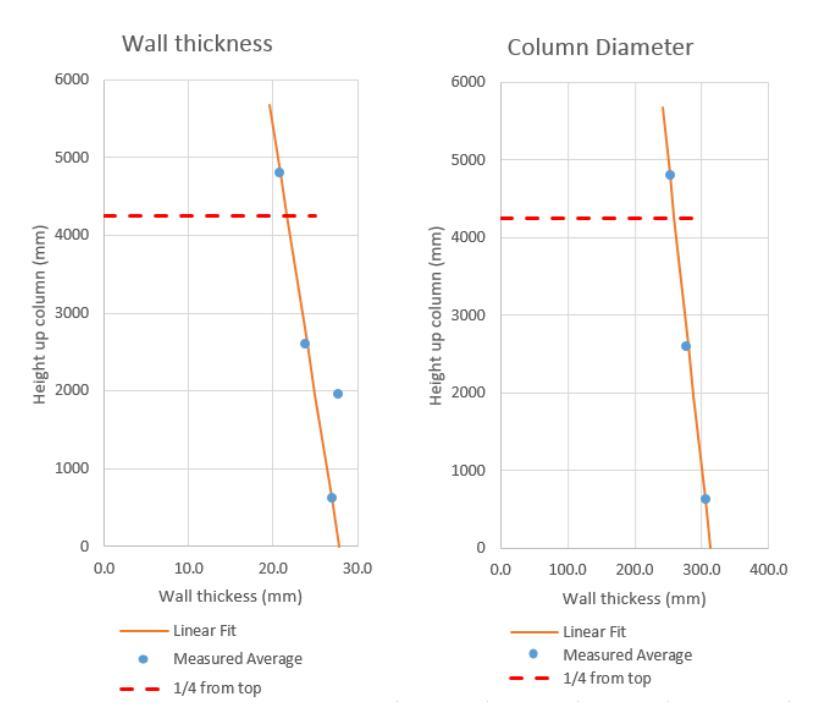
Figure 5: Tapered cast iron columns wall thickness and diameter

The column wall thickness vs. height and column diameter vs. height are shown in Fig 5. The average measured thickness/diameter is plotted as blue points and the linear interpolation is shown as an orange line. The cast iron columns are tapered and have a wall thickness and diameter of 19.6 mm and 241 mm, respectively at the top and 27.8 mm and 313 mm, respectively at the bottom.

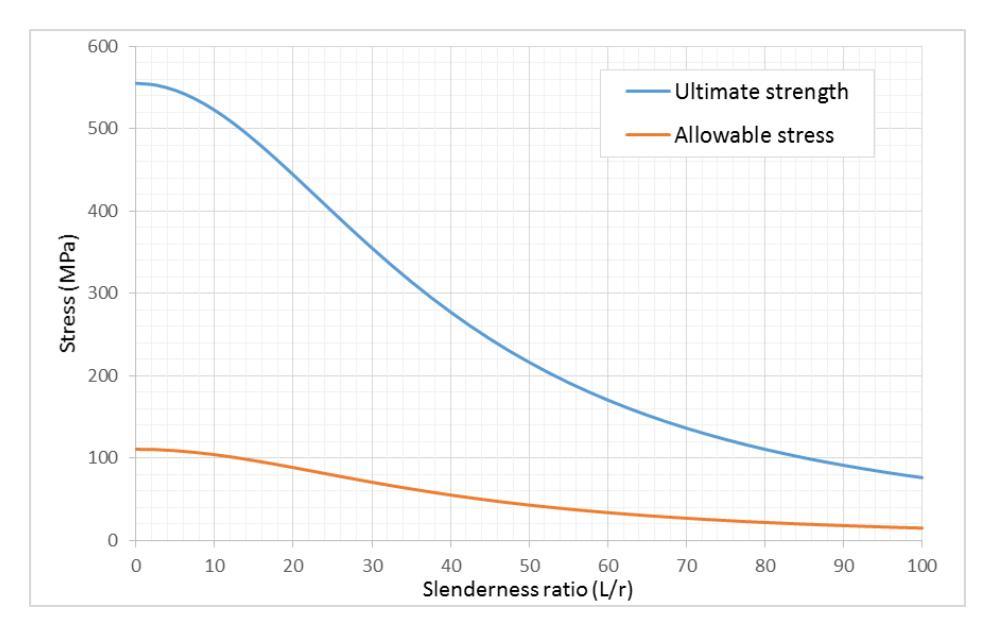
Figure 6: Buckling capacity of cast iron columns.

The slenderness ratio of the column changes over the height of the column. For this feasibility study, the slenderness and column area at a quarter of the total height (from the top) was used to calculate the capacity. This gave an allowable capacity of about 468kN. An estimate of the unfactored loads using a conservative estimate of the live loads gave a usage ratio of 1.0, which is just adequate. As the design evolves, and the imposed loadings become better understood this usage ratio may improve. Nonetheless, the column capacity can also be increased by providing better fixity/restraint at the bottom (and/or top) of the column, which has currently been conservatively been taken as pinned. Thus this study indicates that the existing columns are adequate for concentric loading.

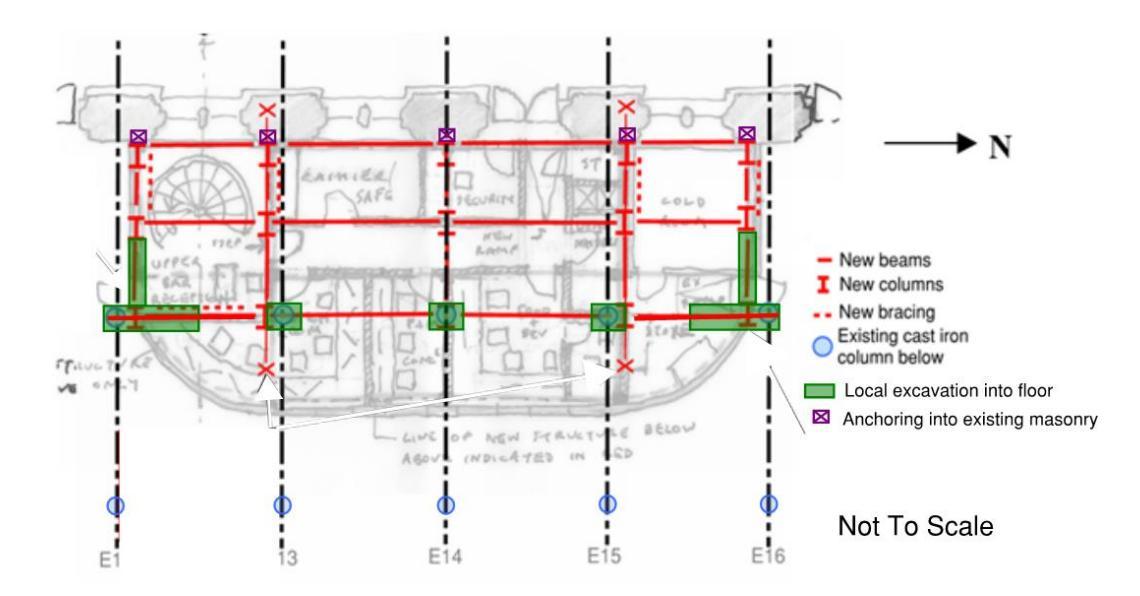
Figure 8: Plan of new structure with excavation and anchoring locations

Fig. 8 shows the approximate locations where the cutting into the existing masonry floor is proposed to accommodate the detail in Fig. 7. The excavation

shall only be into the fill of the floor and should not penetrate into the masonry voussoir part of the arch. The detailing is intended to avoid the existing wooden walls by going beneath them and, as such, assumes that the walls do not extend below the floor level.

Also shown in Fig. 8 are the locations where the new structure will be anchored into the existing masonry columns. To engage enough weight of the existing masonry may involve drilling for up to 0.5 or 1 meter. More investigation is required to determine details of this connection.

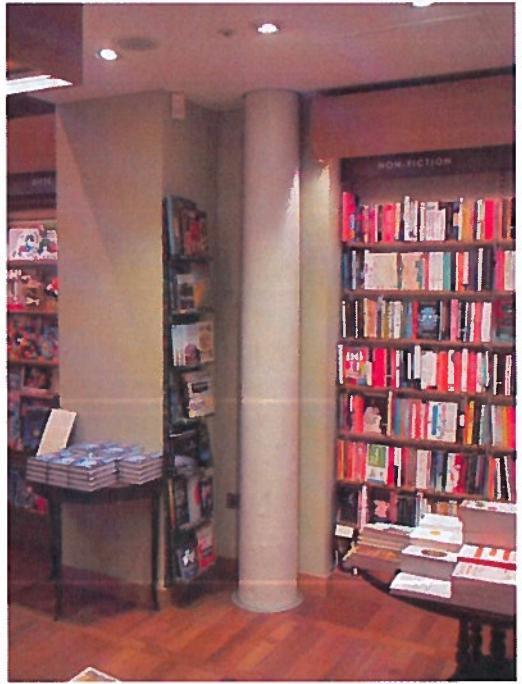
Photograph 3. Showing Column 3

The cast iron columns and wrought iron beams had what appeared to be an intumescent coating system present (see Photographs 1 to 3).

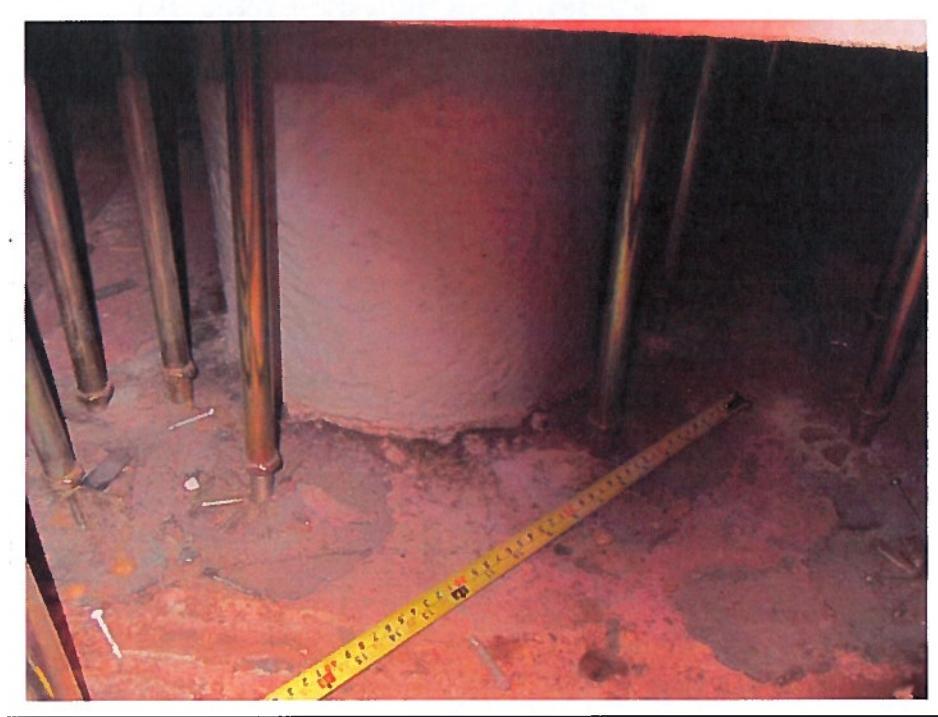
Photograph 4. Showing the concrete base around Column 2

The retail unit had a raised floor which was approximately 500m above the concrete that encased the base of the column (see Photograph 4).

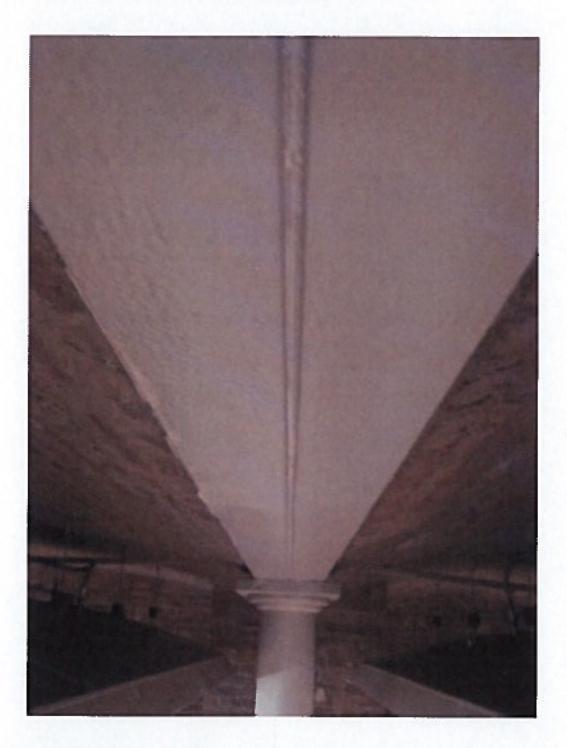
Photograph 5. Showing a length of the wrought iron beam

Only the soffit of the wrought iron beams was accessible during the attendance. It appeared that the beams are a composite using what is assumed to be back to back angles (see Photograph 5).
