Royal Free London NHS Foundation Trust

Fleet Road – Boundary Wall Instability Due to Proximity of London Plane Tree

Initial Structural Engineering Assessment

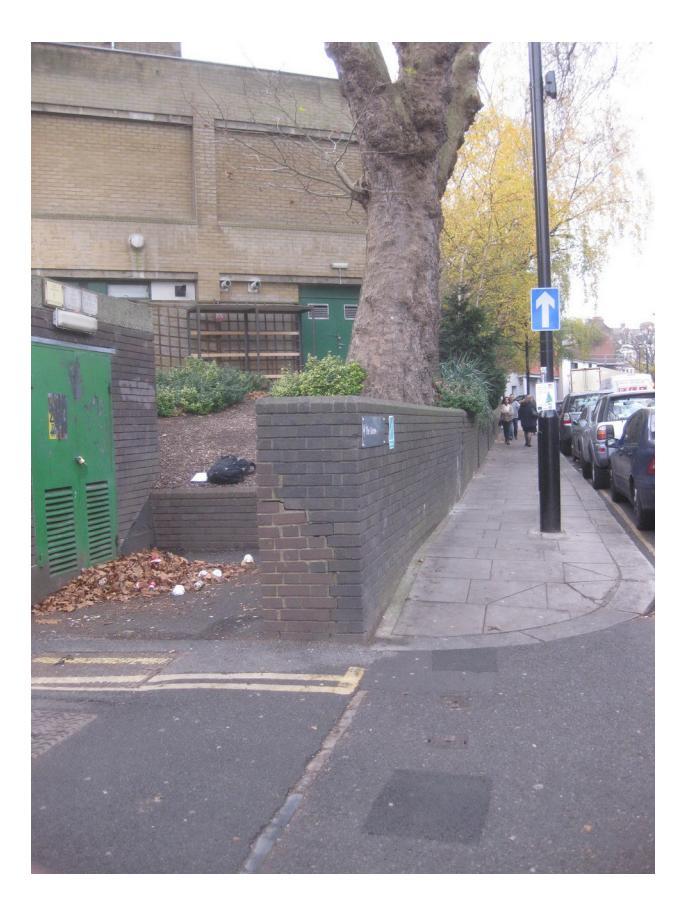
The existing boundary retaining wall is of solid blue engineering brick with recessed mortar joints and a shaped brick on edge coping. Where free standing (not retaining earth), the wall is 215mm thick built in English bond. The wall generally stands approx. 1300mm above the pedestrian pavement and the London Plan stands behind on an earth mound which the wall retains against the pavement.

Photo 1: View along boundary showing tree standing high on ground behind brick retaining wall.

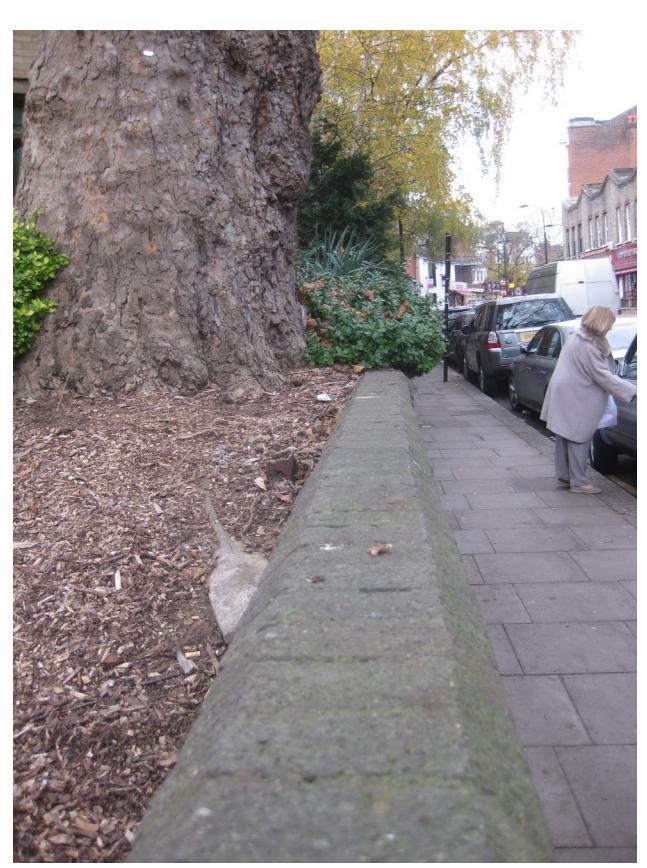
The trunk of the tree rises only 250mm from the back face of the wall.

The wall has a significant lean towards the pavement, measuring approx. 80-90mm approx. over the height of the wall. Hence, relative to the base of the wall and assuming it to be only 215mm thick, the back of the wall would be only 150mm from the tree trunk. It is probable that the wall is thicker at low level, although this could not be detected. This would mean the back face is either flush or rises beneath the tree trunk.

Photo 2: Close proximity of tree trunk to rear of boundary wall at ground level.

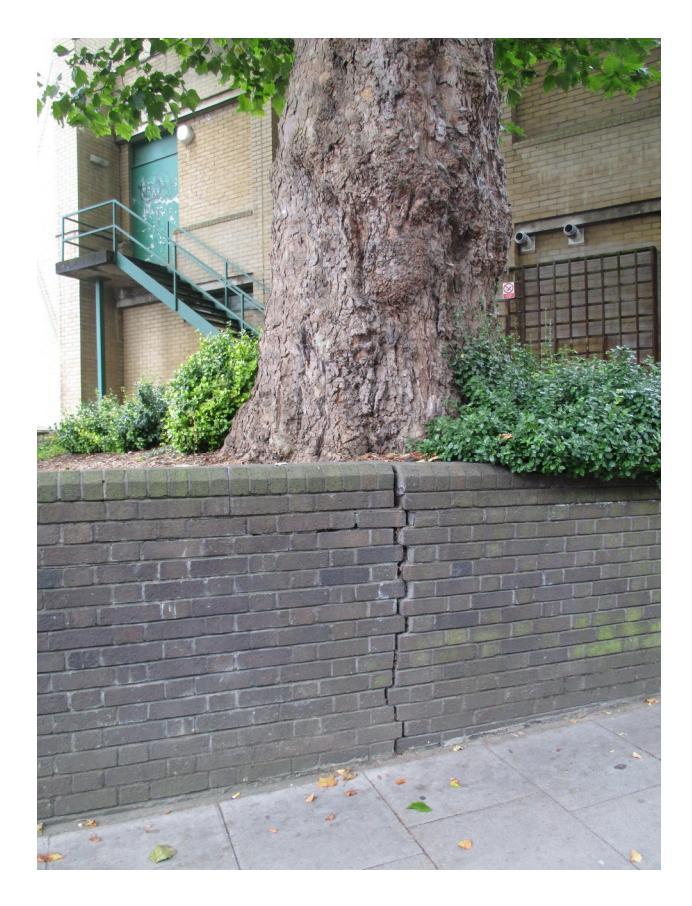
There is a large crack in the masonry against the tree where the brickwork has an offset in the plane of the wall of approx. 20mm. Additionally, a tapering vertical crack has developed at this point which is largest at the top of the wall, opening to approx. 40mm.

Photo 3: Tapering crack in masonry wall adjacent to tree.

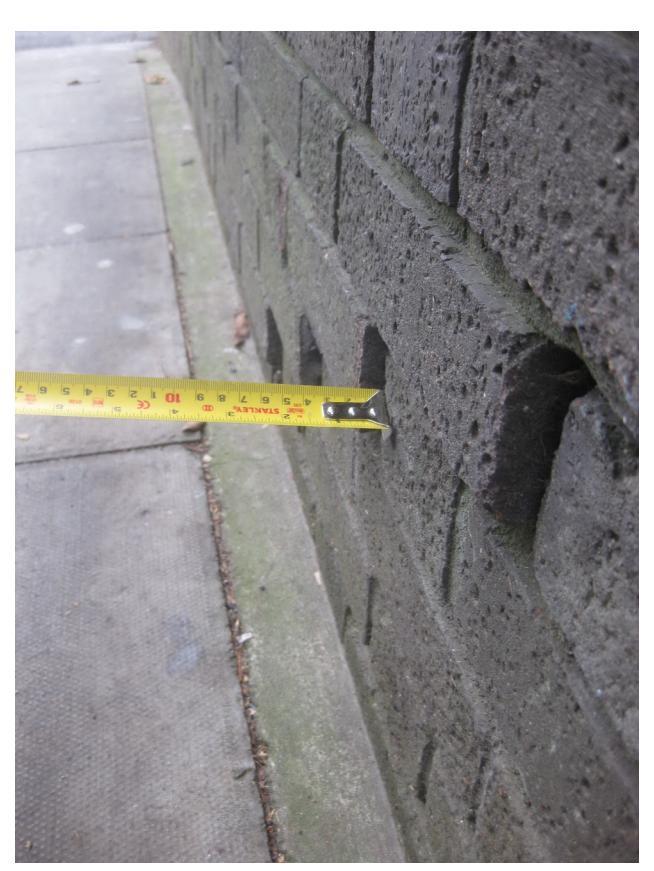
There are several cracks along the length of the wall where it is acting as a retaining wall. There is significant lateral displacement at these cracks which indicates a loss of bond in the masonry bed joints. The retained load has exceeded the capacity of the wall, which has resulted in sliding of the masonry across the bed joints. This will have further reduced the retaining capacity of the wall.

The earth and tree root pressure has resulted in displacement of the wall across bed joints at low level and significant lateral deflection of the wall causing significant vertical incline.

Photo 4: Lateral displacement of brickwork at low level.

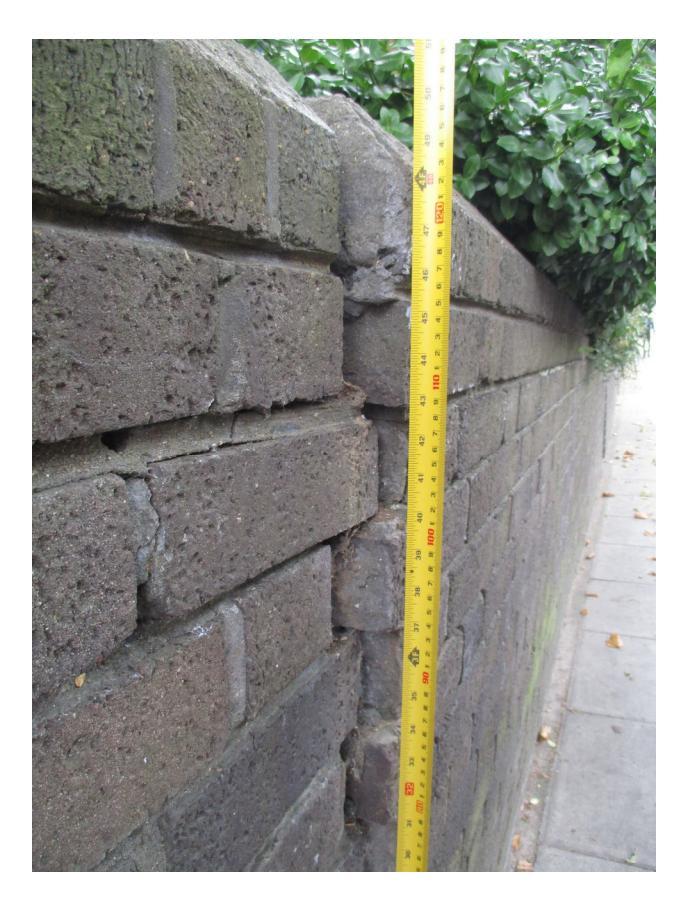
Photo 5: Offset of wall at tapering crack adjacent to tree trunk.

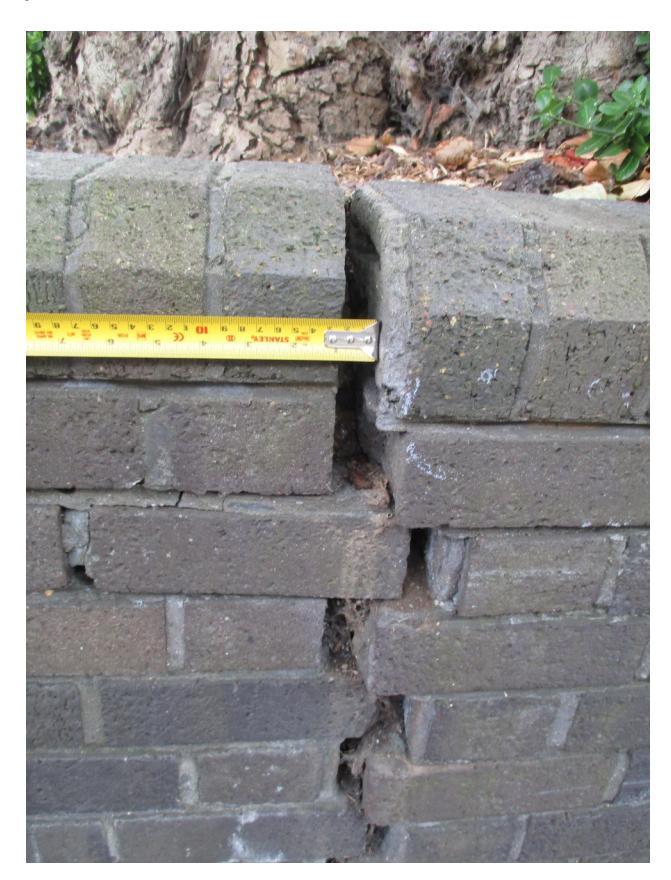
Photo 6: Excessive crack width at top of wall adjacent to tree.
