## Heritage Statement

61 Neal Street

Grade Two Listed

Listing statement (1973)

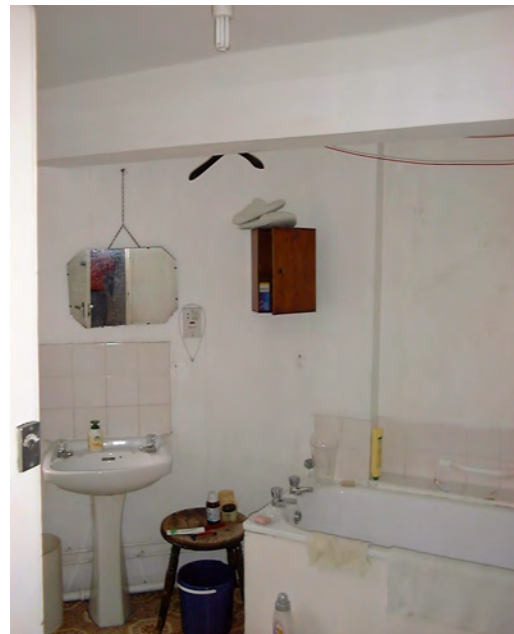
Original Drop Beam in 3<sup>rd</sup> flr  
Bathroom. (Longitudinal)

We are proposing to refurbish the existing bathroom on the 3<sup>rd</sup> floor, reducing its size and forming a bank of cupboards accessed from the front bedroom. This will require punching door openings through the separating wall between the front and rear rooms. The original structural beams in the ceiling will not be altered.

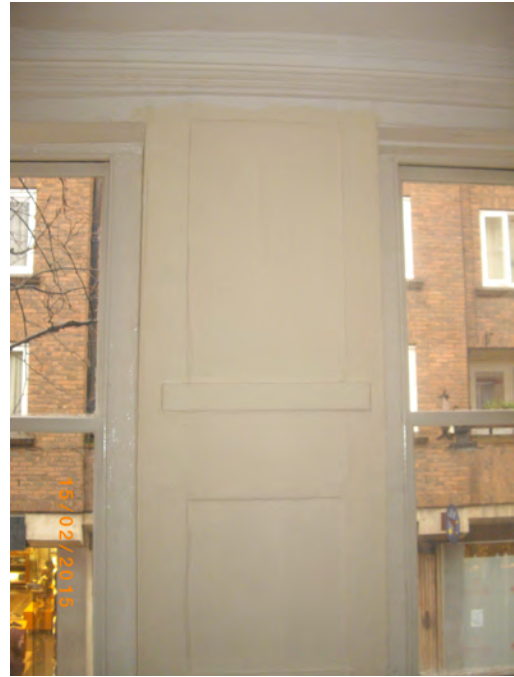
There are disjointed timber panels and niches between each window on the first floor and below the windows (see room elevation drwgs).

Original panelling between Victorian  
Vertically sliding sash windows.

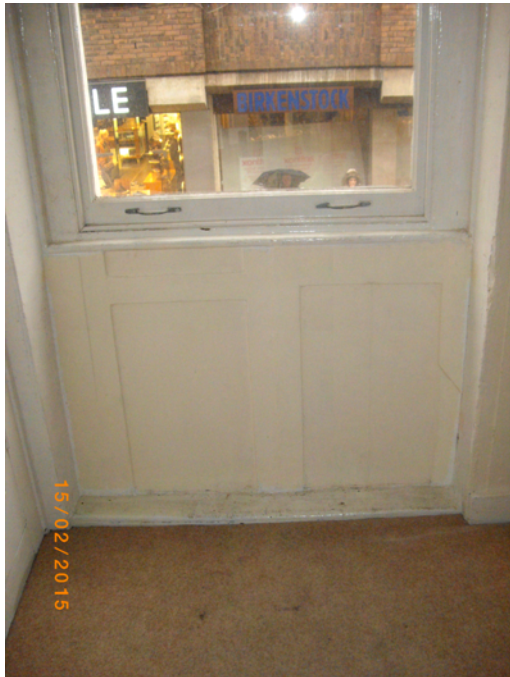
Original panels below front windows

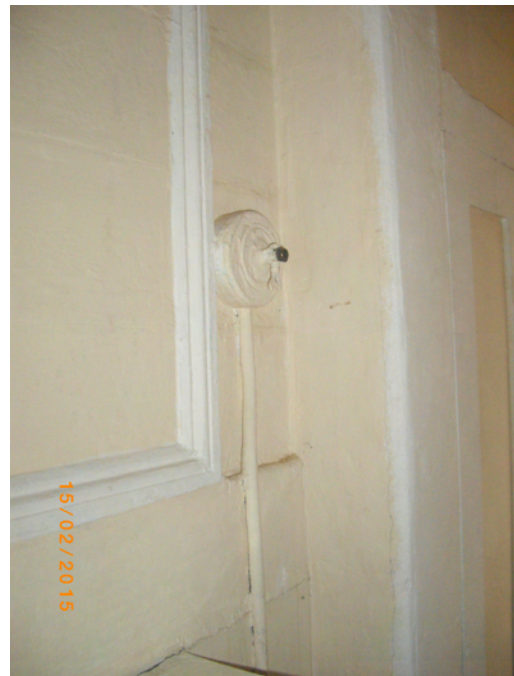
There are simple Victorian gas pipes, for lighting (disconnected), adjacent to each of the fireplaces on the 1<sup>st</sup> & 2<sup>nd</sup> Floors.

Gas supply for gas lighting, 1<sup>st</sup> Flr.

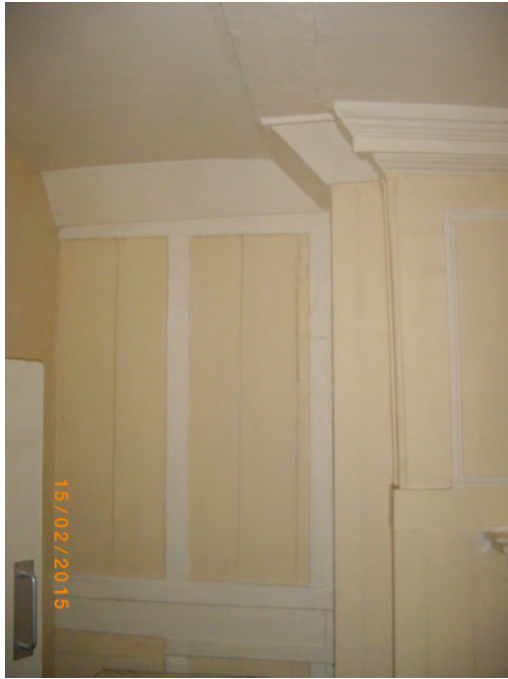
Some decorative cornices are intact, in moderate/poor condition on the 1<sup>st</sup> floor, but a proportion has been removed and replaced with 45°canted hardboard (see drwgs).

Panels above dado & Cornice 1<sup>st</sup> Flr

In the two principle rooms on the first and second floors we intend to repair and sensitively redecorate the existing walls, floors and ceiling. It is proposed to reinstate the missing Georgian cornice on the first floor and add a reduced sized Georgian cornice on the second floor (similar design as 1<sup>st</sup> flr but reduced in height and depth) (see drwg).

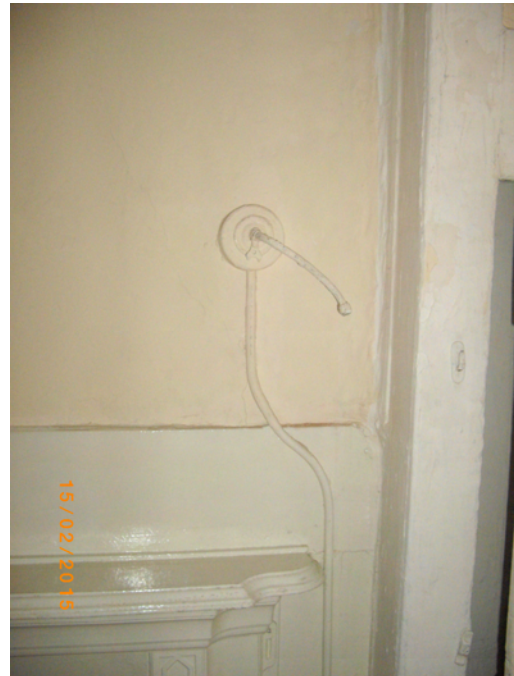
Gas light, 2<sup>nd</sup> Flr

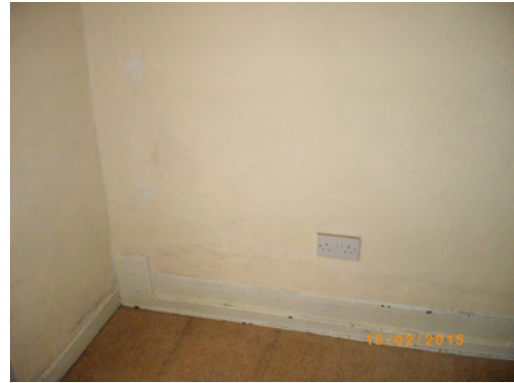
Originla skirting's and plaster.  
2<sup>nd</sup> Flr front room.  
No Panelling

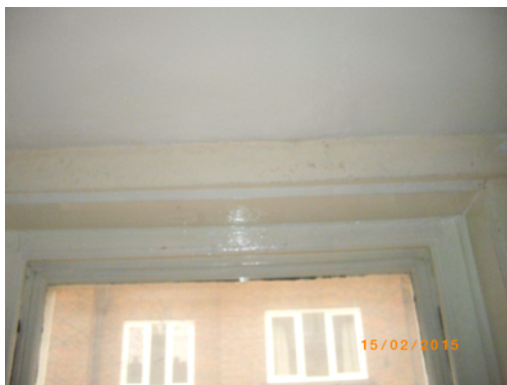
The vertical sliding sash windows on the front elevation (1<sup>st</sup> & 2<sup>nd</sup> floors) are of some age, not necessarily original, probably early Victorian (1800) single pane per sash, or the sashes were altered in the Victorian era (from maybe six pane) and the frames are original.

Window surround 2<sup>nd</sup> Flr  
Front Room

We also propose to replace the eight vertically sliding sashes (four windows, front 1<sup>st</sup> & 2<sup>nd</sup> flr) with six over six panes sashes, vertically sliding (see drwg). The existing frames will remain in position with the sashes being remade. We will be upgrading the glass, but the sashes limit the use of double-glazing.

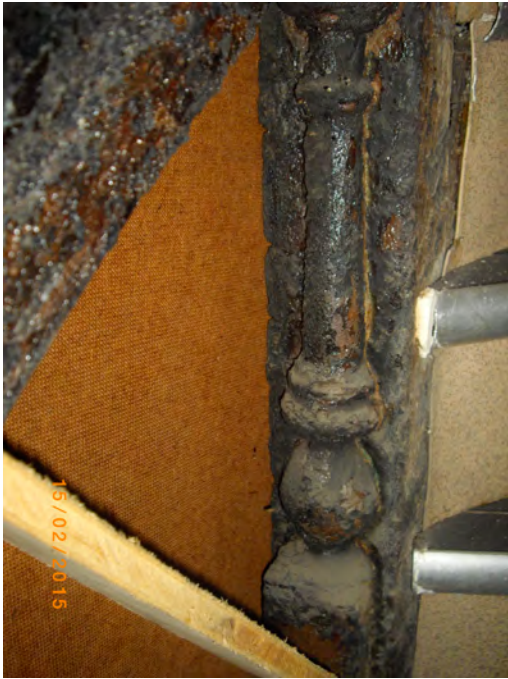
The domestic staircase serving the upper floors has in the past been badly damaged by fire, a lot of the charred remains have been left in place and then over-clad (see attached photos and drawings). The treads and risers are uneven and tilt from the horizontal. The stairs have been used lightly over the past 40 years as a single older lady occupied the residential property until the early 2000 when she passed away.

We have provided a structural conditional survey confirming that the existing staircase is not fit for purpose (within the design access statement) as it was severely damaged during the fire in the 1960's. It has been over clad with hard board and the treads have also been re-supported and over clad. The treads and risers are uneven and tilting throughout the building.

Damage to Staircase, covered with hardboard.

It is the intention to replace the existing closed string timber staircase of simple Georgian town house style with a new staircase matching the existing design and proportion of the original. We will copy as many of the timber sections as possible and will maintain the same winders, treads and nosings as the original staircase. The handrail will be of the same section and set at the same height as the original staircase (below present day standards). The Balusters will also be of the same section and spacing (again set greater than the Part K of Building regulation 100mm centre to centre).

The main design change is that we are proposing to hand the staircase. At present it winds anti-clockwise up the building, which originally allowed for a rear door access to the back yard beneath ground to 1<sup>st</sup> floor staircase. This is no longer required and we are proposing to reverse the staircase to a clockwise direction, occupying the same space as the original staircase.

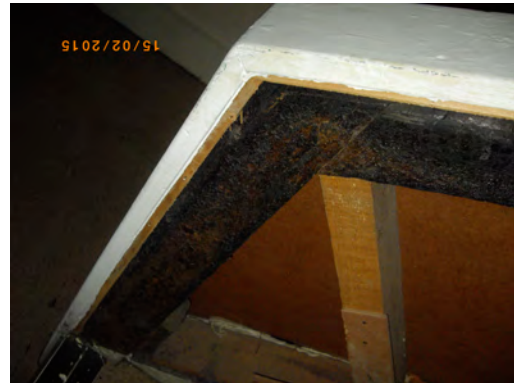
Handrail charred badly

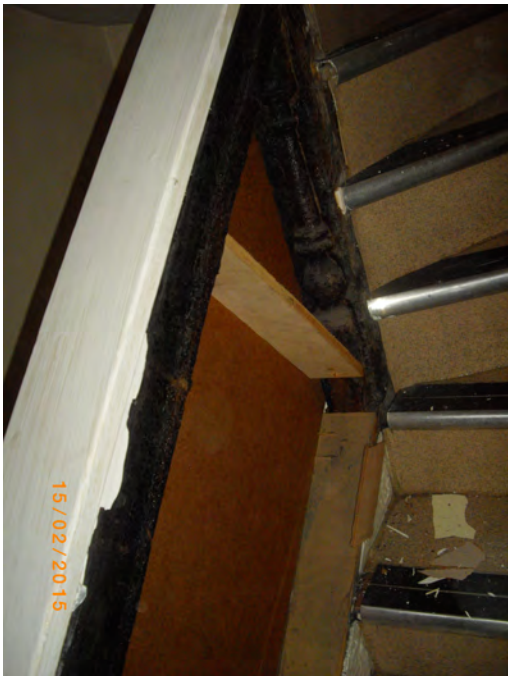
Uncovered banister
