March 2015
CBA10274 v1

ARBORICULTURAL DEVELOPMENT STATEMENT

Site:
5-7 Lancaster Grove, London NW3

Arboricultural Implications Assessment and Method Statement

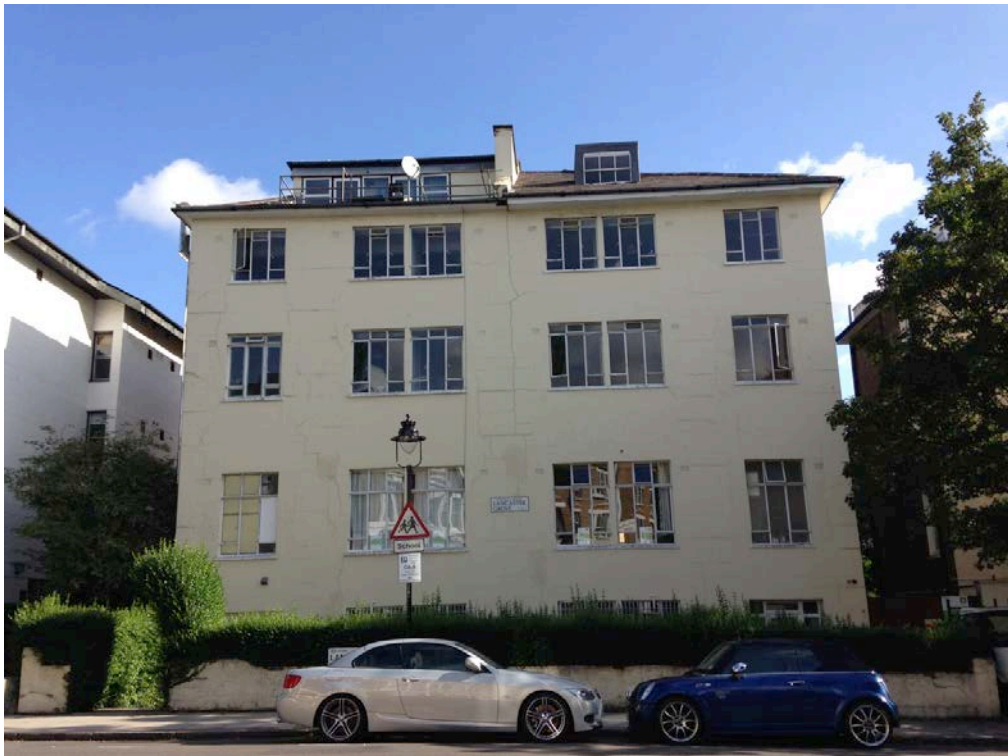
- 3.2 **Photograph 1:** A view of the existing building from Lancaster Grove

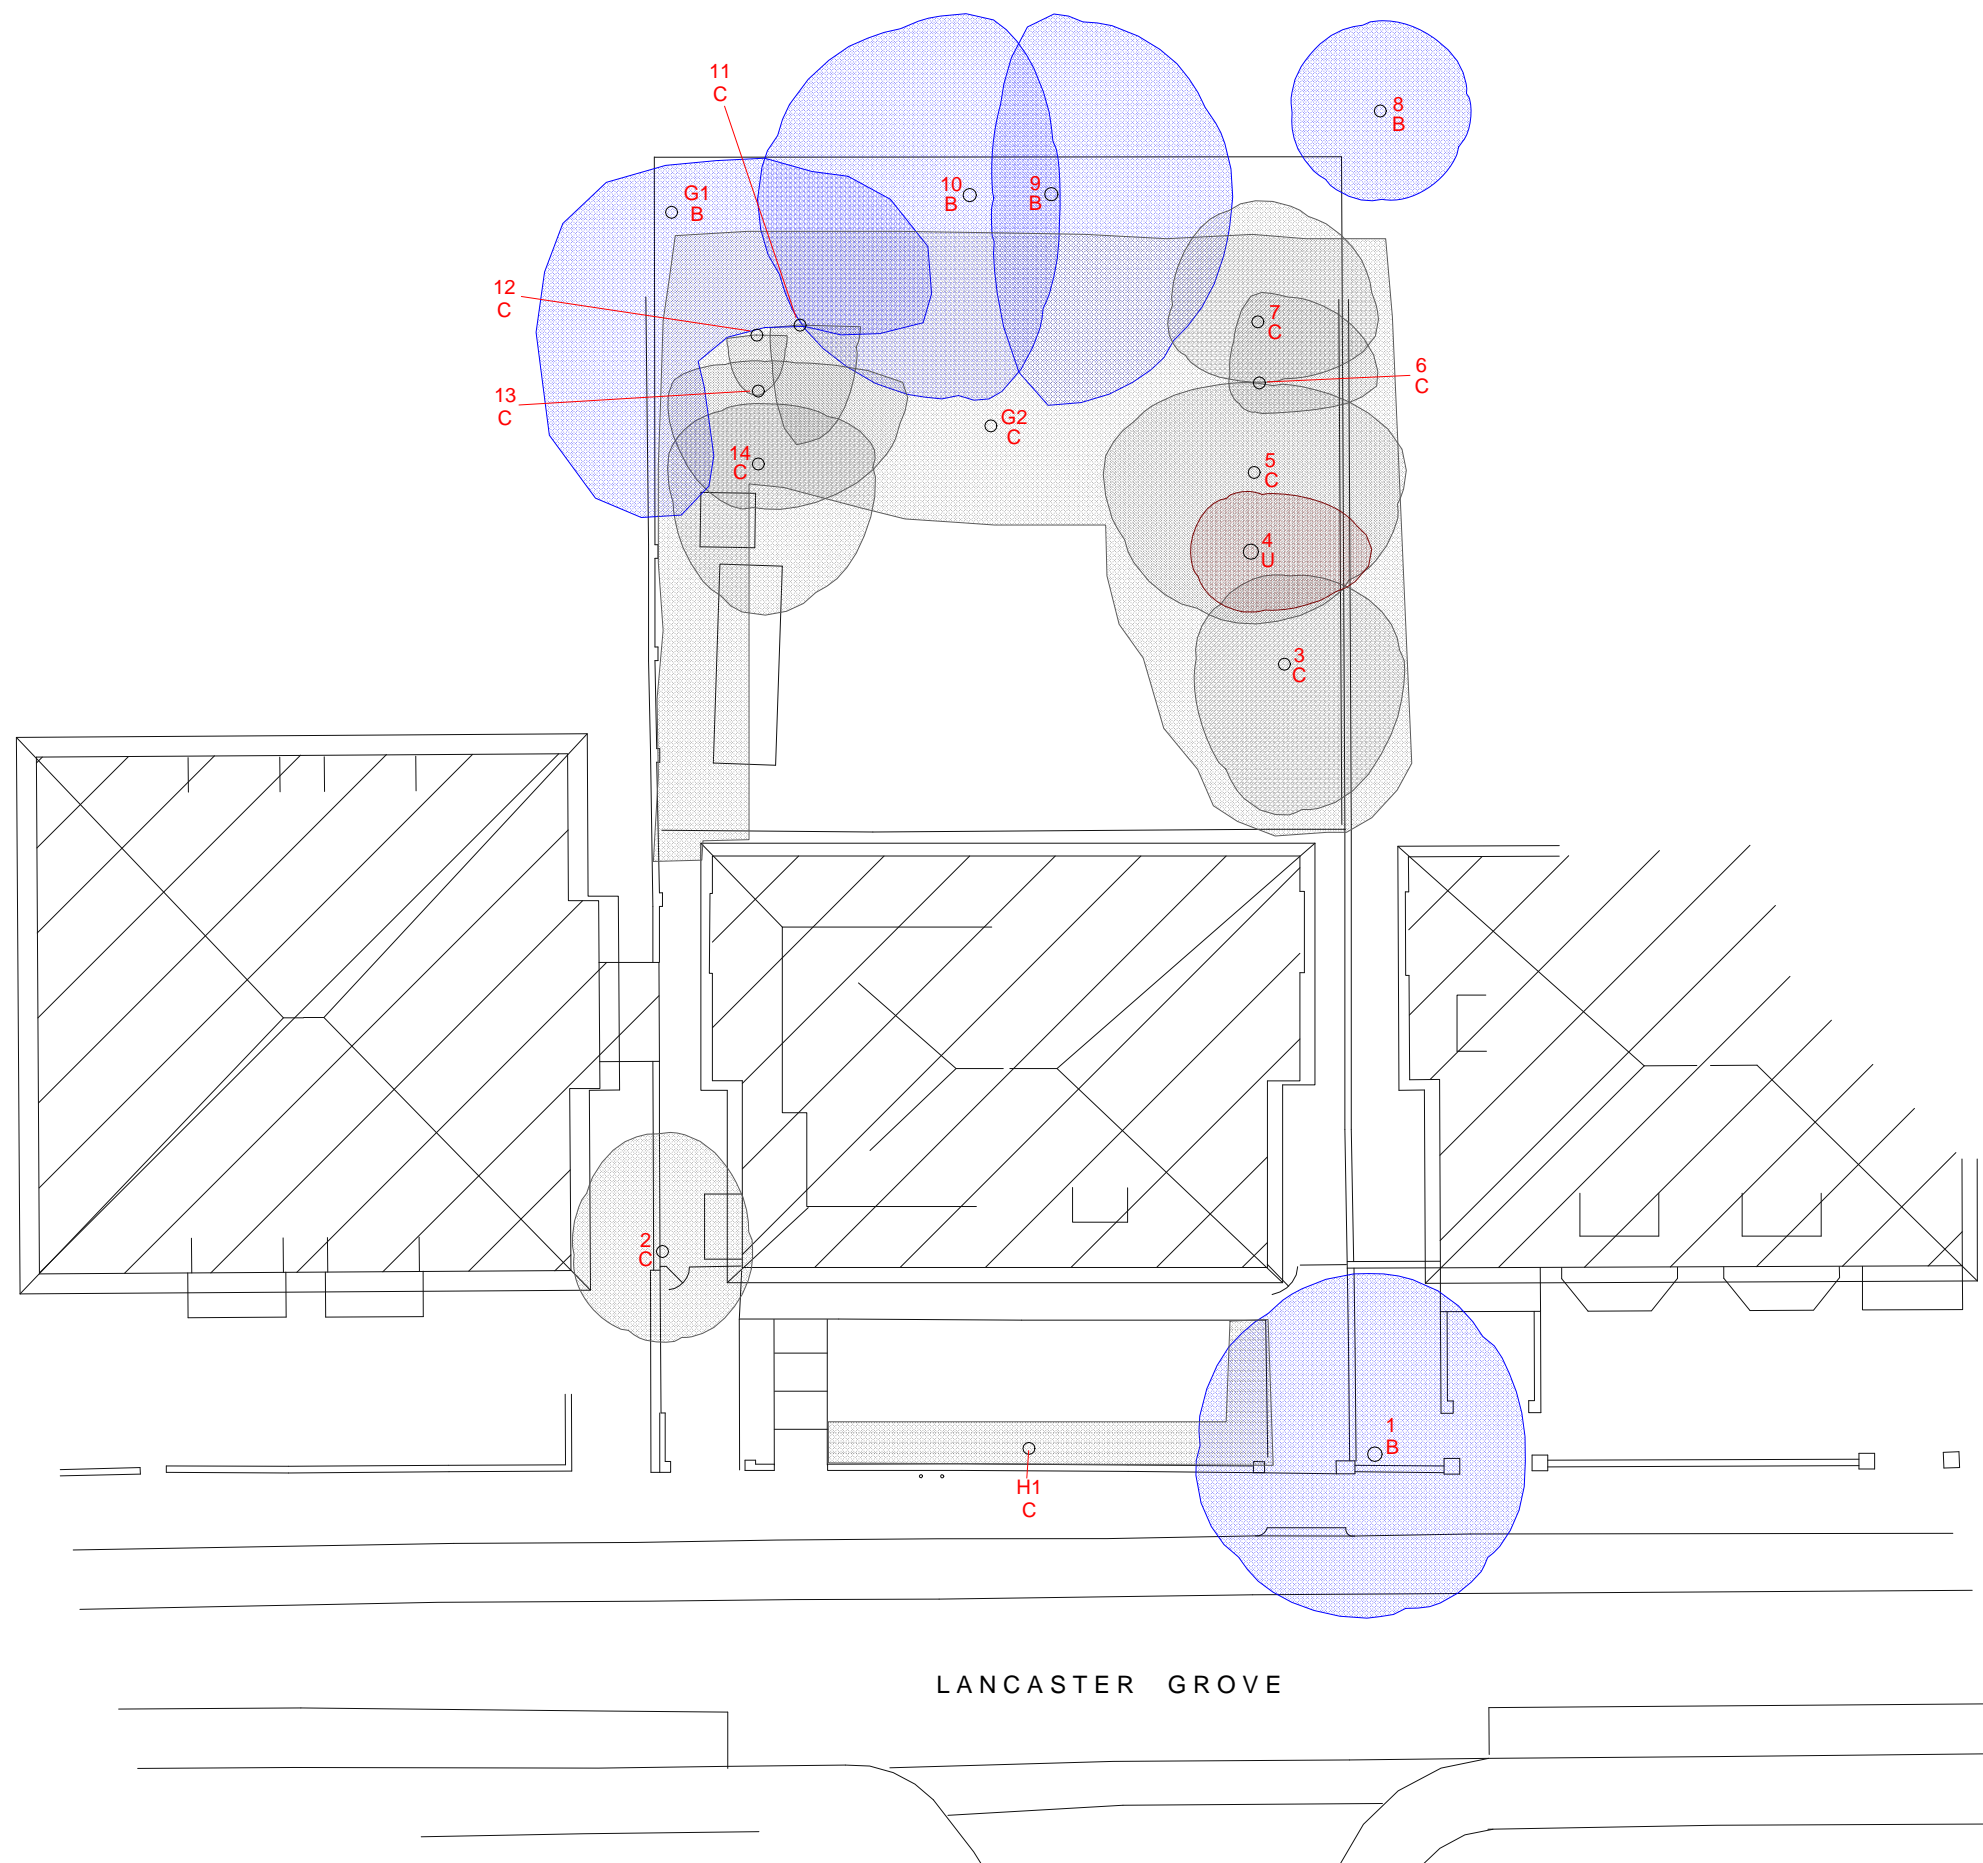
10274
5-7 Lancaster Grove, London NW3
Tree Survey Plan

- 4.1 A tree survey was undertaken by CBA Trees on 11th August 2014 that identified 14 (fourteen) individual trees, 2 (two) groups of trees and 1 (one) hedge. The Tree Survey Schedule is appended at CB1 and Tree Survey Plan (CBA10274.01) is appended at CB2.
