Arboricultural Impact Assessment Report

Castlewood House & Medius House, WC1A

SITE Castlewood W1A New Oxford Street London

OUR REF: SHA 188 Rev A

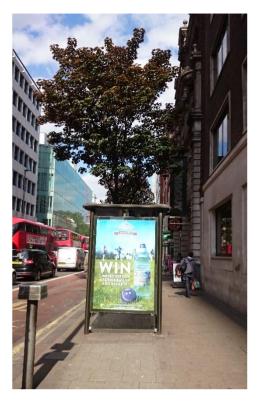
Photo 1 of T1 looking east

These are both street trees managed by Camden Council. They are of moderate value and in early maturity. They are 10.5m high with an average crown spread of 6m. They have been historically crown lifted to clear the traffic, however T1 has a large wound on the lowest branch over the road as a result of being hit by a passing vehicle. I recommend that this damage should be pointed out to the tree officers at Camden Council so that they can prune this branch.

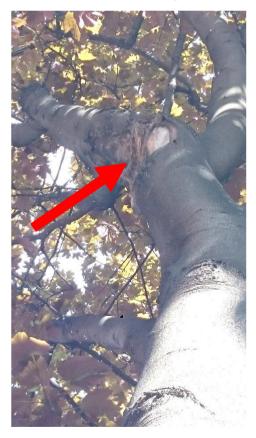
Photo 3 of the damaged branch on T1

This should be pruned to reduce the strain on the wound

- 8.8. That the tree protection for the two street trees, T1 and T2, is discussed with the contractor, Camden Council and the arboricultural consultant at the site planning (construction layout and logistics) stage, but the principle of protecting the trees is incorporated in the tender package for the contractor.
- 8.9. That the method statement for changing the surfaces and removing the cycle stands around T3 and T4 is carried out in accordance with a method statement approved by the landscape architect, Camden Council street trees, the contractor and arboricultural consultant, and that this is carried out under arboricultural supervision (Camden Council, or arboricultural consultant).
- 8.10. That the damaged branch to T1 is inspected by Camden Council for their consideration.

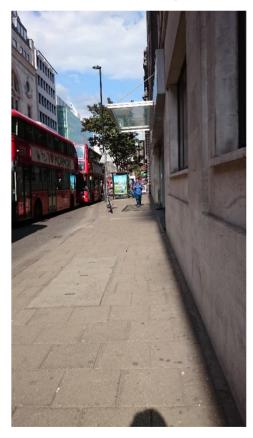
Photo 4 of T1 and T2 looking east showing the expanse of pavement leading up to the trees

Arboricultural impact assessment: The trees are within the ownership of Camden Council. A proposed north-south footpath from Bucknall Street to New Oxford Street will open up a vista of T1 from the south. There may need to be some very light pruning of the crowns of the trees on the southern side to facilitate scaffolding. This should be planned ahead as Camden Council would need to agree to, and carry out, these works. The tree protection will be determined between the consultant, council, and contractor.

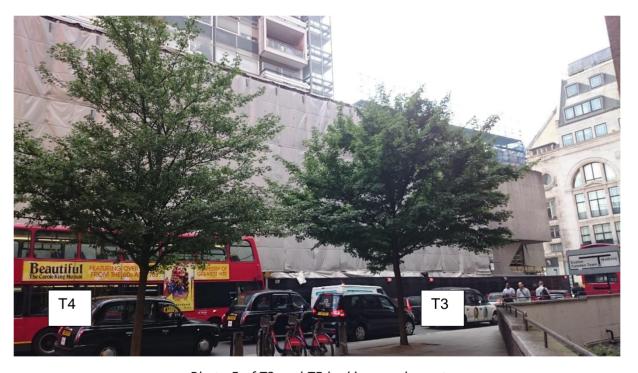
Photo 5 of T3 and T5 looking north-west

These two early mature trees are growing in a wide stretch of pavement on the western side of Castlewood House, fronting Earnshaw Street. They provide an attractive focal point and are the only trees in the immediate vicinity. T3 is a very good example of its species and has been classified as an A class (high value) under BS 5837:2012. It is 7m high with a crown spread of 7m. T4 is also an important tree, but with a very slightly lower vitality than T3.

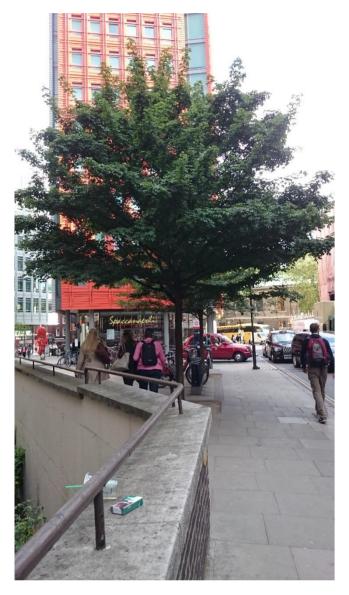
Photo 6 of T3 looking south. The wall enclosing the sunken courtyard will be acting as a root barrier.

Arboricultural impact assessment: The root protection areas of the trees do not extend up to the wall, therefore the demolition of the wall, or any changes of level within the courtyard (if required) do not require an arboricultural method statement.

- 8.6. That no tree works take place until consent is granted.
- 8.7. That the two trees T3 and T4 have their trunks triple wrapped in hessian during the external works phase only. This will need to be agreed with Camden Council.

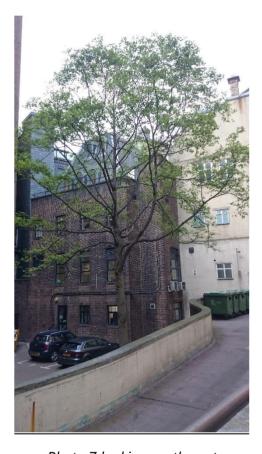
Photo 7 looking north-east

This tree is growing in the sunken parking courtyard on the southern side of Castlewood House, accessed by a sloping drive. It is the largest tree of the survey (at 16.5m tall with a crown spread of 9.5m). The crown has fewer leaves than typical of the species, and the leaves that are present are slightly smaller than expected and some branches have died. There are a few bleeding exudations on the trunk at the lower level. All these factors indicate that the tree is in decline and unlikely to have a safe useful life expectancy beyond ten years. The roots are lifting the tree grille and causing lifting of the paving blocks due to the upward force of growing roots.

Arboricultural impact assessment: The tree will need to be removed to facilitate development. Whilst this is the largest tree, it is in decline and development provides an opportunity for new planting. Large canopy trees are important as they provide greater ecological, environmental and landscape benefits, therefore I recommend that this tree is replaced with two large canopy trees which is a matter for the landscape architect.

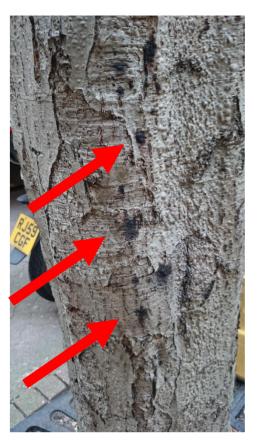
Photo 10 of the trunk showing gummy exudations

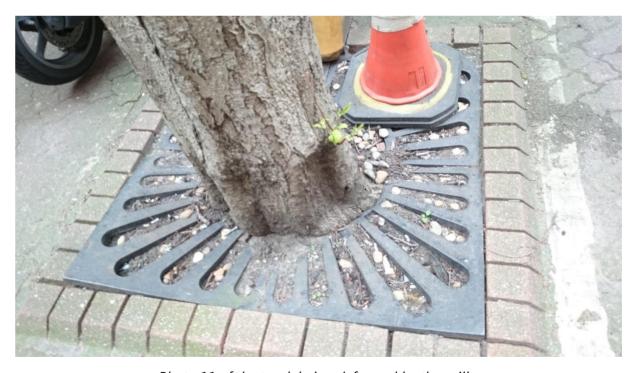
Photo 11 of the trunk being deformed by the grille.

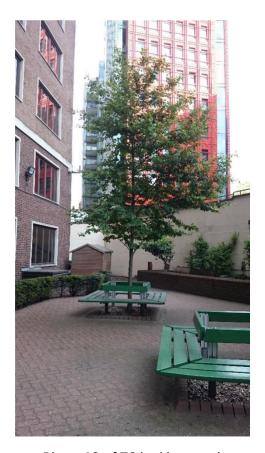
Photo 12 of T6 looking south

This tree is growing within a sunken courtyard on the western side of Castlewood House used by office staff. It is 7m high with a crown spread of 4m. It is in good health, but can be replaced by a similar sized tree as part of the landscaping scheme. The hedges (H7 and H8) are 0.5m high and managed by regular clipping to edge borders. The shrubs are an untidy, disparate group of low value.

Arboricultural impact assessment: The tree, hedges and shrubs will be removed as part of the proposal. I do not consider that this should be a constraint on development as the public realm will provide greater benefits.
