Basement Impact Assessment

Site | 5 Templewood Avenue
London NW3 7UY

Our Ref | BIA/6162 R1.1

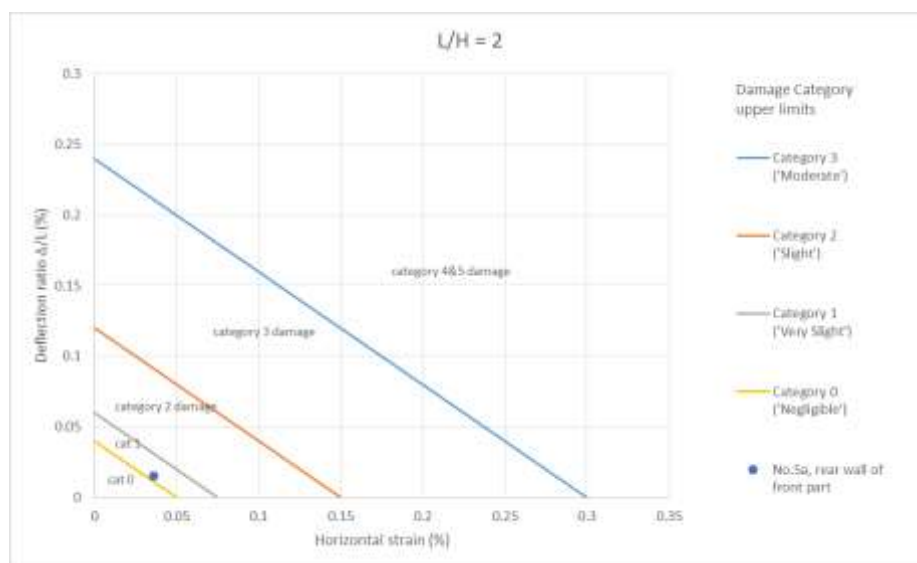
Figure 12: Damage category assessment for rear wall of front part of No.5A.

- 10.6.8 Once again a zero vertical displacement was predicted by the PDISP analysis in Stage 1 for this part of No.5's north-east flank wall and only the settlement caused by relaxation of the ground alongside the basement in response to excavation of the underpins is relevant to the damage category assessment. Using the low support stiffness profile on Figure 2.11b from CIRIA Report C580, gave a maximum deflection beneath this wall of, $\Delta = 0.054\%$ of excavated depth = 1.86mm. This represents a deflection ratio, $\Delta/L = 1.5 \times 10^{-4}$ (0.015%).
- 10.6.9 Using the graphs for $L/H = 2$, these deformations represent a damage category of 'very slight' (Burland Category 1, $\epsilon_{lim} = 0.05\text{-}0.075\%$) as given in CIRIA SP200, Table 3.1, and illustrated in Figure 12 below.

- 10.6.10 Use of best practice construction methods, as outlined in paragraphs 10.4.4 to 10.4.7 above, will be essential to ensure that the ground movements are kept in line with the above predictions.

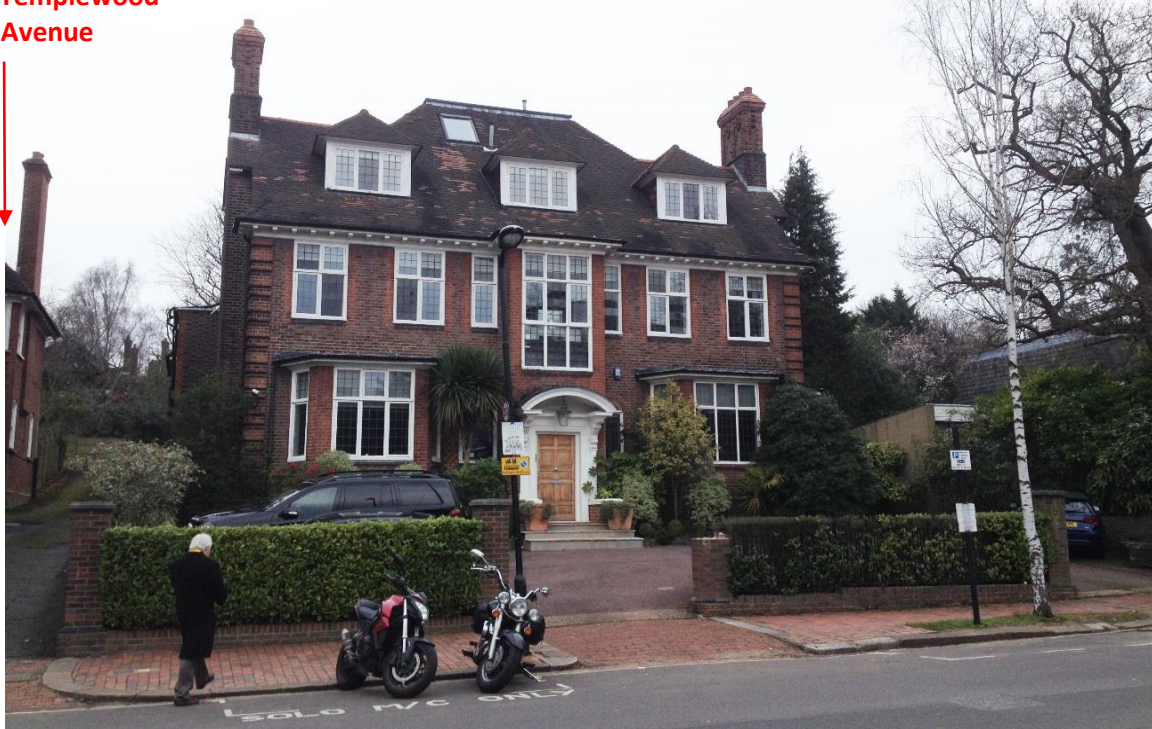
Photo 1: Front elevation (street scene). No.5 Templewood Avenue is a large, three storey detached house situated on the north side of Templewood Avenue.

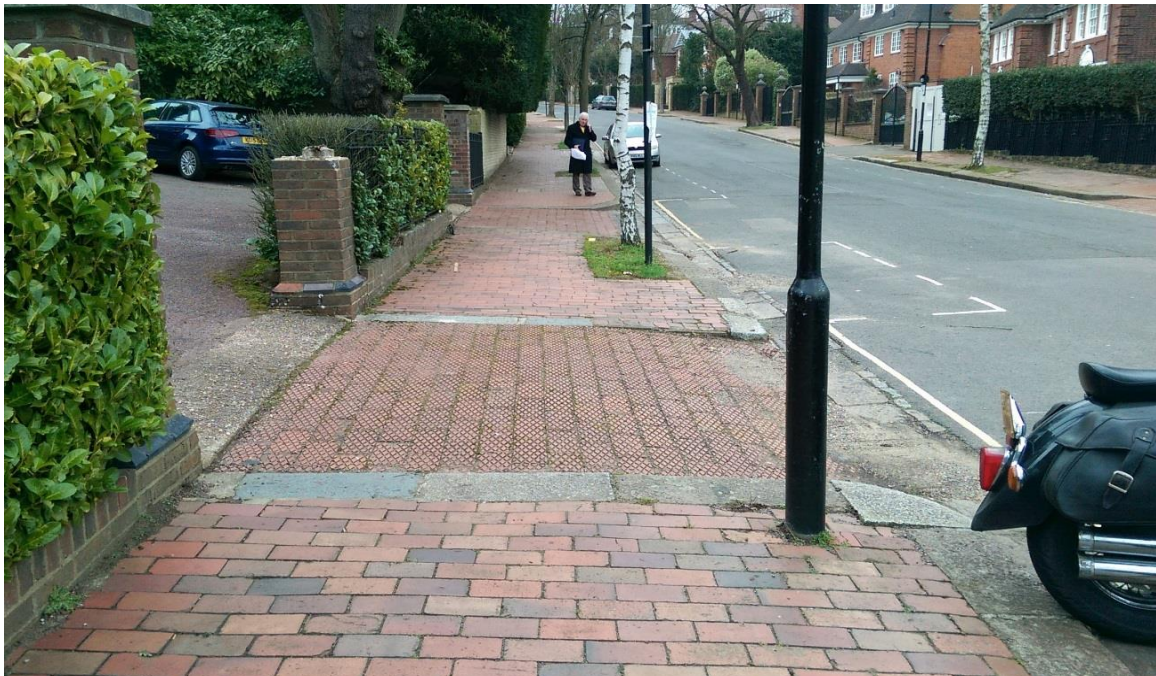
Photo 2: The footway in front of No.5 falls gently towards the Templewood Avenue carriageway, away from the property. In the vicinity of No.5, the Templewood Avenue carriageway falls very gently to the south-west, however further to the north-east, it falls more steeply.

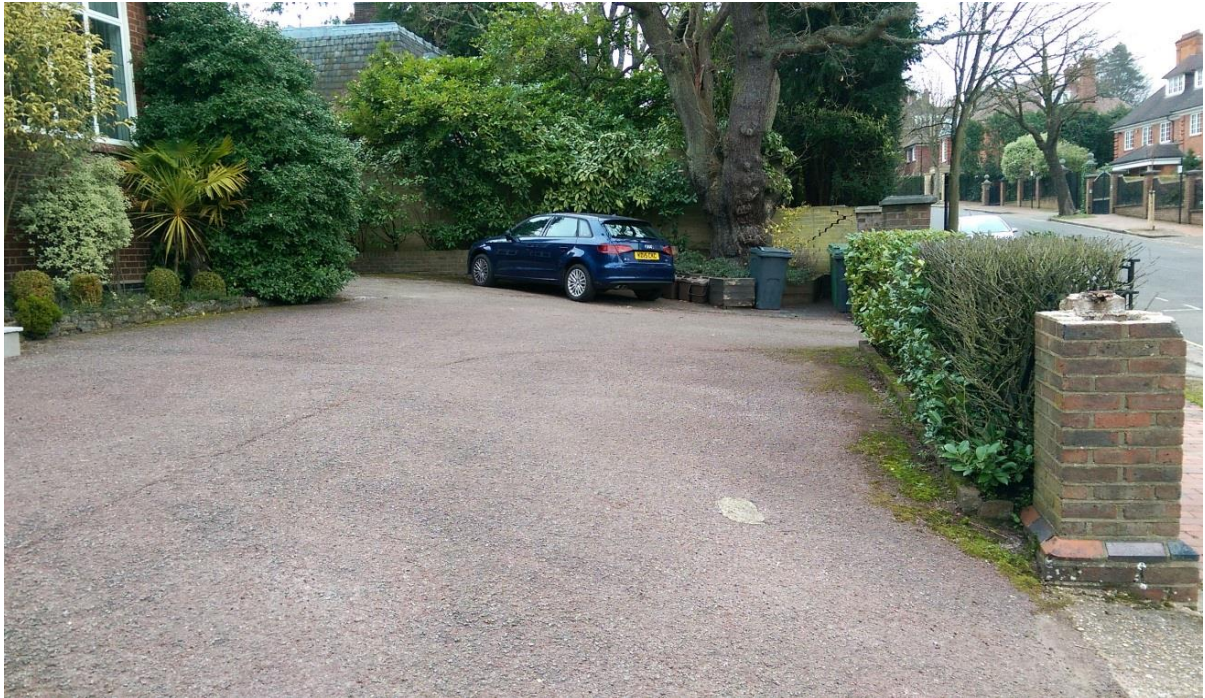
Photo 3: Externally there is a large parking/amenity area at the front of the house which is predominantly surfaced with asphalt, with a distinct fall towards the Templewood Avenue carriageway, away from the front of the house.

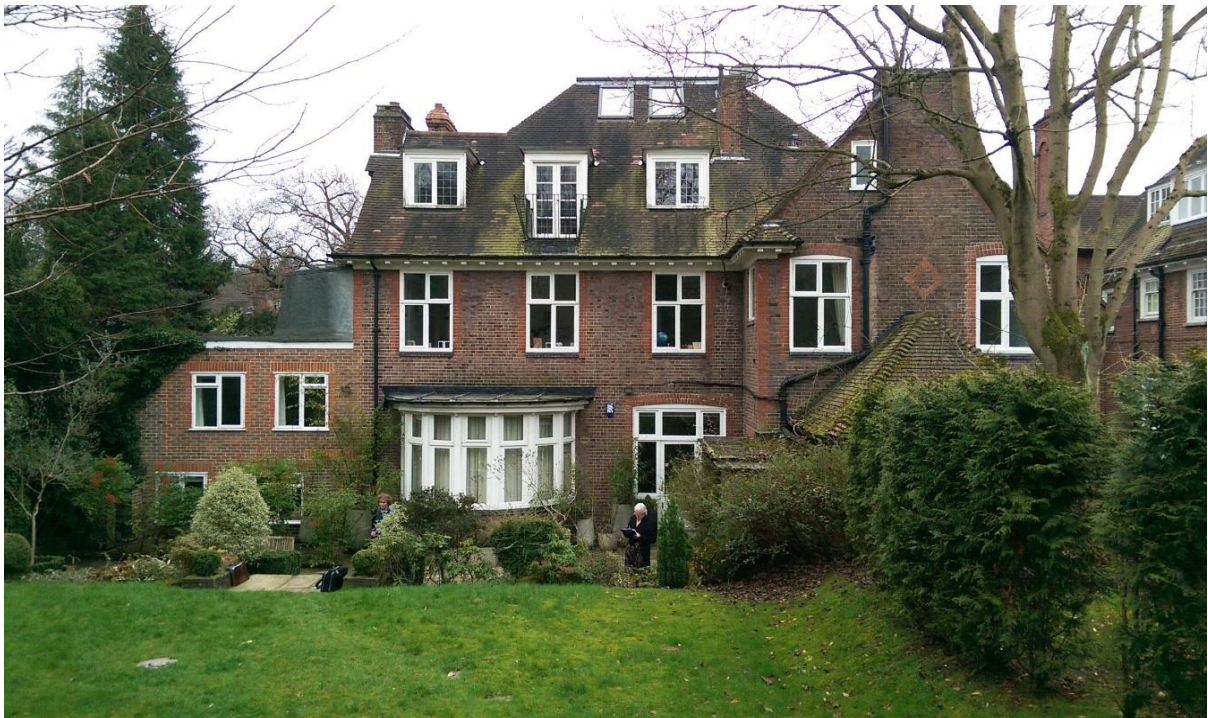
Photo 4: Overall, the rear garden falls relatively steeply towards the rear of the house, however it has been terraced, to form two broadly level areas.

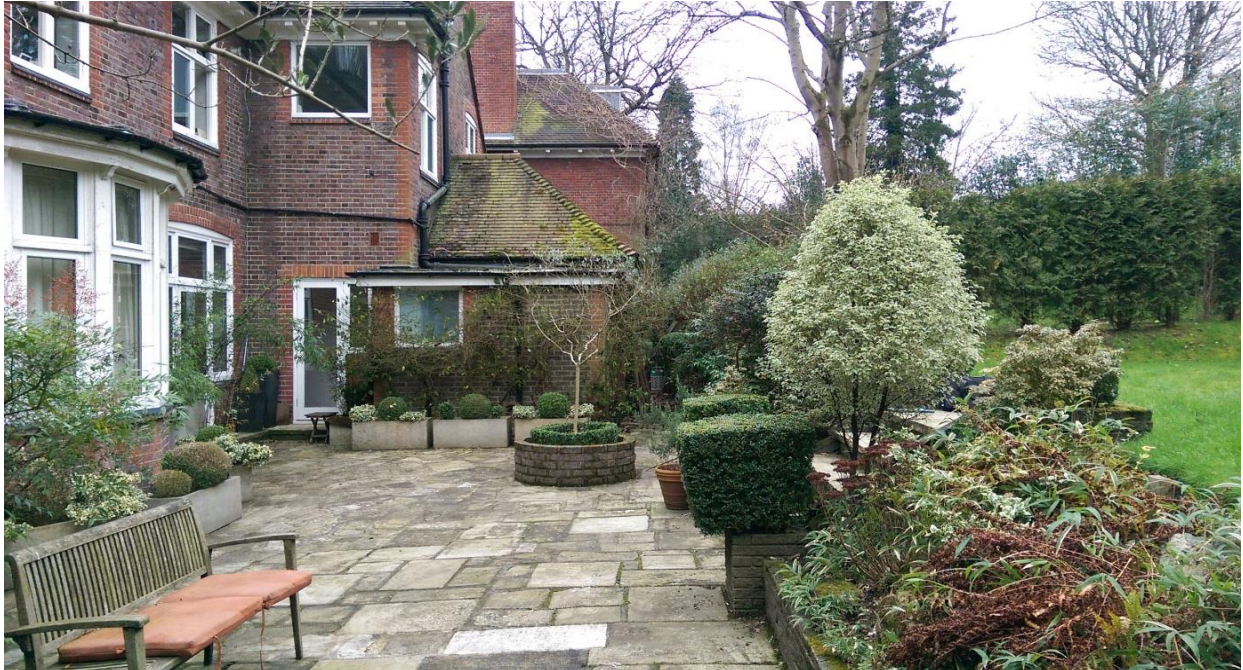
Photo 5: To the rear of the house, there is a large patio area which adjoins the rear wall of the house, within which are raised herbaceous borders. Upslope of this patio is an area which has been mostly laid to lawn.

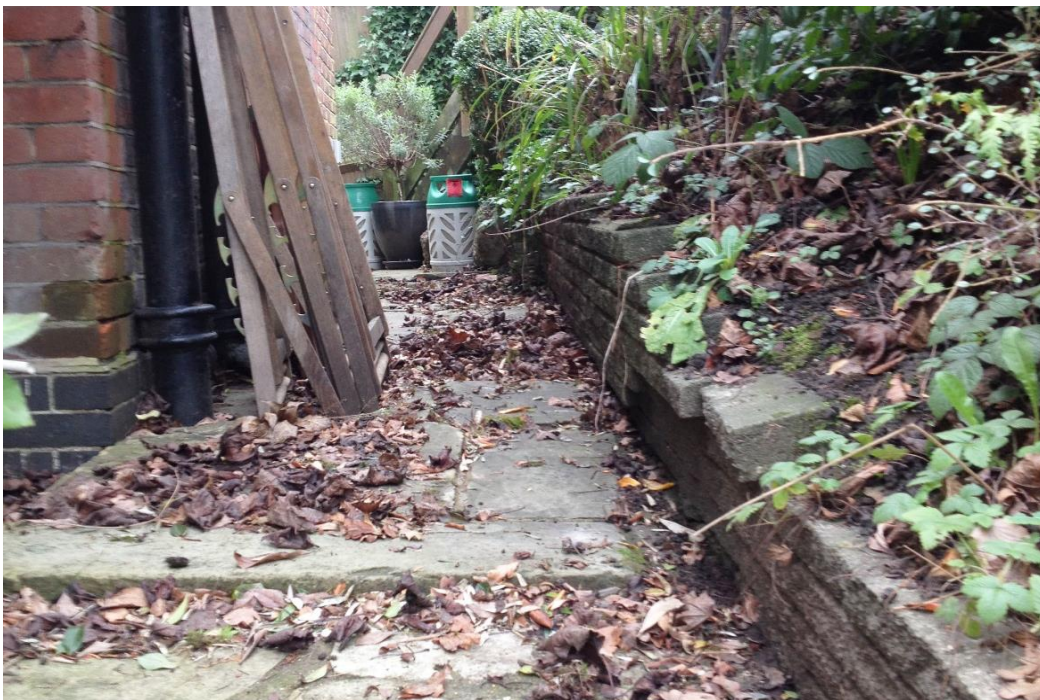
- 2.4 No evidence was seen of major crack damage to the superstructure of No.5 Templewood Avenue, however within the rear garden, immediately to the rear of the single-storey projection, the low retaining wall which separates part of the rear patio from a planting area appeared to be failing, and is leaning towards the house (Photo 6). At the front of the property, the south-western brick boundary wall which separates the front parking/amenity area to No.5 from the access road to the garages shows some crack damage, some of which may have been caused by an impact with a vehicle (lorry/van?). On the opposite side of the front parking/amenity area, the brick boundary wall which separates No.5 Templewood Avenue also shows significant crack damage, which is thought to have been caused by tree root activity, given the close proximity of a large Oak tree (trunk and damaged wall visible in Photo 3).

Photo 6: Immediately to the rear of the single storey extension, the low retaining wall which separates part of the rear patio from the herbaceous border was seen to be failing. It was both leaning towards the rear of the house and had slid forwards on one of the mortar beds.
