Bangor Wharf

Report on Trees
Broad Oak Tree Consultants Limited

**ARBORICULTURAL IMPLICATIONS ASSESSMENT
FOR
PROPOSED REDEVELOPMENT**

**BANGOR WHARF
LONDON
NW1 0QS**

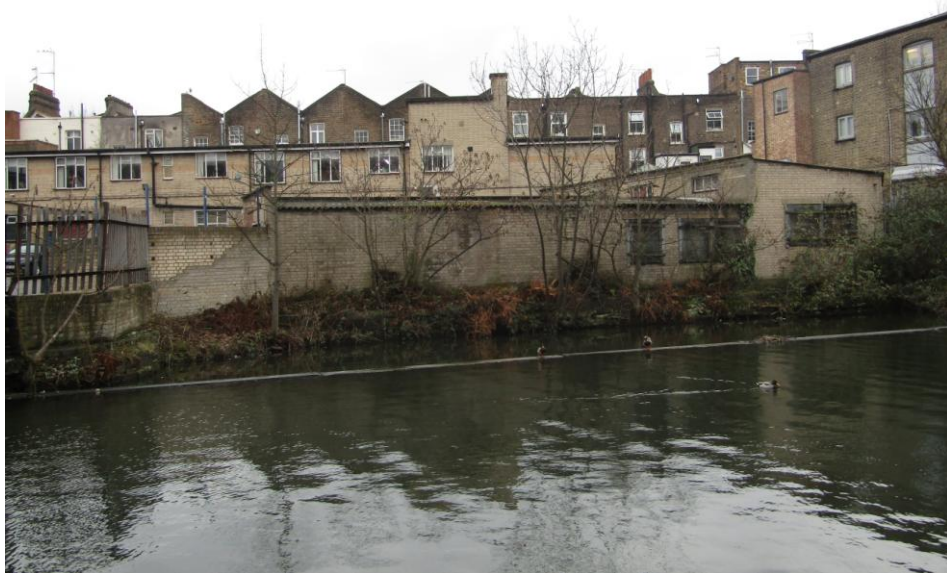
G3 Sycamores growing along edge of Canal

- 8.3 G3, Sycamore, would need to be removed to allow for repairs to the Canal edge and future growth potential would be incompatible with the proposed buildings. G4, Sycamores, are also in unsustainable locations in terms of any reactivation of the site in its current form or in relation to the proposed buildings.

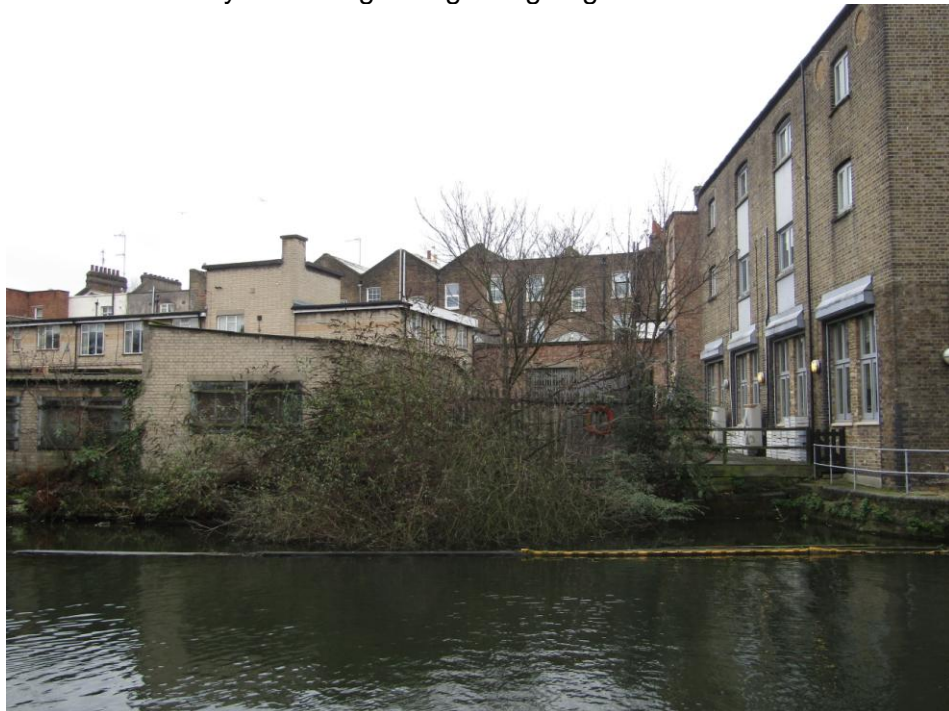
G4 Sycamores within fence lines of a restricted access area

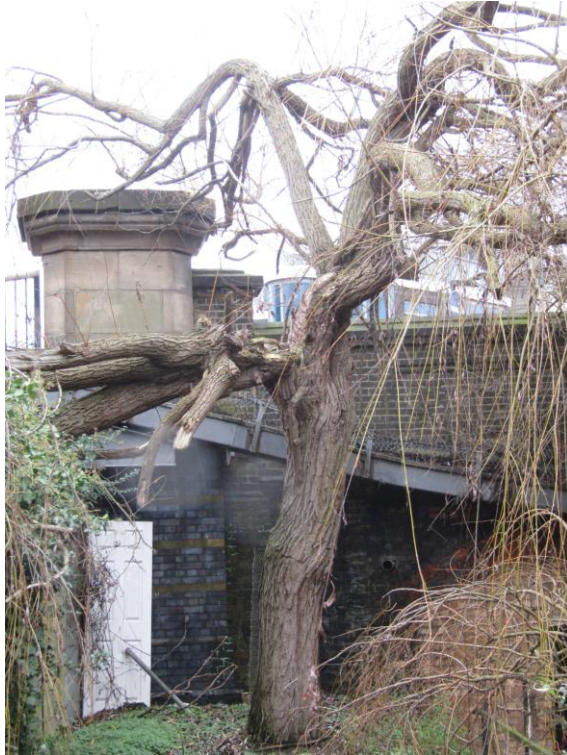
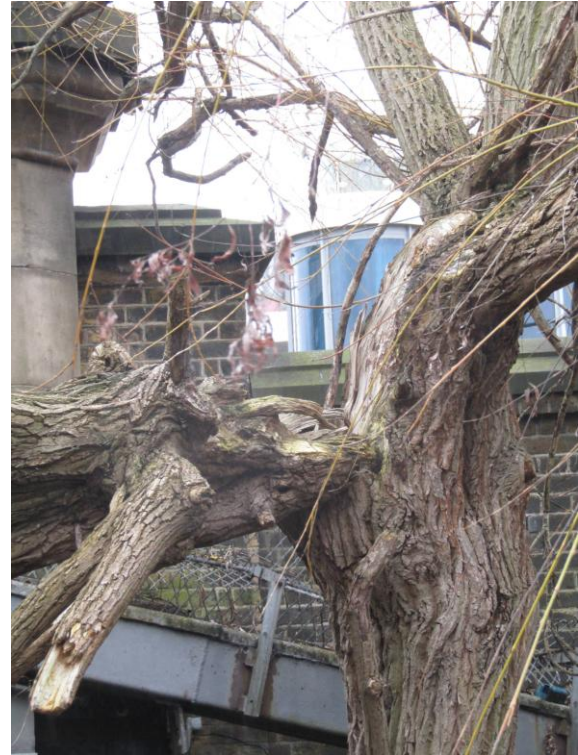
- 6.2 The Willow, T1, was previously assessed as providing some localised visual amenity in its setting, albeit that its canopy was constrained by the bridge structure and rooting restrictions were severe.
- 6.3 Reinspection has discovered the since February 2015 the tree has suffered a catastrophic failure of over half its crown. This has collapsed into the Canal, crushing T2 Sycamore in the process.

Major collapse of canopy of Weeping Willow, T1, to north with extensive tearing back into remaining stem. Complete canopy failure inevitable.

- 6.4 The Willow is now considered to be in a dangerous condition. The collapsed part of the canopy requires removal to avoid detriment to the Canal and any use by vessels. The remaining section is at a very high risk of complete collapse. The tear wound extends back into the remaining support tissue, which is weakened by structural deformities. Within the remaining canopy there are several other partially torn/collapsed limbs and the tree is no longer in a viable condition. Consequently it has been classified as BS category U and requires removal on safety grounds.

- 6.5 T2, Sycamore, has been partially crushed, with one stem broken and requiring removal from the Canal and the other under significant loading from the collapsed crown of T1, if complete failure has not since occurred.

- 8.1 Based on the Proposed Ground Floor Plan, drawing no. SK206/P1 produced by TM Architects all of the trees detailed above would require removal.
- 8.2 Trees T1 and T2 will require removal on safety grounds, whether or not the redevelopment proceeds.

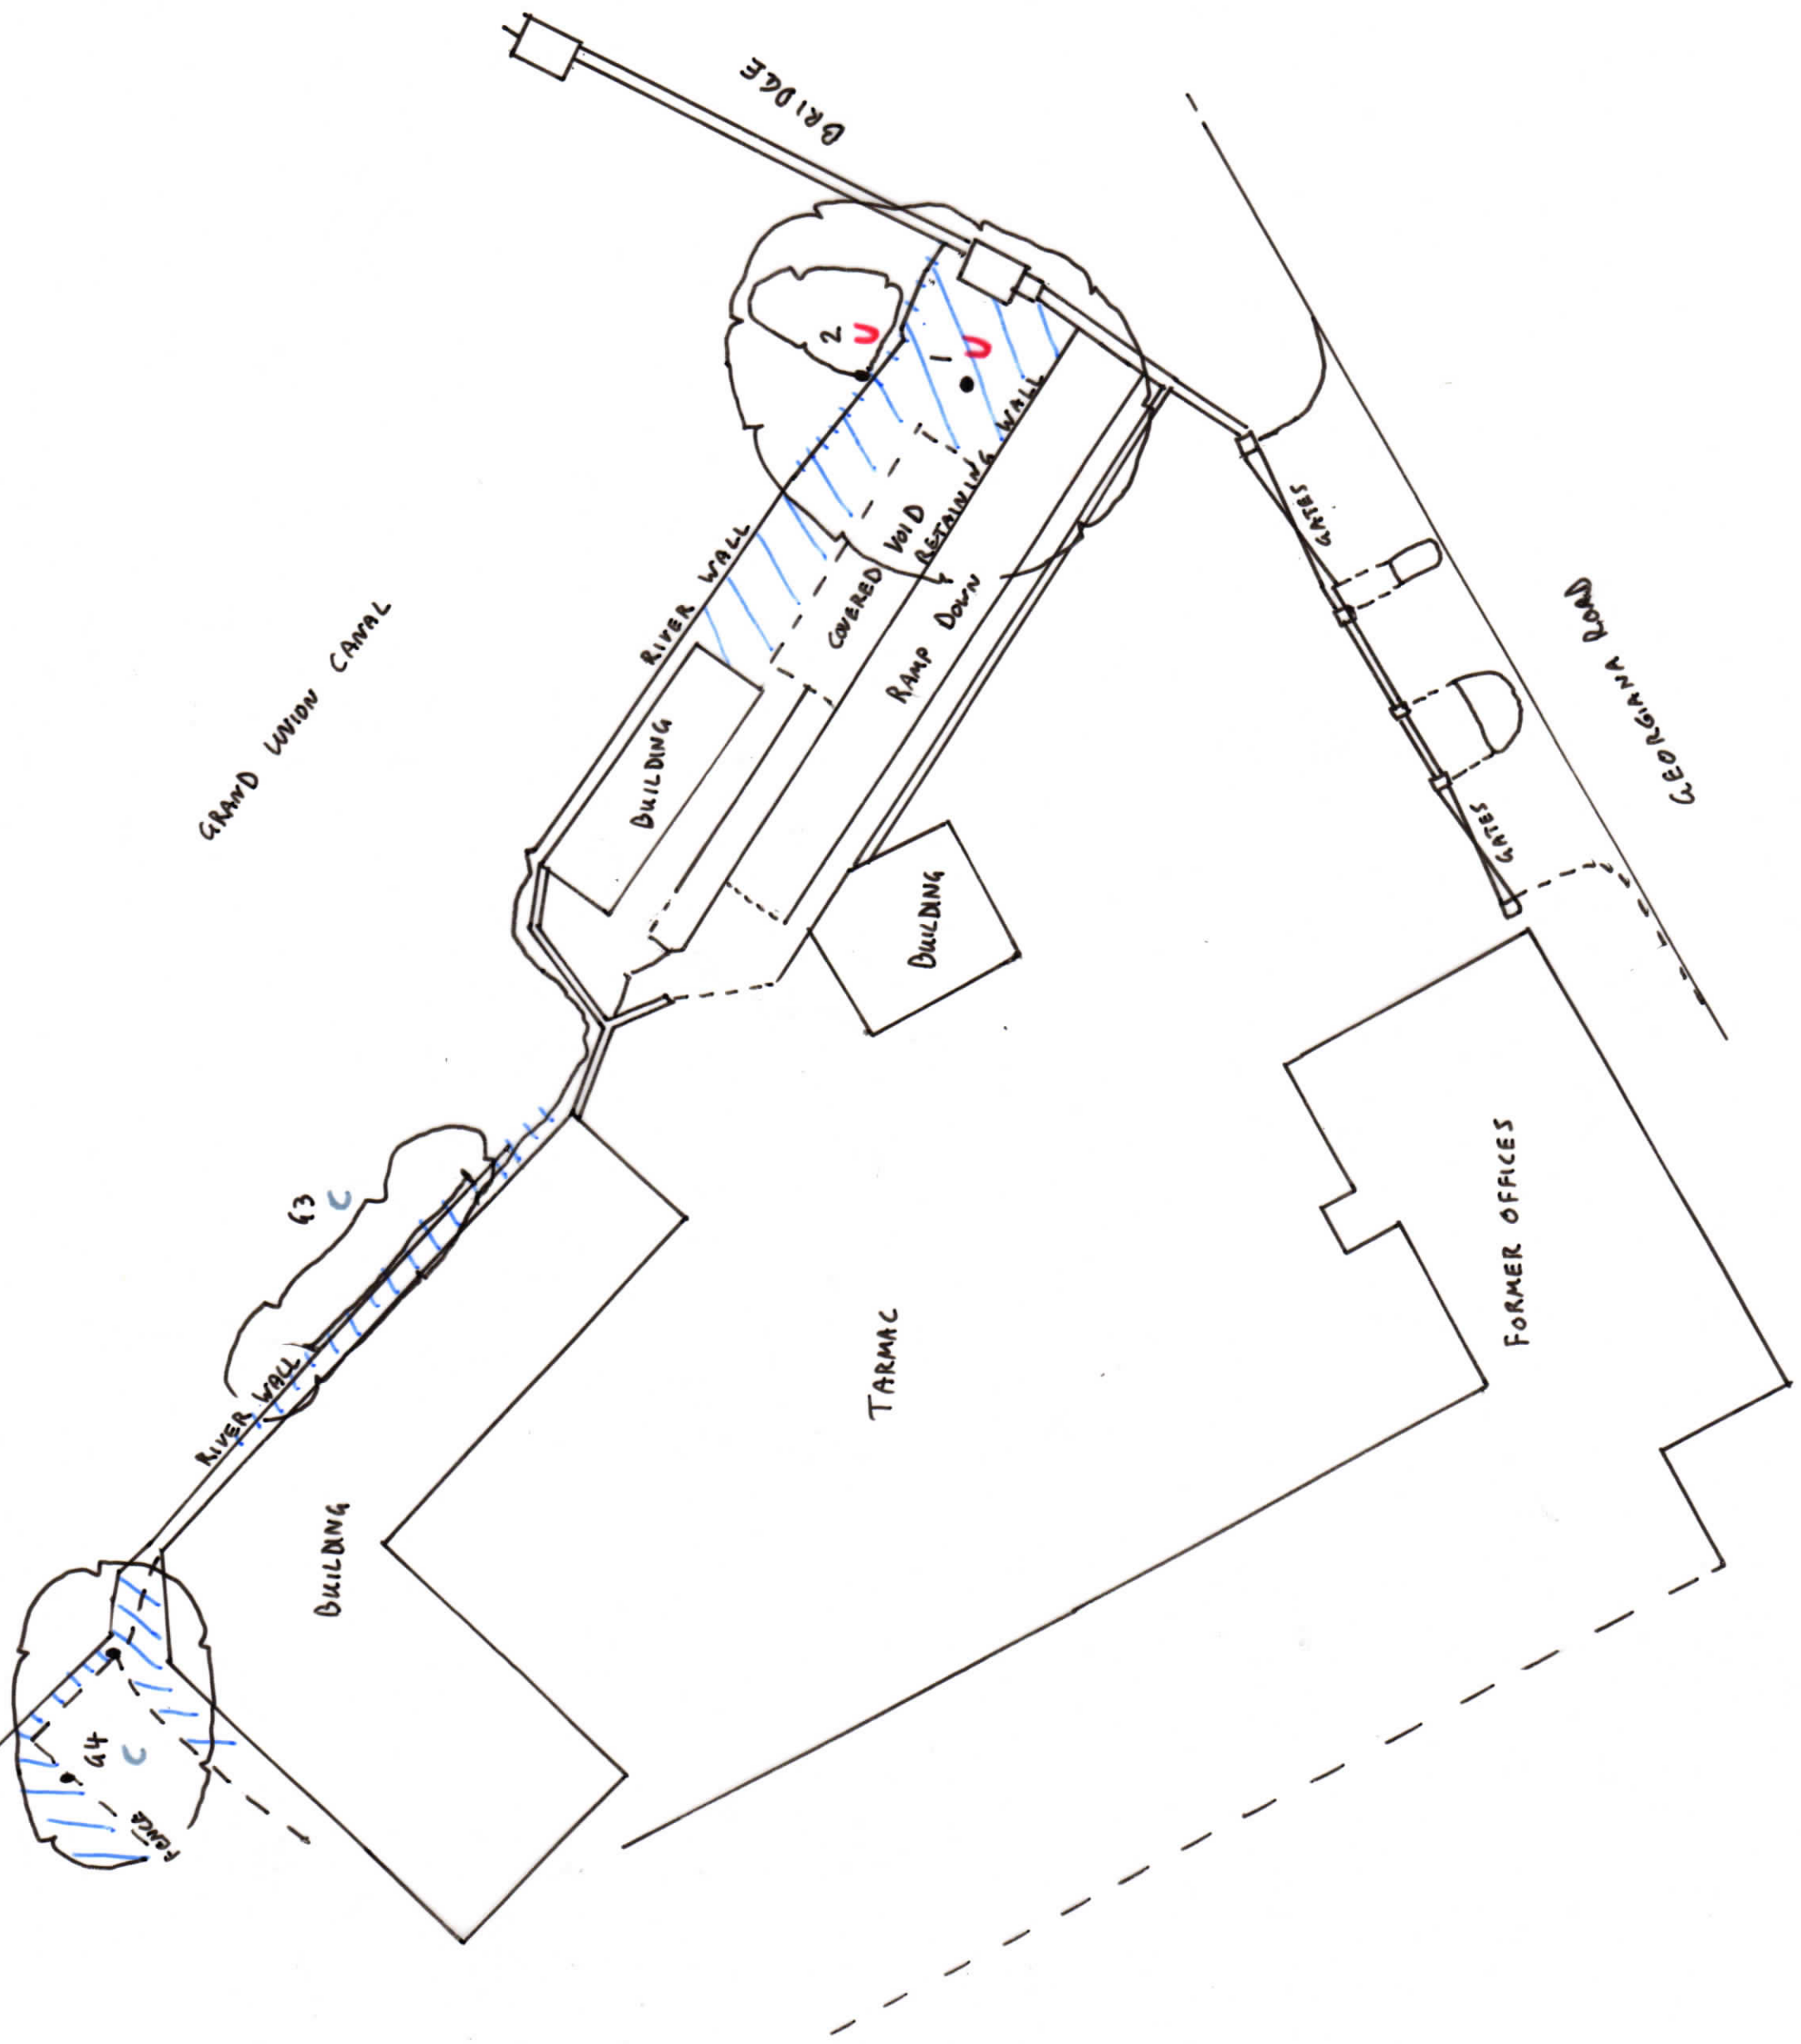
4.2 The tree survey followed the numbered sequence from T1 to G4 inclusive. Tree numbers, together with BS recommended colour coding of condition, have been added to the Tree Constraints Plan, our drawing no. J50.05/01 Rev. A in Appendix 2. This drawing also includes crown spreads based on four compass points and anticipated rooting areas, given the severe site constraints.
