The Elms, Fitzroy Park, London, N6 6HS.

Design Statement for the application to discharge planning condition 4a;  
Reinstatement of the tented veranda on the West Elevation.

Planning Ref: 2014/1313/L

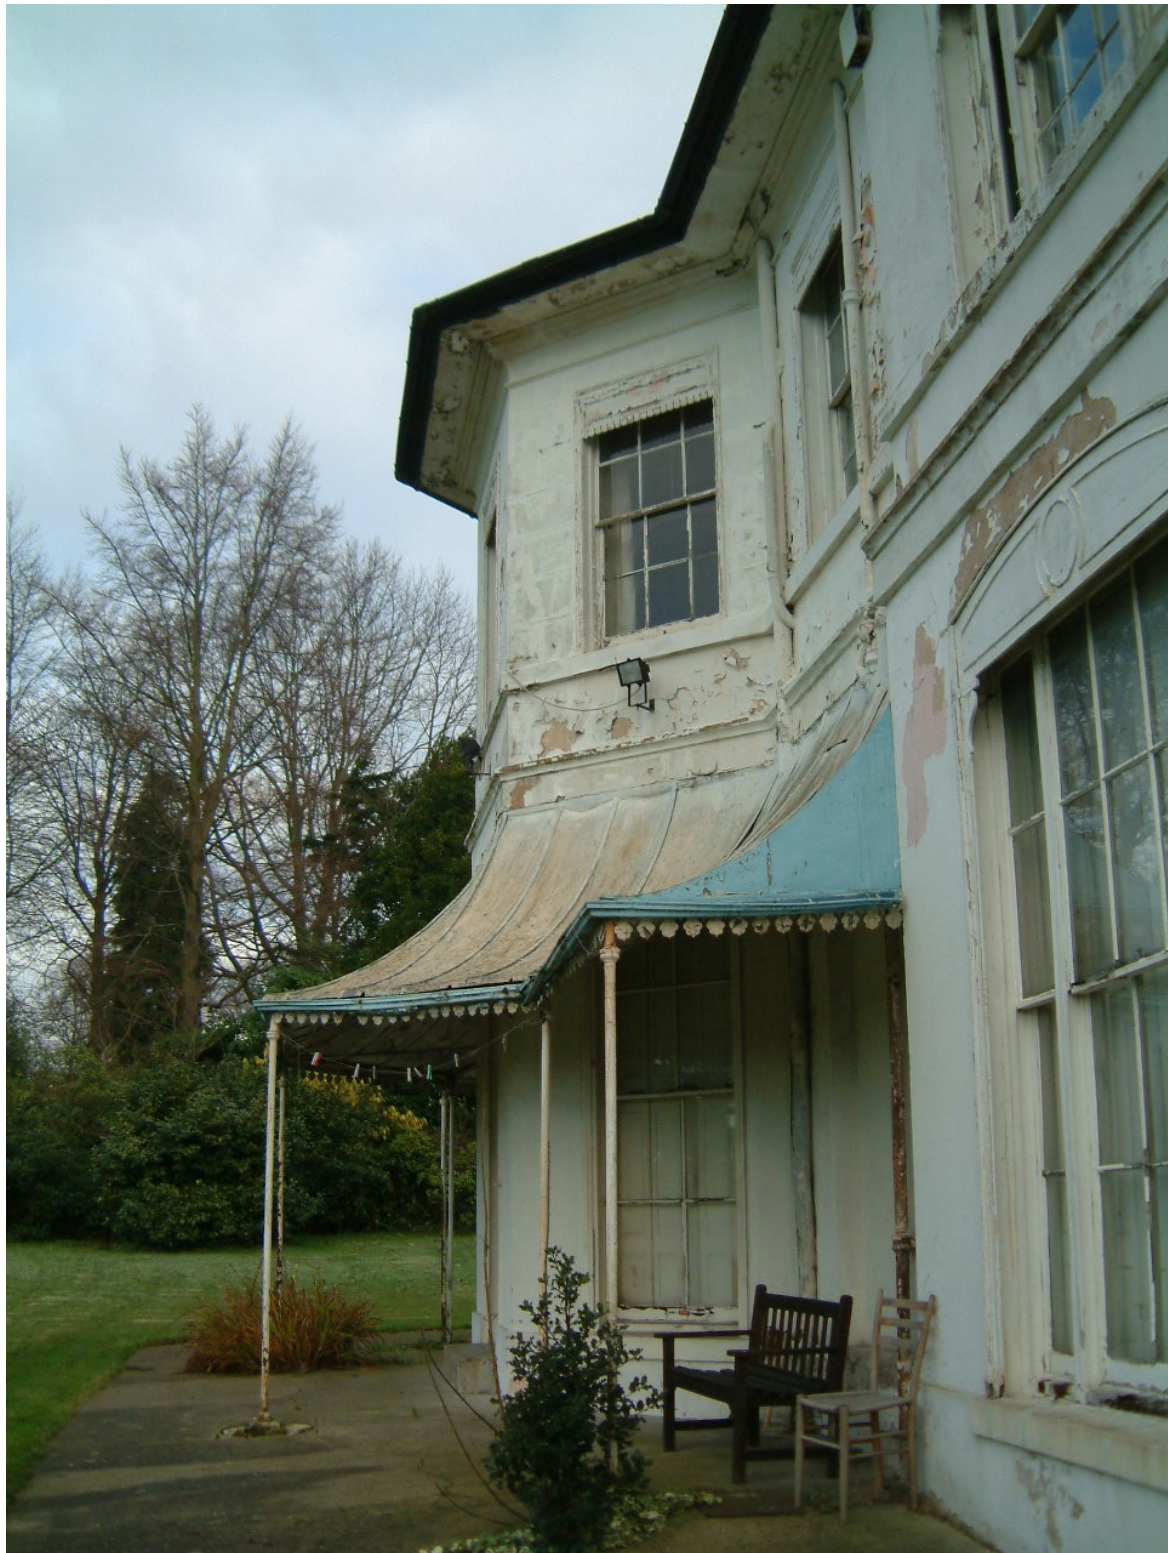
photo 1.

Historical photographs of the tented veranda taken prior to the works commencing in 2003.
