TREE SURVEY, ARBORICULTURAL IMPACT ASSESSMENT AND TREE PROTECTION PLAN

A report to accompany a planning application for the enlargement of the lower ground floor and an extension to the rear of 16 Hollycroft Avenue, London NW3 7QL.

15 September 2016

MDA reference F08

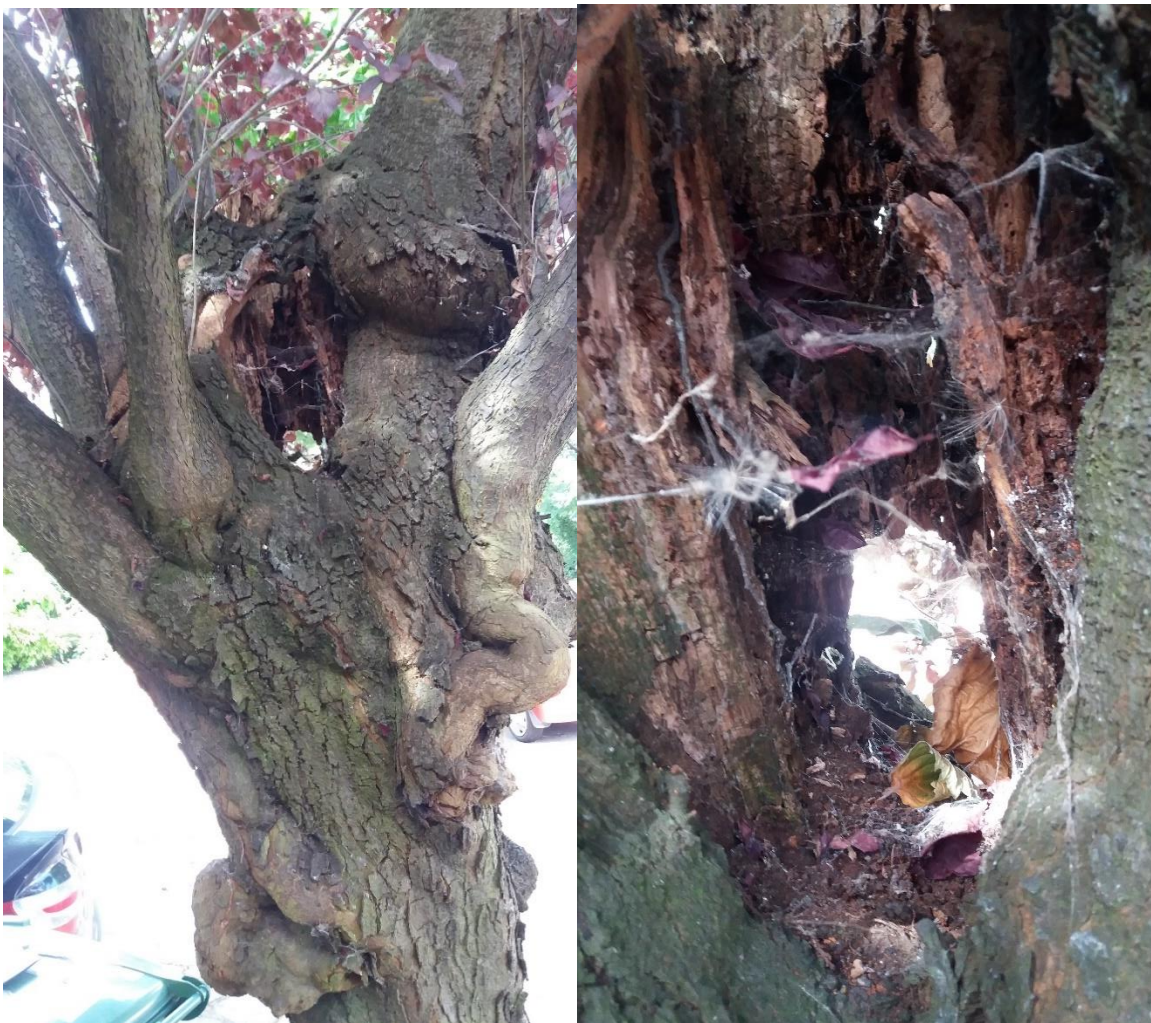
- 4.3 The proposed development includes the removal of two category C trees (T2 and T4) one at the front of the property and one at the rear.
- 4.4 T2 is a mature purple plum at the front of the property. This tree has a large decayed cavity in its central stem immediately below the main union as shown in Figure 2. The tree is beside the pavement and road and therefore has a high target area. It is considered that the tree is unsuitable for retention as it is in a hazardous condition and poses an unreasonable risk.

Figure 2. Cavity at 1.5m from ground level in main stem of purple plum T2.

- 4.5 It is proposed that T2 will be felled on safety grounds and a replacement tree planted in a similar location as part of final landscaping once the development is complete.
- 4.6 T4 is another purple plum which situated in the rear garden of the property on the south-eastern boundary. It is a category C tree with no public amenity value, but significant nuisance value – it is growing through the boundary wall. Thus, it can never be allowed to grow any larger due to the risk of further disturbance of the boundary wall. It is therefore proposed that T4 should be felled and a replacement planted in a more suitable location.

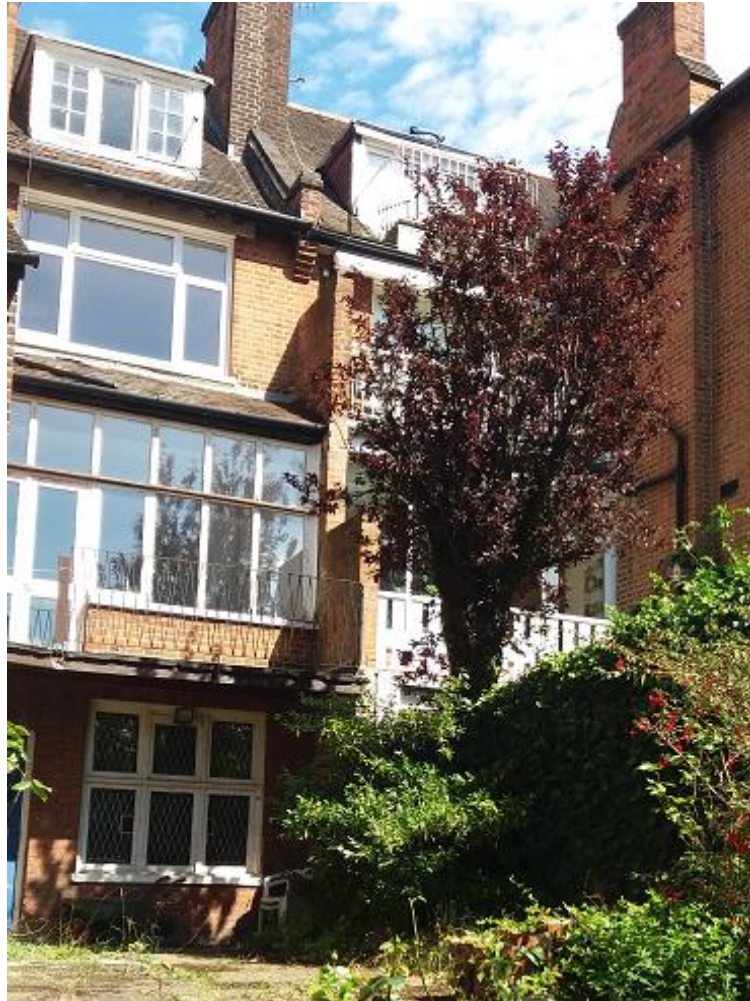
Figure 3. Purple plum T4 in the rear garden exhibiting poor form.

- 4.7 A large portion of the RPA of this tree would be affected by the proposed development, as it lies within the footprint of the extension and the basement.
- 4.8 The tree would be rendered unsafe for retention as a result of the development so it will be removed and replaced with a suitable ornamental native tree species in a more appropriate
