## BSi 5837 Tree Survey for Development

**CLIENT:** Vivien Bradley  
**SITE:** 28 Belsize Lane, Hampstead,  
London NW3 5AB  
**OUR REF:** 1150DCS2602  
**DATE OF  
REPORT:** 26 February 2017

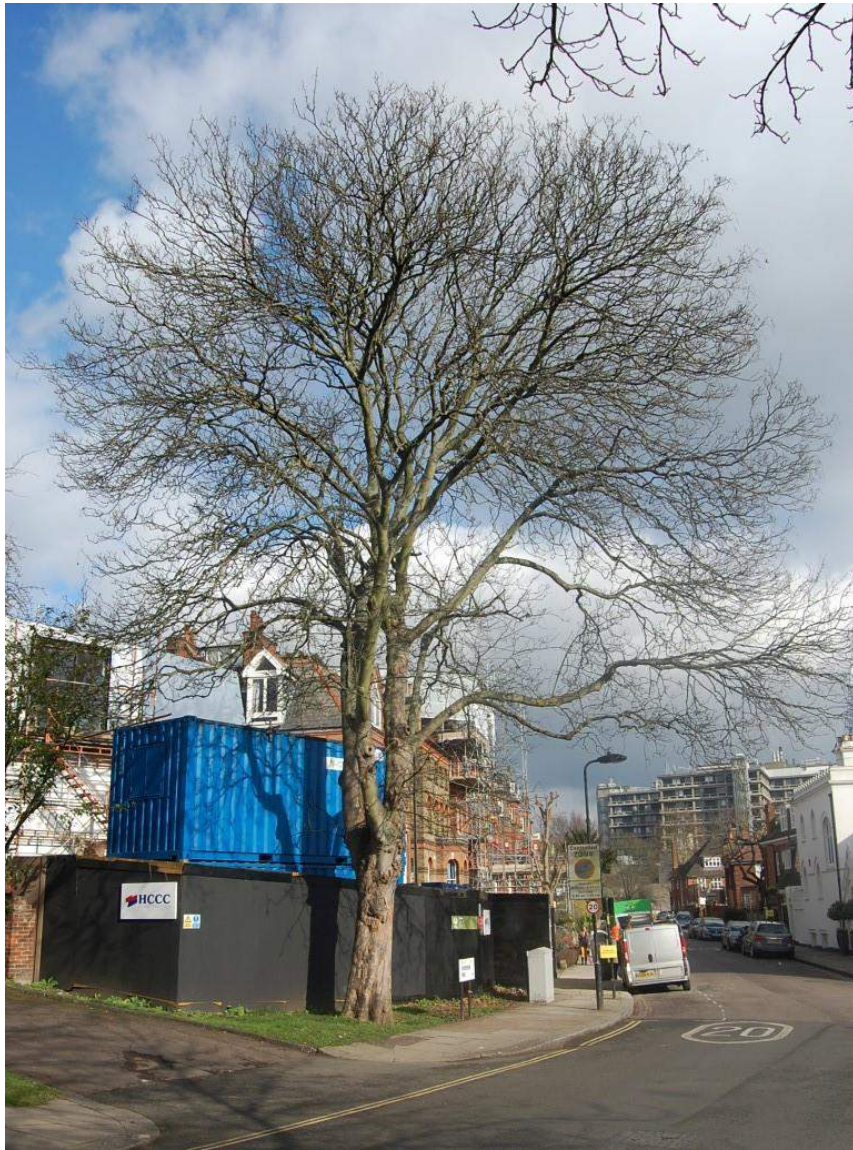
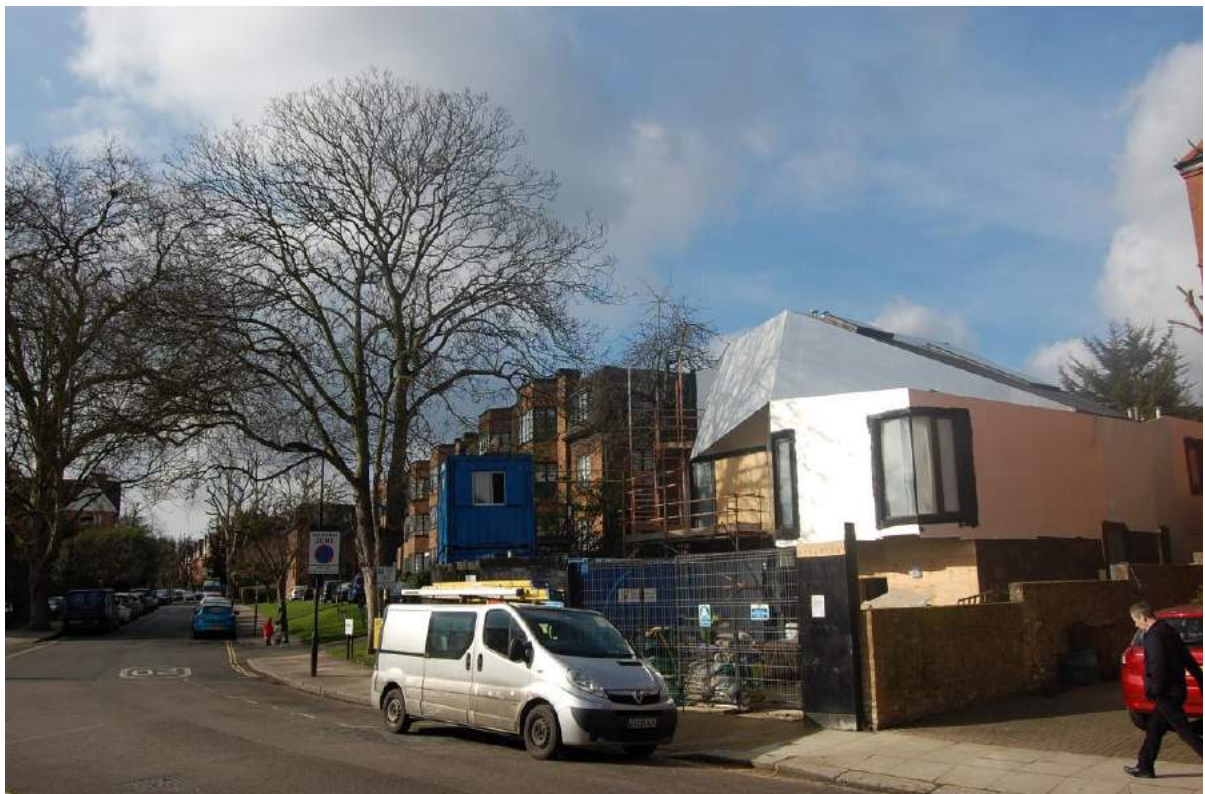
**Above / below:** T1 as viewed from the highway

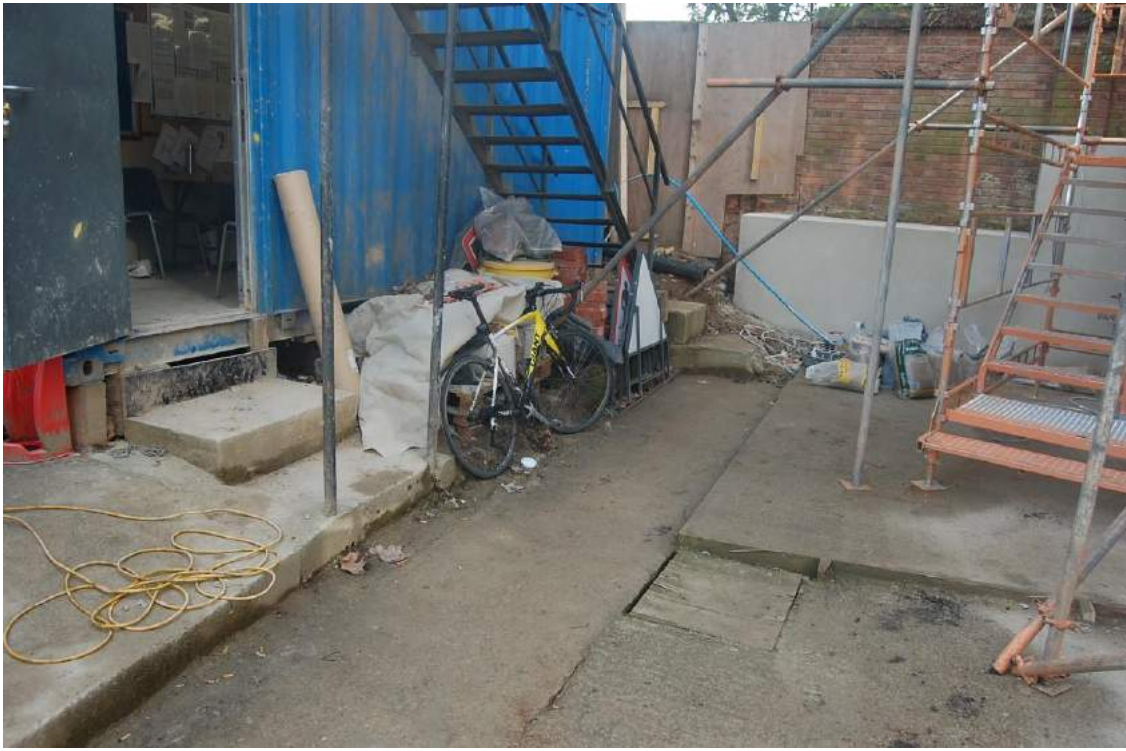
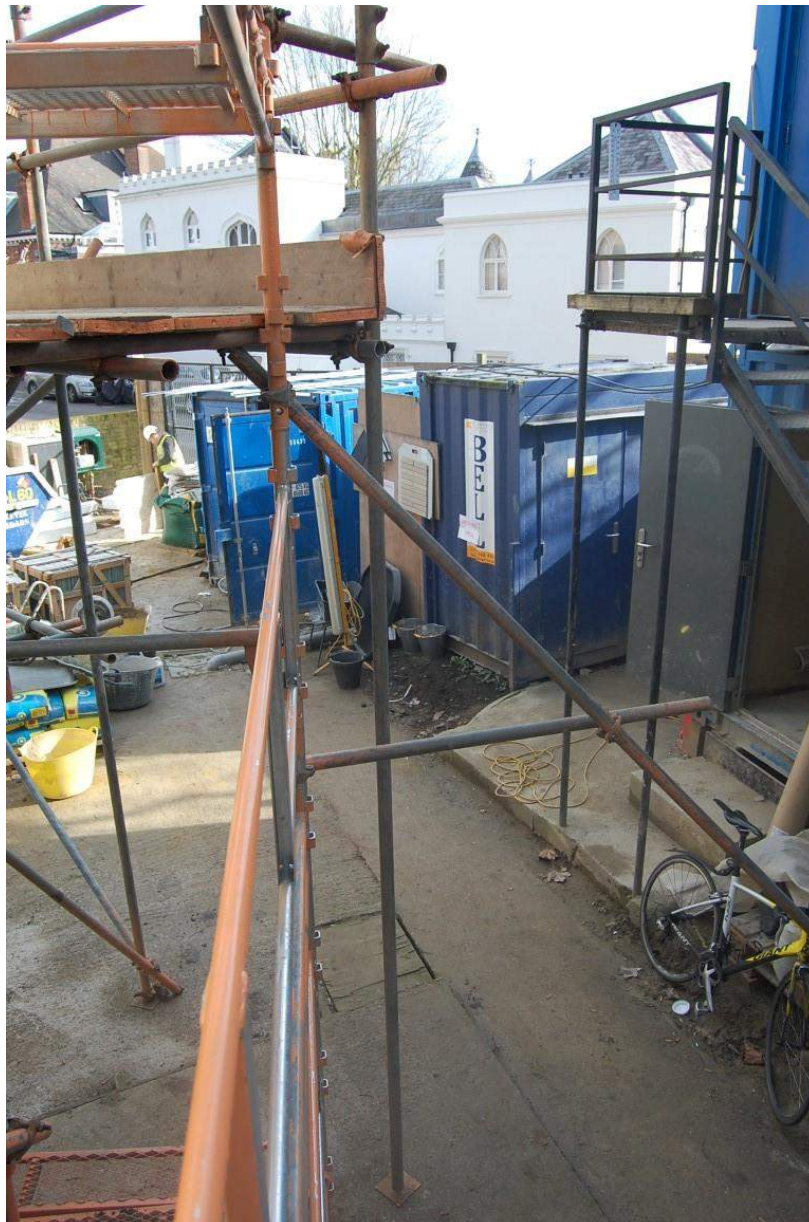
The soil within T1's RPA has been subject to considerable disturbance and compaction in the course of the construction and it is strongly advised that soil remediation measures are undertaken prior to soft landscaping works, to improve its structure, moisture infiltration/retention and nutrient content. Remediation will take the form of sub-soil aeration with the use of compressed air, and the incorporation of bulky organic mulch e.g. well composted woodchip or leaf mould – peat must not be used due to its potentially acidifying effects.

**Above / Below:** New front garden area - as currently exists
