This report contains the supporting tree information relating to the development proposal to refurbish and extend the existing building to include a new basement level and associated landscaping at 27 John Street, London.

This is an arboricultural impact appraisal report describing one magnolia tree (T1) near the development area, what the impact of the development proposal will be and how any adverse impact will be mitigated. It also includes an arboricultural method statement describing how the tree will be protected and managed during the development. Its purpose is to provide sufficient tree information for the LPA to assess the impact of the proposal on local character as part of the process of determining the planning application.

1.1 IMPACT ON ONE TREE (T1)

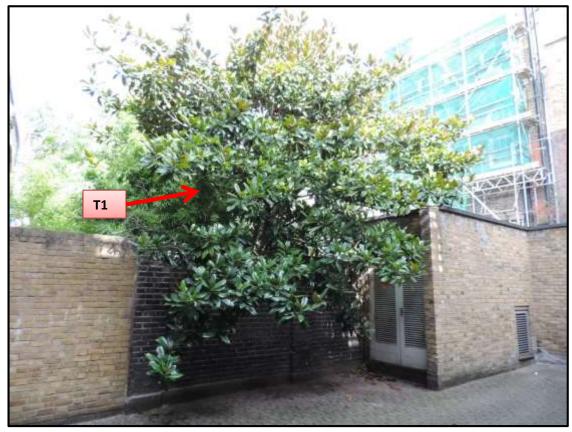
Tree 1: From the provided layout, only one tree (T1) growing in the adjacent property is close enough to be affected by the proposed basement works. Based on its estimated stem diameter it requires a RPA radius of 3.6m or an area of soil 41m². However, the tree grows about 0.5m from the boundary wall where the foundations are likely to have restricted root growth on this side (Image 1). From my observations, I believe it is unlikely that roots from this tree have found their way beneath the wall foundations and are probably growing in the adjacent garden. If this is the case, the tree is unlikely to be affected by the works. However, if some roots have managed to find their way beneath the wall foundations, special precautions will be required to investigate whether any roots are present using hand digging techniques. If roots are encountered, then it may be possible for careful root pruning to be done but this will need specialist advice and should only be done under a supervision agreement to minimise any adverse effects on the tree's health or amenity value. There are some small low branches that are likely to be restricting access for construction works but any necessary remedial pruning can be done without adversely affecting the health or visual amenity value of the tree.

Image 1: The foundations of the boundary wall are likely to be providing a significant root barrier on the side of 27 John Street.

The new basement will encroach into the outer extent of the RPA for the magnolia tree (yellow filled area). However, I have reviewed the situation carefully and believe that it would be feasible to first establish the extent of root growth through exploratory digs close to the edge of the existing boundary wall and where necessary, any significant exposed roots can be carefully cut back following the guidance in Appendix 3 (paragraph 7).
