BS5837 Arboricultural Impact Assessment

Garden Flat, 117 Priory Road, London, NW6 3NN

Job Reference: 02607Rv2

April 2017

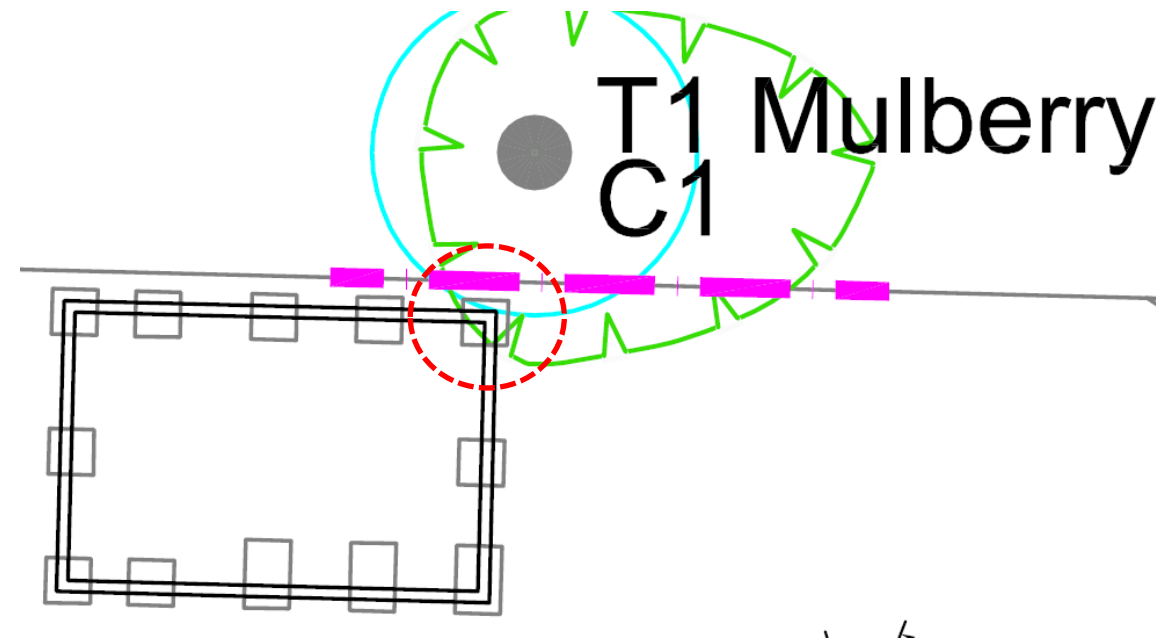
Fig 1 – Proposed pad installation relative to T1 (Mulberry)

5.4.1 The pad foundation will be located within the RPA of T1 as indicated below:

- Encroachment is <0.5% of the trees RPA.
- 99.5% of the trees RPA remain unaffected.
- Boundary wall acts as physical barrier to direct damage.
- Boundary wall likely to have deflected surface roots in the vicinity of the proposed pad location.

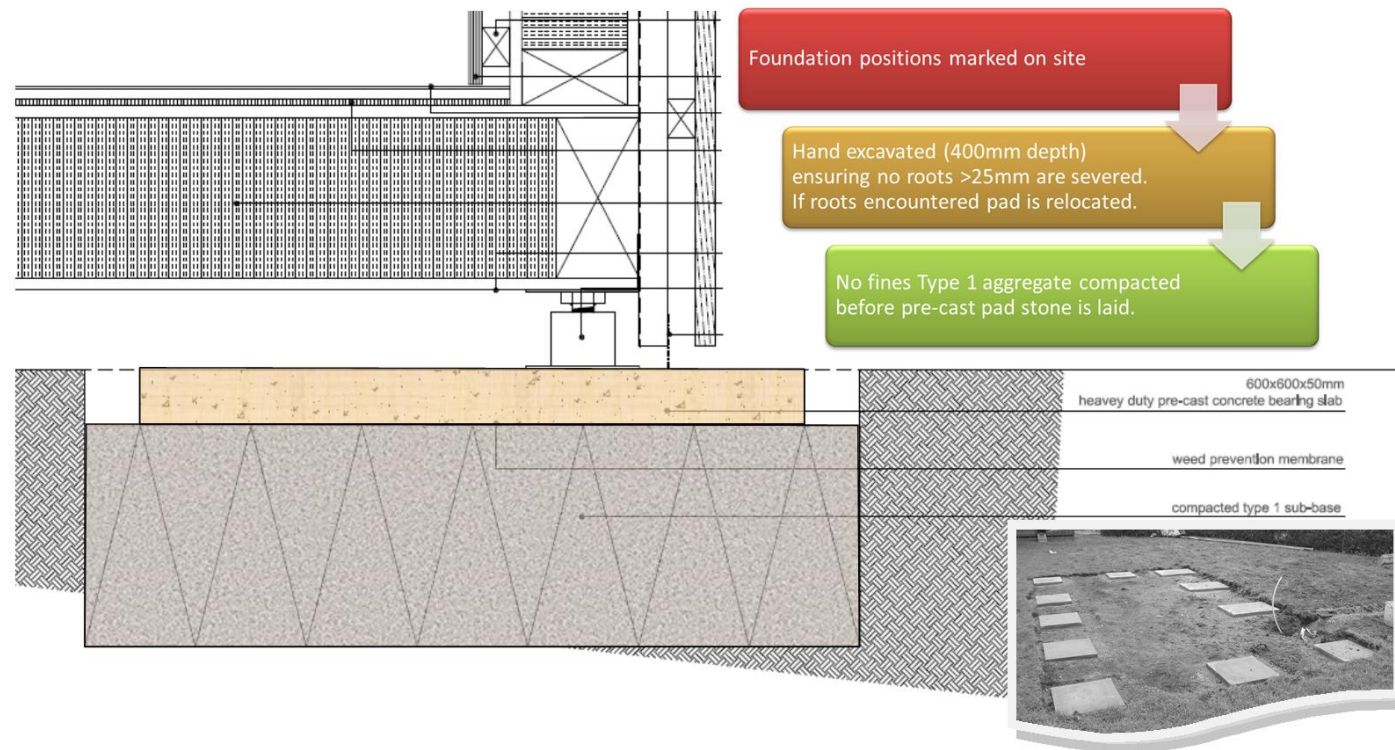
Fig 2 – Typical pad detail with installation (inset). This approach removes the need for a ‘strip’ foundation reducing the impact on underlying roots. Note: T1 encroachment so minimal that foundations unlikely to have any negative impact regardless of proposed type.

5.4.3 All hand dug pad excavations are lined with a non-permeable membrane prior to the wet pour of the pad stone. If the pad stone is a precast stone (depending on site conditions/ availability) there is no need to line the pad stone excavations.

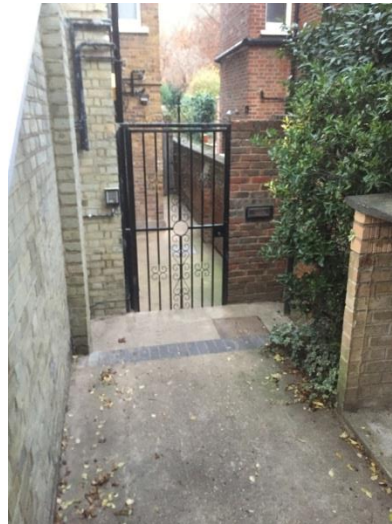
Fig 3 – Existing side access

- Existing side access point.
- Hard surface present already removes the risk of compaction to underlying soil close to T3 & T4

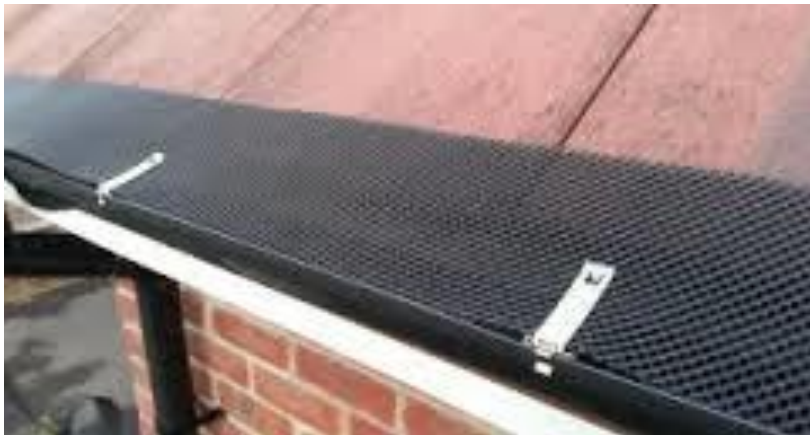
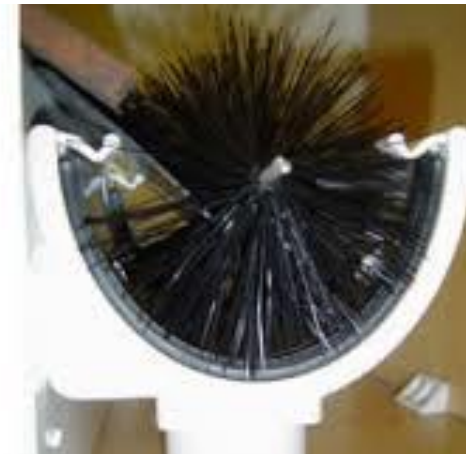
Fig 4 - Suitable gutter guards (2 types shown above) should be fitted to ensure that leaf drop from adjacent trees does not block new guttering leading to potential pressure for tree works.

- 5.6.1 The proposal will draw on the existing site services and any connecting trench for electric or water will run through the middle of the rear garden to locate it away from retained tree RPA areas.
- 5.6.2 To limit maintenance impact to the proposal from leaf drop given the proximity/ overhang of trees it is recommended that [gutter guards](#) be installed.

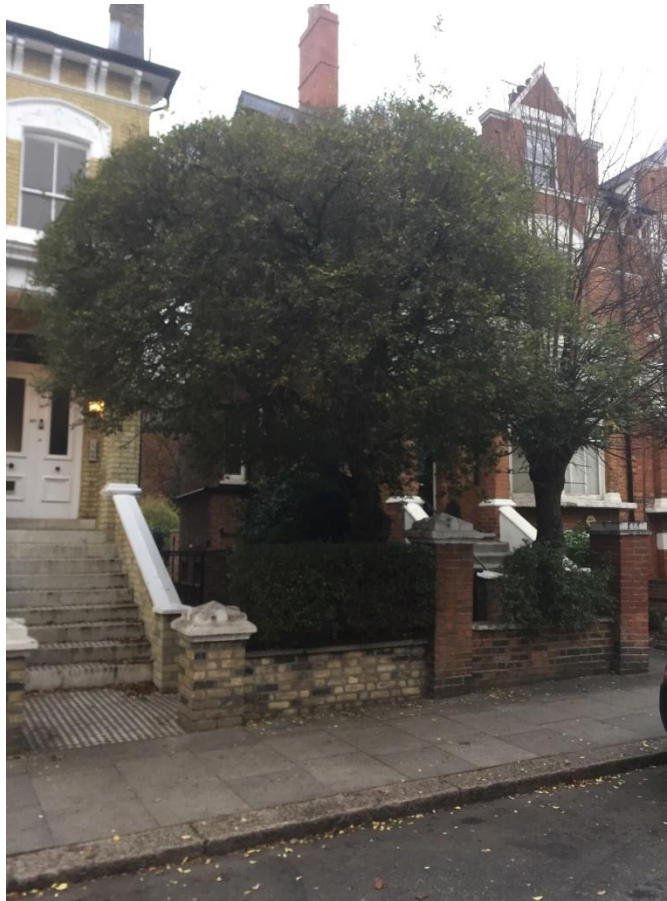
Image 1 – Site access/ clearance and T3 (Privet)

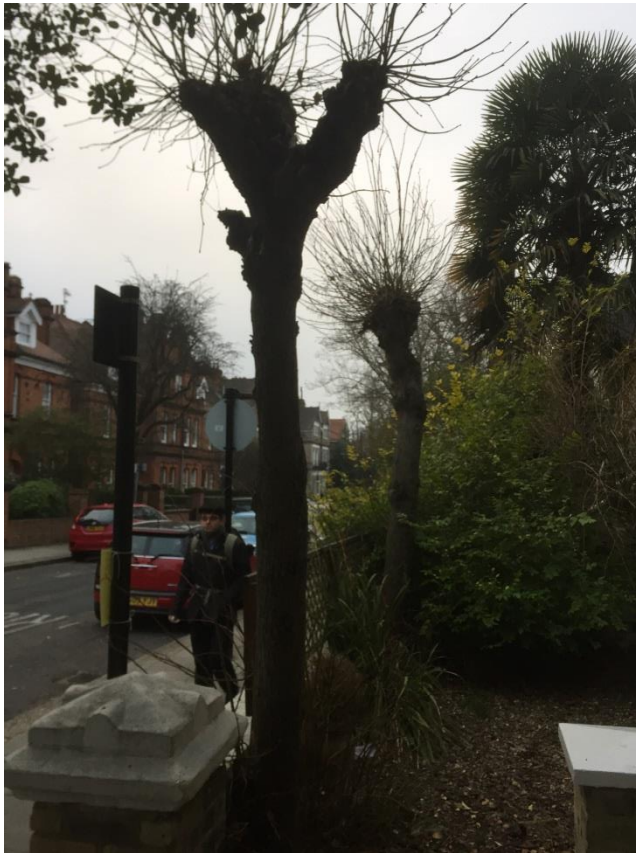
Image 2 – T4 (Lime)

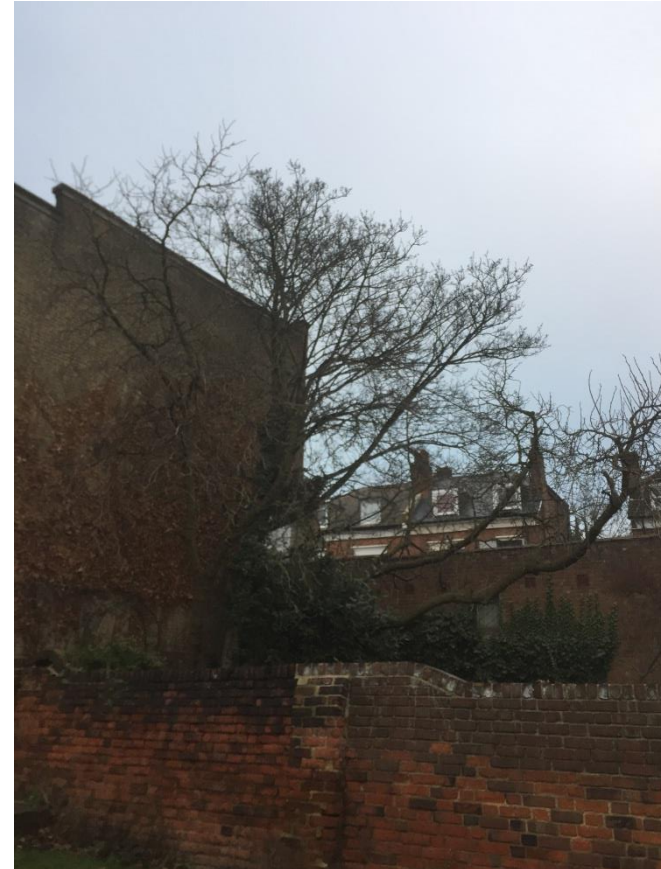
Image 3 –T1 (Mulberry) and existing boundary wall

- 1.4 No trees will be removed to facilitate the installation. Minor tipping back of branches from T1 (Mulberry) to provide 1m clearance from the new structure may be required. The exact level of work will be ascertained when the proposal is 'set out' on site.
