BASEMENT IMPACT ASSESSMENT

40 FROGNAL LANE

LONDON NW3 6PP

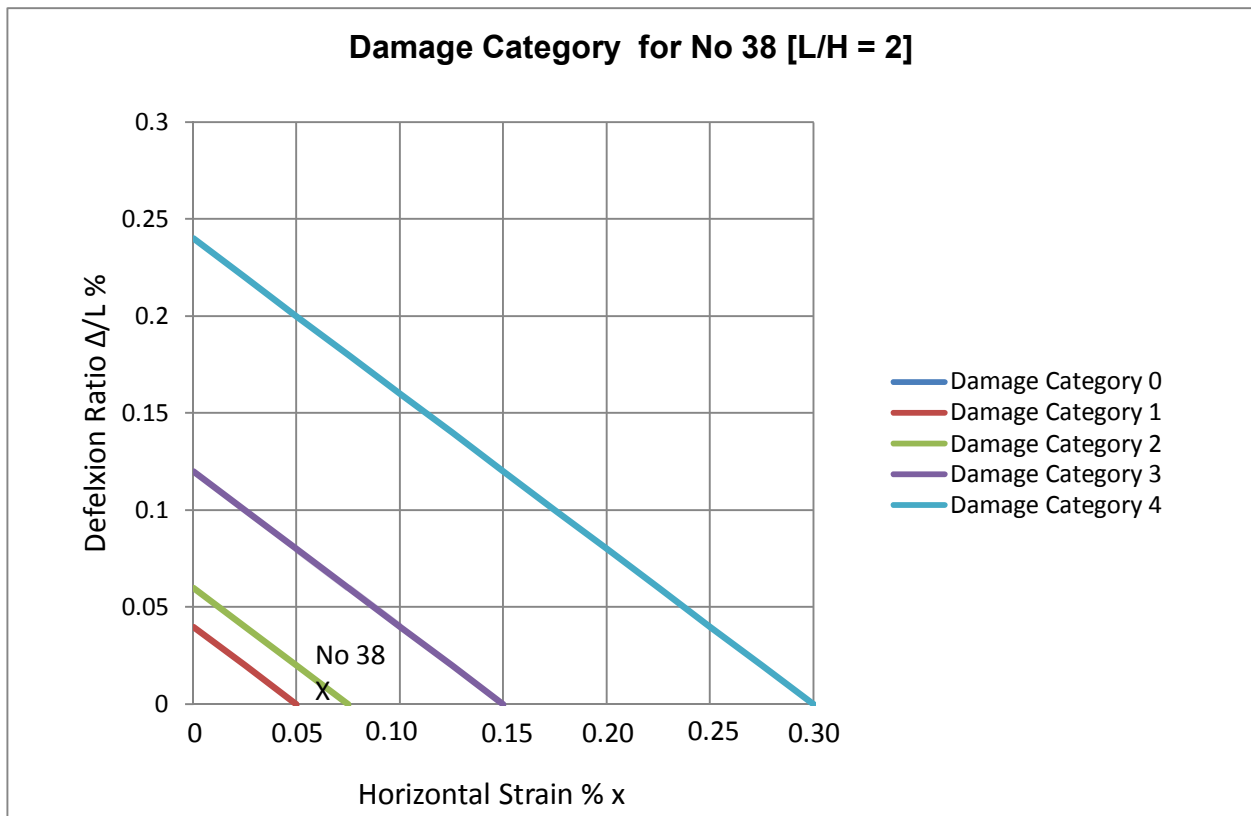
No 38 is of Damage Category 1

CPG4 Para 3.30, requires mitigation measures where the risk of damage is Category 1 or higher. The mitigation is that the pool excavation be propped.

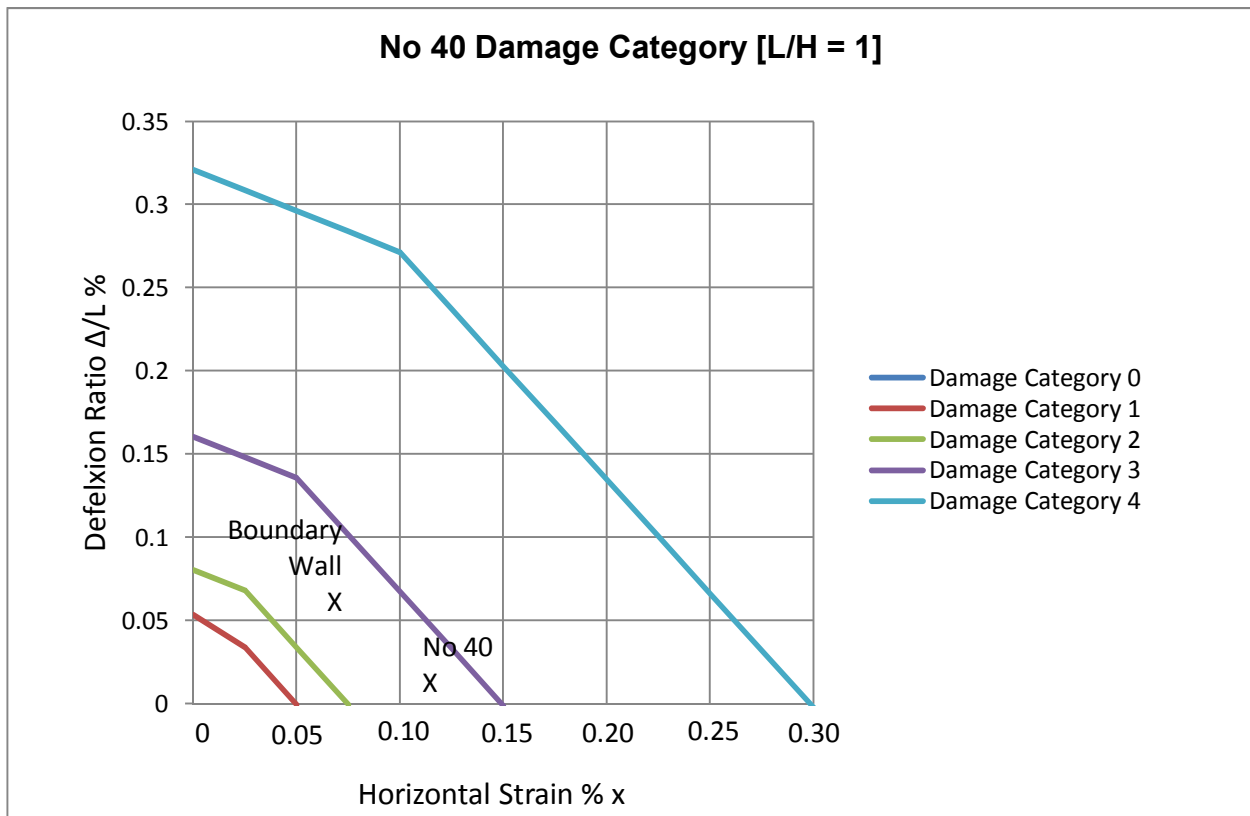
No 40 is of Damage Category 2. No 40 will be redecorated and repaired as part of the works. Redecoration and repair of No 38 can be addressed through the party wall award arrangements.
