Your ref: 0ur ref: 1-38-3816

Re: 5 Templewood Avenue, London, NW3 7UY

SAFETY APPENDIX

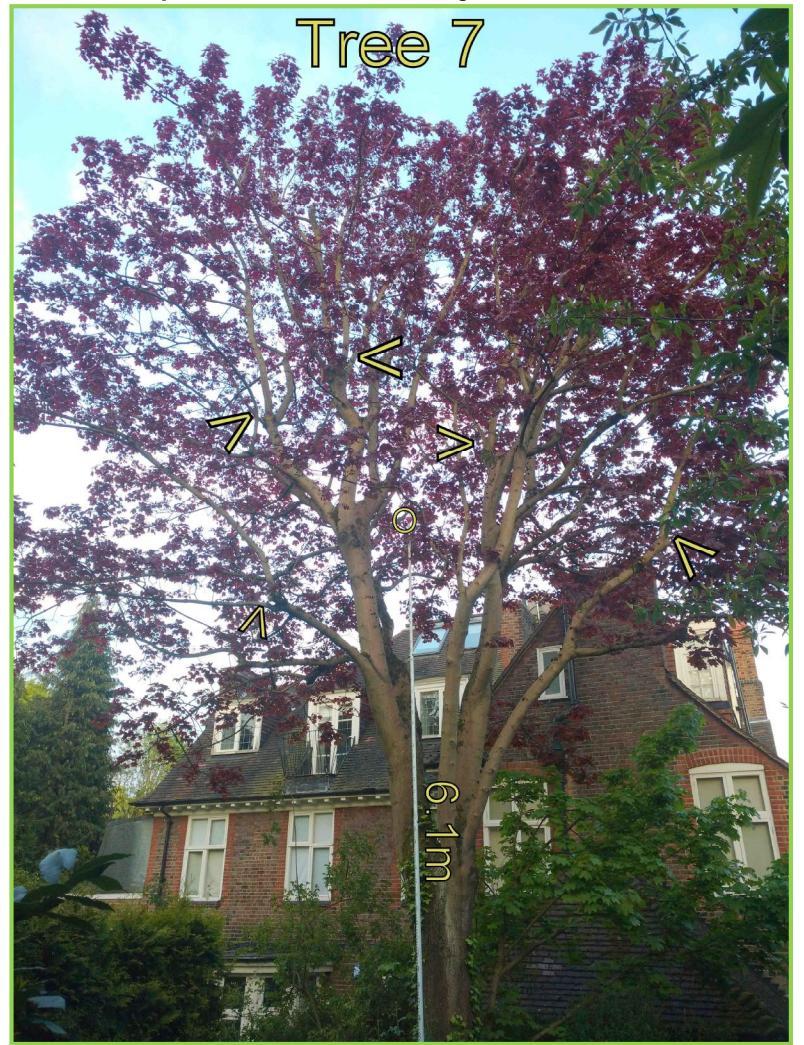
The classification assessment is a matter of where the tree lodges, so to speak, in the descriptive net, on the way down from the A category. Tree 7 has been reduced

very heavily in the past, to the points indicated on the photo below left. This pruning, for safety reasons, will, if the tree is not removed, need to be repeated soon, (and thereafter from time to time) to prevent the now long and heavy new shoots that have grown since that heavy reduction detaching and falling onto the house and into the garden. This means that the tree will inevitably be diminished in size, and also diminished as regards any small contribution it makes to public amenity (see photo below, overleaf). The tree is also rather one-sided by reason of a tree now long-removed which stood to the rear (NW).

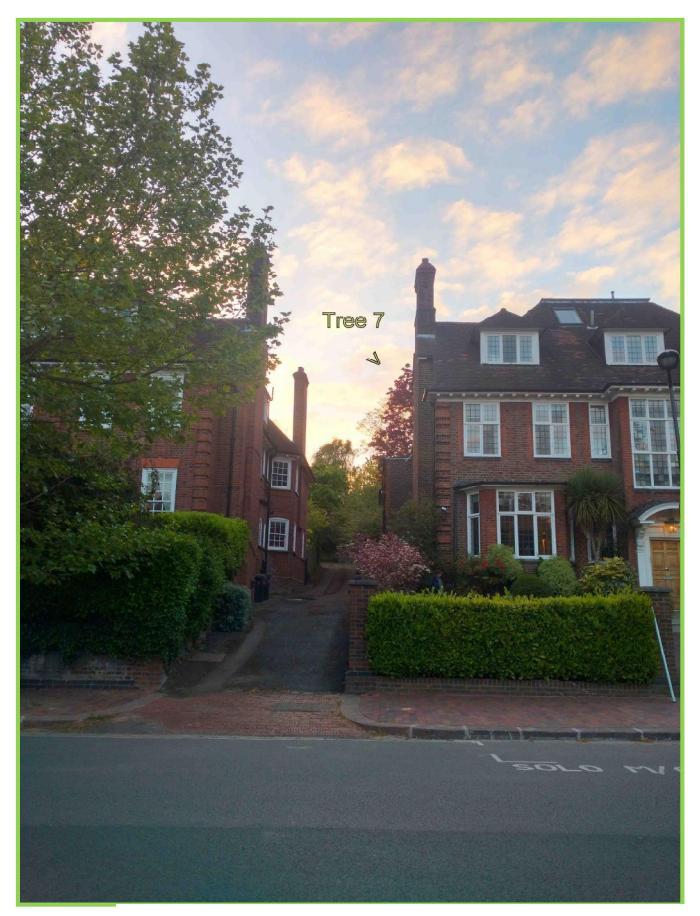
As can be seen the tree currently makes only a very limited contribution via a partial and glimpse view from Templewood Avenue. The only private households that have any reasonably close view of the tree are nos. 7, 5a, and 3 Templewood Avenue. I therefore consider the tree to be unremarkable and to most naturally fall into the C category.

It follows that the removal of the tree will have negligible impact on public amenity. Whilst a landscaping scheme is not currently agreed, I see no reason why a suitable replacement tree could not be agreed between LPA and client and thus satisfactorily address public and private amenity concerns.

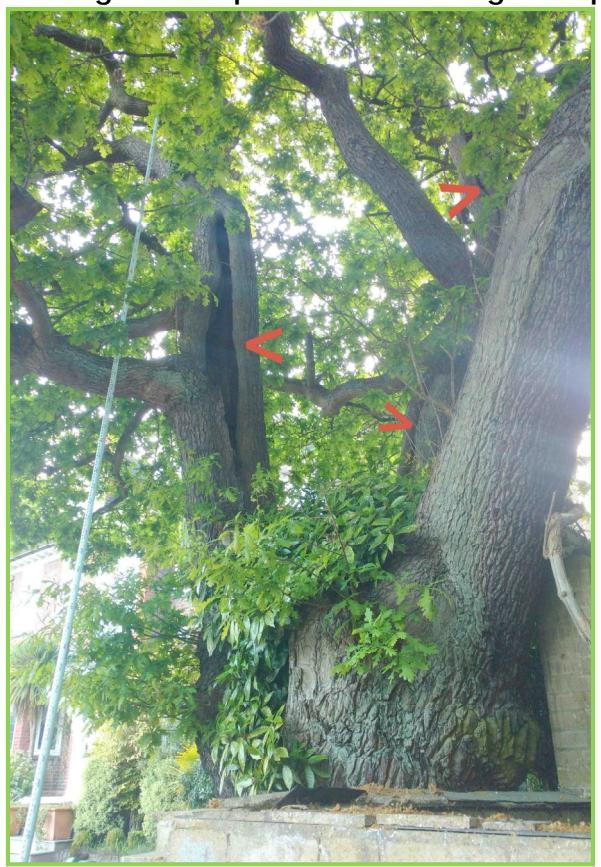
4) Major limbs are also affected, probably by the same fungus. See photo below :

The whole tree is likely now rather inflexible and has little tolerance of bending or flexing. For this reason the tree should in the short term be maintained at around 9m in height and spread. Further regular appraisal is absolutely required to determine

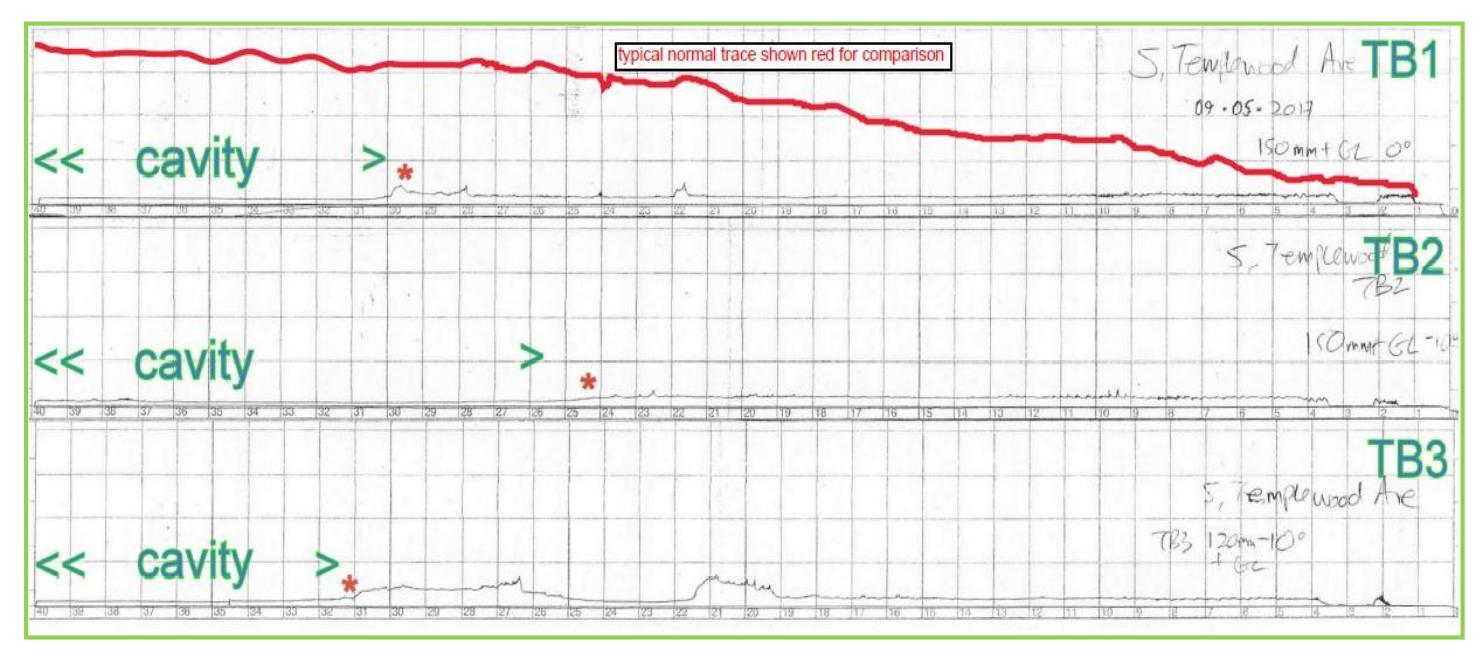
1) I carried out three test bores with a 'Resi F400', an instrument that reveals the position and extent of decay in trees. It incorporates a very fine drill that penetrates 400mm into the tree. The instrument draws a trace which can be interpreted by a trained person to indicate the presence or otherwise of decay.

The traces are very low in comparison to the typical norm for oak wood. There is very little wood indeed where any normal 'peak' characteristics (see TB3 at 20-21 cm, TB1 at 22cm etc.) are present. The red asterisks are where 'barrier zones' (after Shigo) should form. These are typically (when the response of the tree to decay is vigorous) zones of rapid transition from high to low trace : in this case in each of the three test bores no such pattern was observed – the slope is by contrast very shallow. It can be concluded that the defensive response of the tree is almost zero and that the decay is probably rapidly progressive.

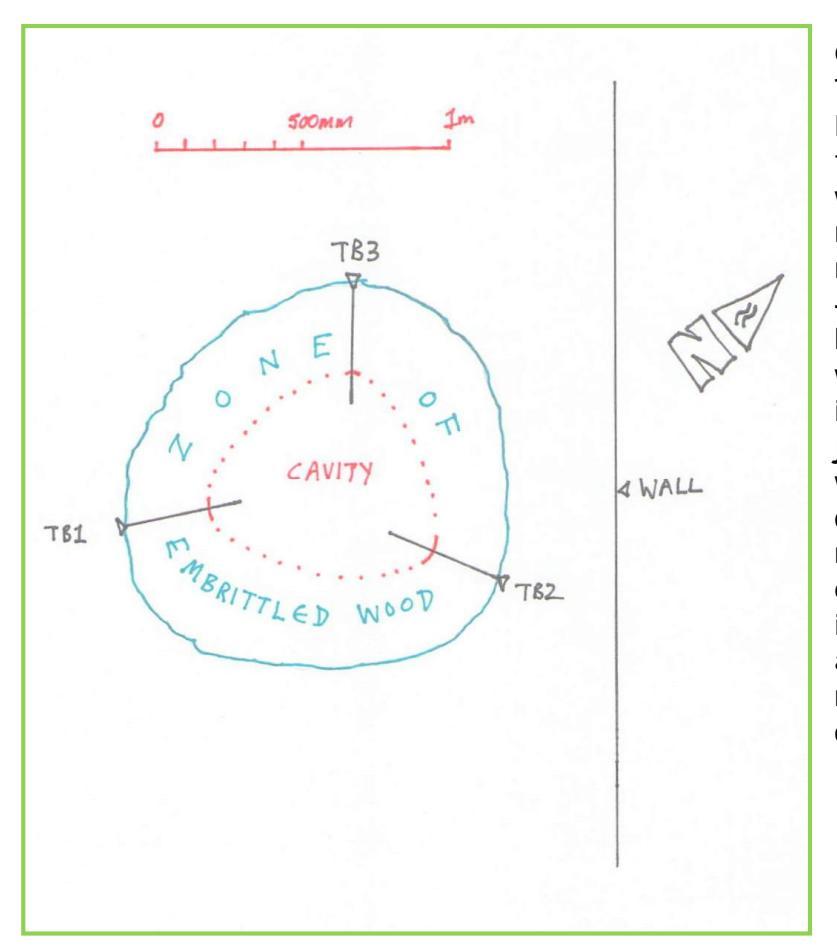
CROSS SECTION OF BASE OF TREE

2) Criteria exist for establishing the significance of decay in trees. Using a formula suggested by Mattheck (*Mattheck and Breloer*, 1994) for this purpose, given the diameter of the tree (+/-1300mm) the minimum residual wall thickness (the outer part of the tree's cross section – the bark and sapwood zone) in this case would be 390mm. However, this is for an unreduced tree.

Note that in the diagram left the width of the outer zone at would typically be on the margin of sufficiency to maintain the tree at full height - perhaps 17-20 metres in height - if the zone was of wood at full strength. It is not, in this case, and therefore a judgement is necessary as to whether the embrittled wood can support the tree even at reduced height. It is my opinion that further reduction is required (as recommended above) to maintain the tree in reasonably safe structural condition in the short term.
