Simon Pryce Arboriculture

Report

Site: 17/19 Lyndhurst Terrace, Hampstead, London, NW3 5QA

Subject: Trees in the garden and the effects of proposed building work at no.15.

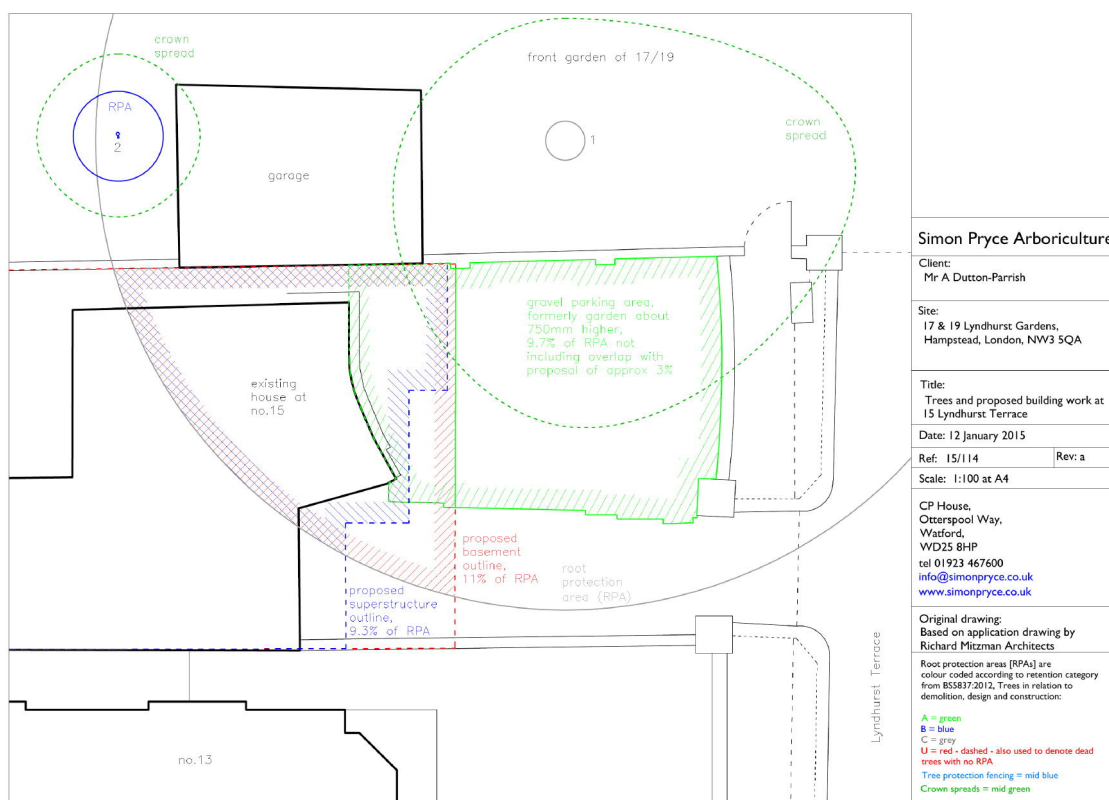
- 4.9 A substantial part of the tree's RPA is under the front garden of no.15 and the boundary wall is unlikely to be deep enough to be a barrier to root growth, so it will have been affected by recent changes there as well as the proposed works. The tree would have been present when the ground level in the front garden was raised by depositing the topsoil. During the 50 or so years that the soil was present was present roots will have grown into it and, as they need air as well as water, they are likely to have proliferated at the expense of the deeper roots. The area concerned is about 53m² or about 12.7% of the RPA although, as the area has been resurfaced, it is not possible to tell exactly what the effect on the roots was.

- 4.10 The tree was not in leaf when inspected but from the appearance of the twig growth it has tolerated the removal of the soil. However the basement footprint takes up about 11% of the RPA. There is some overlap with the former raised garden, so the overall incursion into the RPA is just over 20%. A younger healthier tree might tolerate that but, while this one is in reasonable physiological condition for its age, the cumulative effect of the recent and proposed ground work nearby would carry a high risk of harming it significantly. The loss of small feeding roots at the periphery of the root system would reduce its ability to absorb water and nutrients. Most of the main structural roots are within about 3x the trunk diameter, so with this tree these would be within no.17/19 and the work would be unlikely to affect the tree's stability directly. However damage to slightly roots could lead to the tree being colonised by honey fungus, which could kill it or decay the roots, leading to longer term stability problems. The fungus is present in the gardens and is a virulent form that has already accounted for several tree losses.

Simon Pryce Arboriculture	
Client: Mr A Dutton-Parrish	
Site: 17 & 19 Lyndhurst Gardens, Hampstead, London, NW3 5QA	
Title: Trees and proposed building work at 15 Lyndhurst Terrace	
Date: 12 January 2015	
Ref: 15/114	Rev: a
Scale: 1:100 at A4	
CP House, Otterspool Way, Watford, WD25 8HP tel 01923 467600 info@simonpryce.co.uk www.simonpryce.co.uk	
Original drawing: Based on application drawing by Richard Mitzman Architects	
Root protection areas (RPAs) are colour coded according to retention category from BS5837:2012, Trees in relation to demolition, design and construction:

- 4.11 With a basement there is no possibility of using less damaging techniques, such as piled foundations. However much of the area affected is near the outer edge of the tree's RPA and a substantial part of the new house is outside it completely. Therefore a relatively small reduction in the extent of the nearer part of the new house, such as limiting the extent to the north to match the existing one, would reduce the risk to the tree significantly. However the detailed design of that is a matter for others.

- 4.12 The proposed work is a relatively large scale project for a site like this and will involve major excavation with heavy plant and vehicles to remove spoil. The boundary wall will provide some protection but the tree would be vulnerable to incidental harm from soil compaction or contamination. The applicants' tree report, rightly, refers to protective measures but does not go into any details. Therefore if consent is granted for any building work it should include a condition requiring a detailed tree protection plan and method statement to be submitted and approved before any work starts.
